December 17, 2019
ES-2074.08

**Subject: Geotechnical Evaluation
 Failing Bulkhead
 10750 Northeast Broomgerrie Road
 Bainbridge Island, Washington**

Bulkhead Site Plan Manlowe SFR Bainbridge Island, Washington

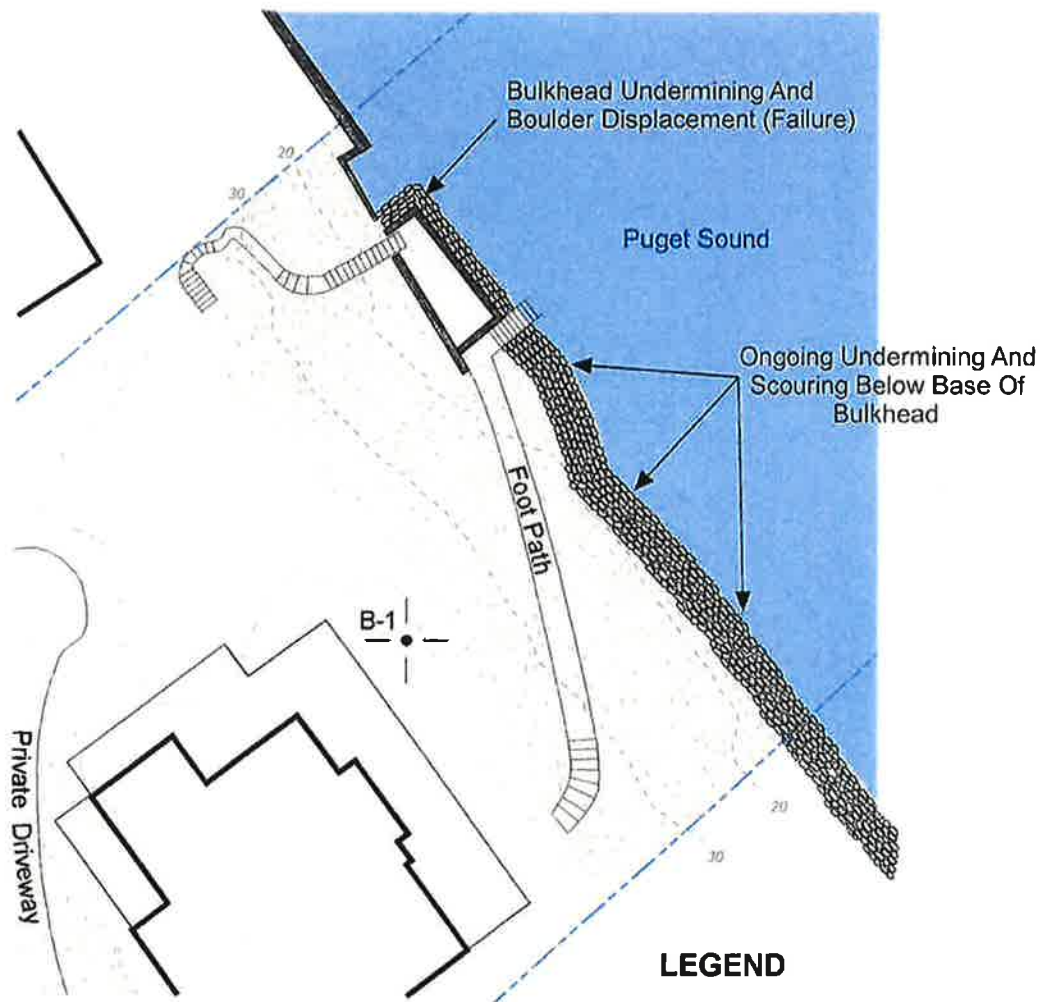
As requested, Earth Solutions NW, LLC (ESNW) has prepared this letter and evaluation of the existing bulkhead alignment along the shoreline frontage of the property. The attached site plan (Plate 1) illustrates the subject site and associated bulkhead structure. A boring log representative of the site geology above the slope is also provided. Indications of bulkhead displacement and related dislodging of boulders has recently been observed. Overall degradation of the decades old bulkhead is also ongoing and has been evident over the past several years. The undersigned ESNW representative visited the site in October 2019 and recently on December 6, 2019. During our October 2019 site visit, the effects of ongoing bulkhead displacement were evident along the beach access trail that descends from the rear yard area of the residence. Most notable were localized areas of downset along the descending slope areas above the bulkhead structure. A follow up visit by the undersigned on December 6, 2019 indicated a worsening of the downset below the trail and obvious additional indications of continued bulkhead displacements. During our December 6, 2019 site visit, a representative of Ellisport Engineering, Inc. was also present. Most concerning at the time of our December site visit was the degree of scour along the bulkhead alignment and the absence of keyway support below the base boulders. A partial collapse of the bulkhead near the north end of the structure was also identified and was determined to have resulted from the ongoing undermining of the structure.

From a geotechnical standpoint, there is a high degree of certainty that failure of the entire bulkhead is imminent. Based on the compromised nature of the structure that has resulted from scour and undermining, we recommend steps be taken immediately to replace the bulkhead. Given the bulkhead support afforded to the descending slope and associated residence above, an immediate and imminent threat to the property exists. Collapse of the bulkhead structure would most certainly result in a progressive failure of the descending (high bank) slope areas, likely resulting in significant impacts to the residential structure above. As such, and given a high degree of certainty that the bulkhead could fail during the current winter storm season, we recommend the owner and engineer immediately engage the services of a bulkhead contractor and contact the City of Bainbridge Island to declare an emergency with respect to the condition of the bulkhead. ESNW will be available, as necessary, to provide geotechnical support during the implementation of repairs and related bulkhead replacement.
