Re: Fisher Residence - Final Letter for Geotechnical Special Inspections 12400 Sunrise Dr. NE, Bainbridge Island, Washington – Permit No. BLD22704 Aspect Consulting Project No. 160350

11	E: 11/16/2017 (THU) Report #001	PROJECT NO.: 160350	PROJECT NAME: Fisher Residence Slope Protection
WEA ⁻	WEATHER: Partly cloudy, 50's °F		PROJECT LOCATION:
		MUNICIPALITY: City of Bainbridge Island	12400 Sunrise Dr. NE Bainbridge Island, Washington 98110
то:	TO: Mark Fisher 12400 Sunrise Dr. NE, Bainbridge Island, WA 98110		ENGINEER: Aspect Consulting, LLC CONSTRUCTION MANGEMENT:
			GENERAL CONTRACTOR: GSI
			LANDSCAPER: Reyes Lawn Service
EQUI	PMENT USED:

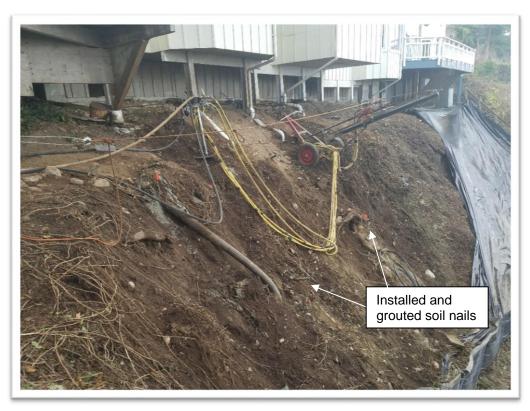
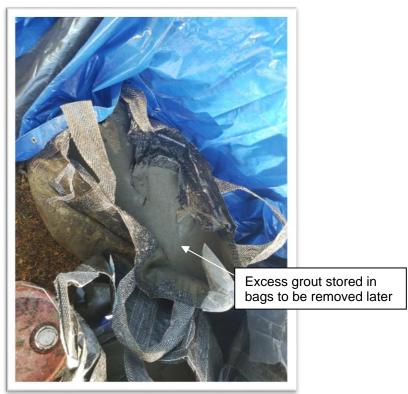
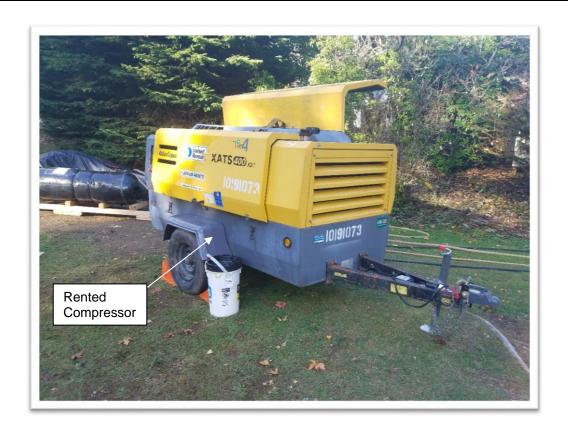
The contractor, GeoStabilization International (GSI), drilled 2 soil nails and 1 perimeter anchor today in the Southern Stabilization Area, numbered A3, B3, and B3_V (see attached installation schematic). Drill logs were recorded for each nail and the encountered soil conditions during drilling were consistent with project design assumptions and plans. All nail lengths, bar diameters, and materials were installed in accordance with the project plans. The soil nails and perimeter anchors were laid out using field measurements according to the approved plans. All 3 nails and anchors were grouted today. Grout test samples were collected for compression testing, to be completed by MTC, contracted to GSI. Results from the grout compression testing will be included in future reports. Excess grout used for priming was placed into impervious bags to be removed from the site once set (see photo). Drilling production was cut short today when the compressor broke down (see photo).

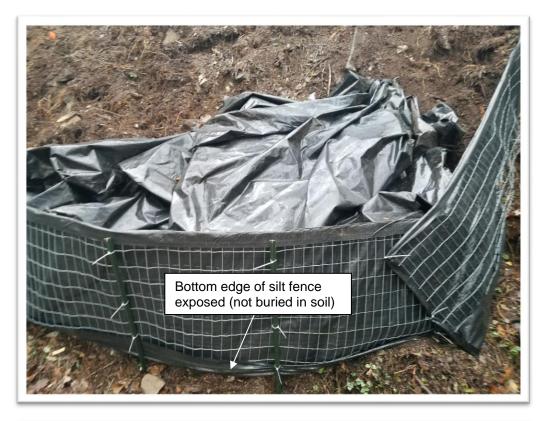
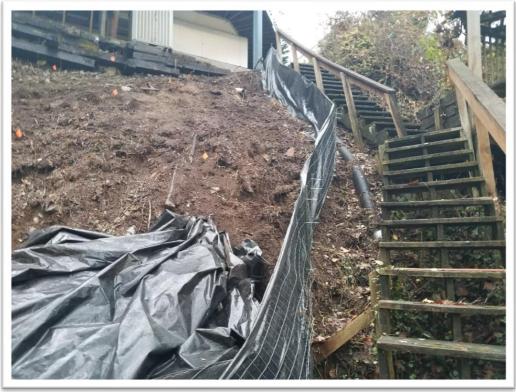
All earthwork is interior to the site. We observed that the bottom edge of the silt fence in the northeastern corner of the work area had been exposed and was no longer buried by soil (see photo). We brought this to the attention of the contractor. We were informed that the landscaper will repair the silt fence tomorrow. We recommended that the contractor postpone work in this area until the section of silt fence is repaired. Besides the exposed section of silt fence, all temporary erosion control measures are functioning appropriately. The entrance/exit to the site and the nearby street are clear of tracking. We observed the contractor consistently using Duradeck traction plates and plywood to reduce soil disturbance and tracking by equipment. The only vehicles entering or leaving the site today were driving exclusively on clean pavement.

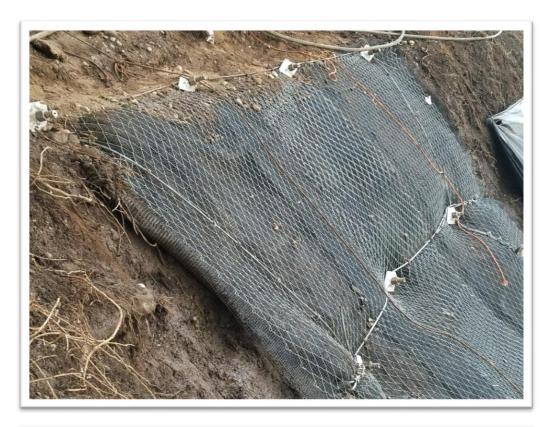
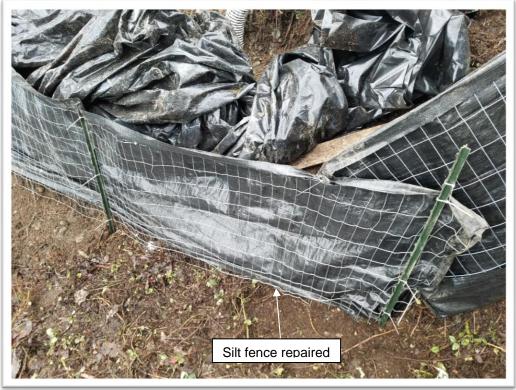
All earthwork is interior to the site. All temporary erosion control measures are functioning appropriately. The section of silt fence that was exposed has been repaired (see photo). No sediment was observed passing over or under the silt fence. The entrance/exit to the site and the nearby street are clear of tracking. We observed the contractor consistently using Duradeck traction plates and plywood to reduce soil disturbance and tracking by equipment. The only vehicles entering or leaving the site today were driving exclusively on clean pavement. In our opinion, the work area is appropriately stabilized for erosion control; the TESC elements are generally performing as intended, and if properly maintained, will minimize the chance for erosion and off-site sediment transport.

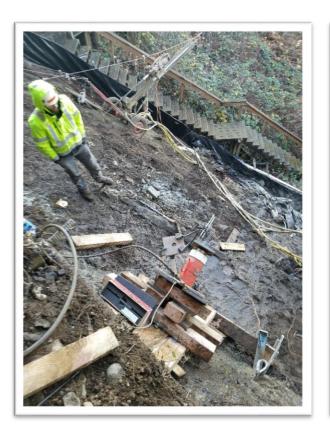
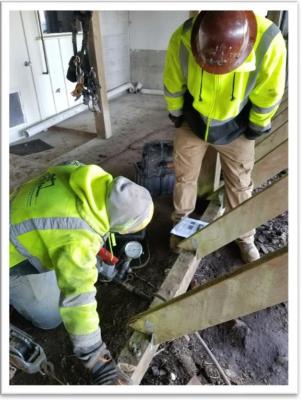
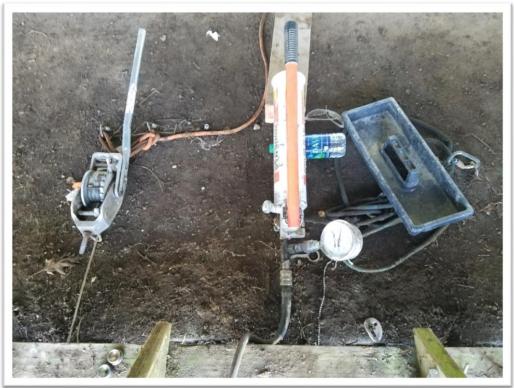
A proof test was performed today on a production soil nail (B1 in the Shotcrete Wall) following the FHWA Soil Nail Walls Manual, 2015, NHI-14-007 (see photos). The location of the proof tested soil nail is shown on the attached installation schematic. Aspect observed and recorded the total displacement and creep displacement as the nail was loaded to a test load of 42 kips, which was then held for 10 minutes. The observed total displacement and creep displacement were within project specifications.

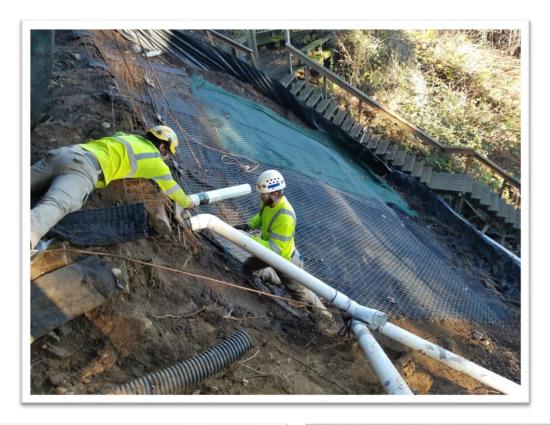
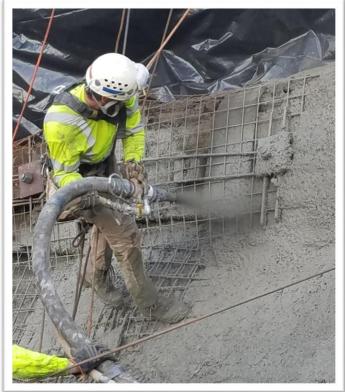
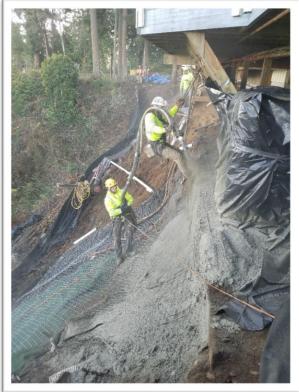
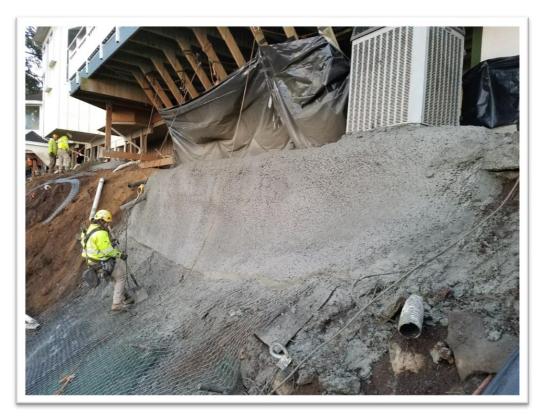
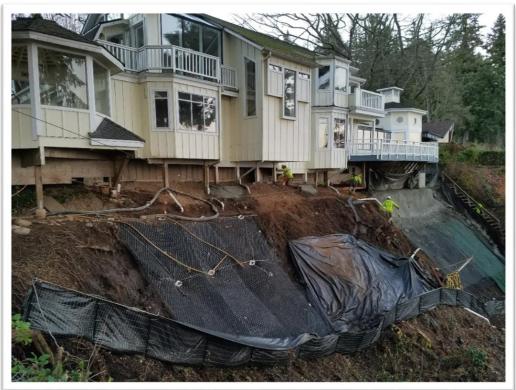
The contractor finished installing the reinforcement for the Shotcrete Wall today (see photo). The wall will be faced with 4-inch-thick shotcrete reinforced with welded wire mesh (WWM), steel bearing plates, and horizontal and vertical rebar. We observed the reinforcement and drainage strips were installed according to the approved plans. A PVC drainage pipe that daylights out the face of the Shotcrete Wall was extended and capped during shotcrete application (see photos). This pipe

will be tied into the drainage system later. We observed shotcrete being applied to the entire wall face and being pumped into the void space within the timber cribbing (see photos).

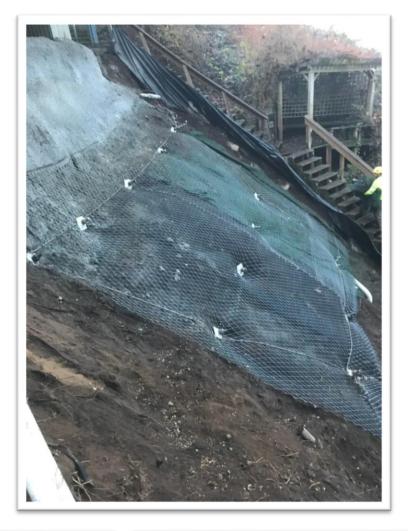
A proof test was performed today on a production soil nail (B4 in the Northern Stabilization Area) following the FHWA Soil Nail Walls Manual, 2015, NHI-14-007 (see photo). The location of the proof tested soil nail is shown on the attached installation schematic. Aspect observed and recorded the total displacement and creep displacement as the nail was loaded to a test load of 42 kips, which was then held for 10 minutes. The observed total displacement and creep displacement were within project specifications.

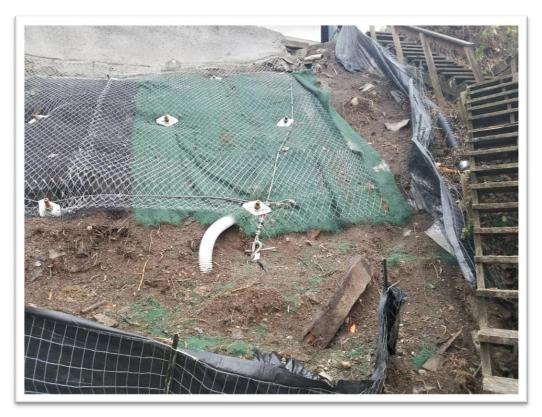
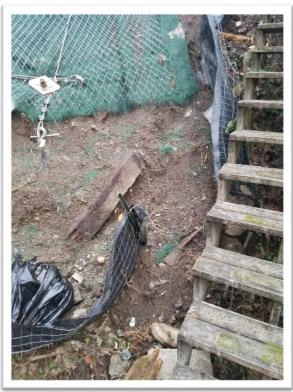
All temporary erosion control measures are functioning appropriately. A silt fence is in place along the downslope edge and sides of the project area. We observed that a section of the silt fence in the northeastern corner of the work area has been damaged and is no longer continuously enclosing the cleared area (see photos). We brought this to the attention of the contractor. We were informed that the landscaper will repair the silt fence in this area. Besides the damaged section of silt fence, all temporary erosion control measures are functioning appropriately.

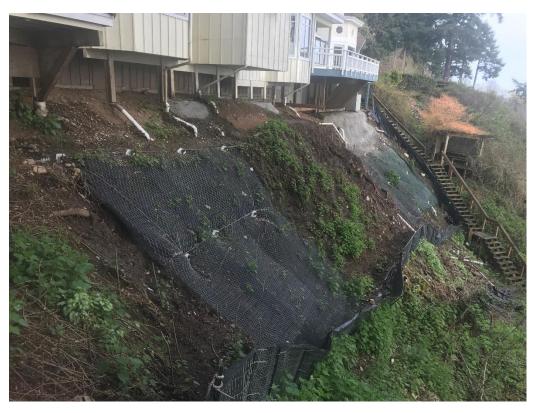
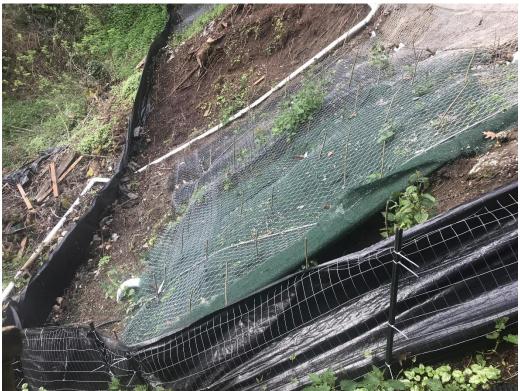
Aspect staff visited the site at the request of the client, Mark Fisher, to observe performance of the permanent erosion control measures. We observed that erosion control blankets were in place underneath the mesh behind the soil nails, and that live stakes had been planted according to the approved planting plan by Sound Native Plants throughout the entire disturbed area of the slope face. The live stakes have not started budding or sprouting yet, but appear to have been properly installed through the mesh.
