RE: Wyatt Way NE and Madison Ave N project

I was asked by Cutler Anderson Architects to assess trees growing on the southeast corner and close to the northeast of the property they are designing at the northeast intersection of Madison Ave North and Wyatt Way NE. I completed a Level 2 assessment of these trees on May 24, 2017. All levels of tree assessment are detailed in an attachment to this memo. See approximate tree locations on the attached Site Maps.

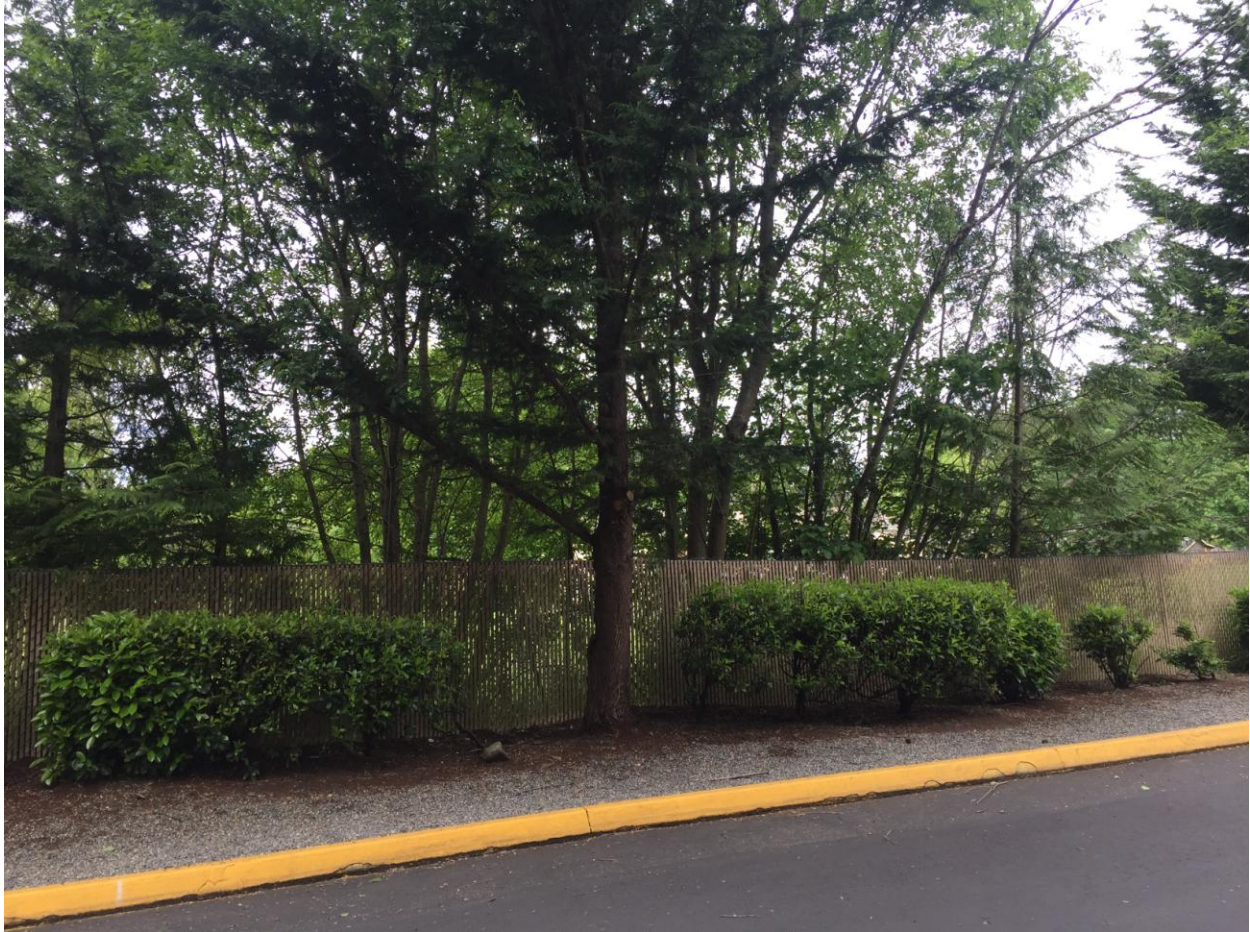
Leyland cypress – 11.5" and 11.5" DBH (Photo 1): Both of these trees are young and growing vigorously. They have been pruned to keep foliage from extending to the east. The mature size of these trees is considered large (over 30' wide x 30' tall). Although these trees are in good condition they are not the best candidates for leaving in this growing area.

Photo 1: One of the Leyland cypress trees.

- If retained provide tree protection fencing on all sides installed at 8' from the trunk. (One contiguous line of fencing can be provided from the southeast corner of the property to 8 feet north of the northernmost cypress instead of encircling each tree).

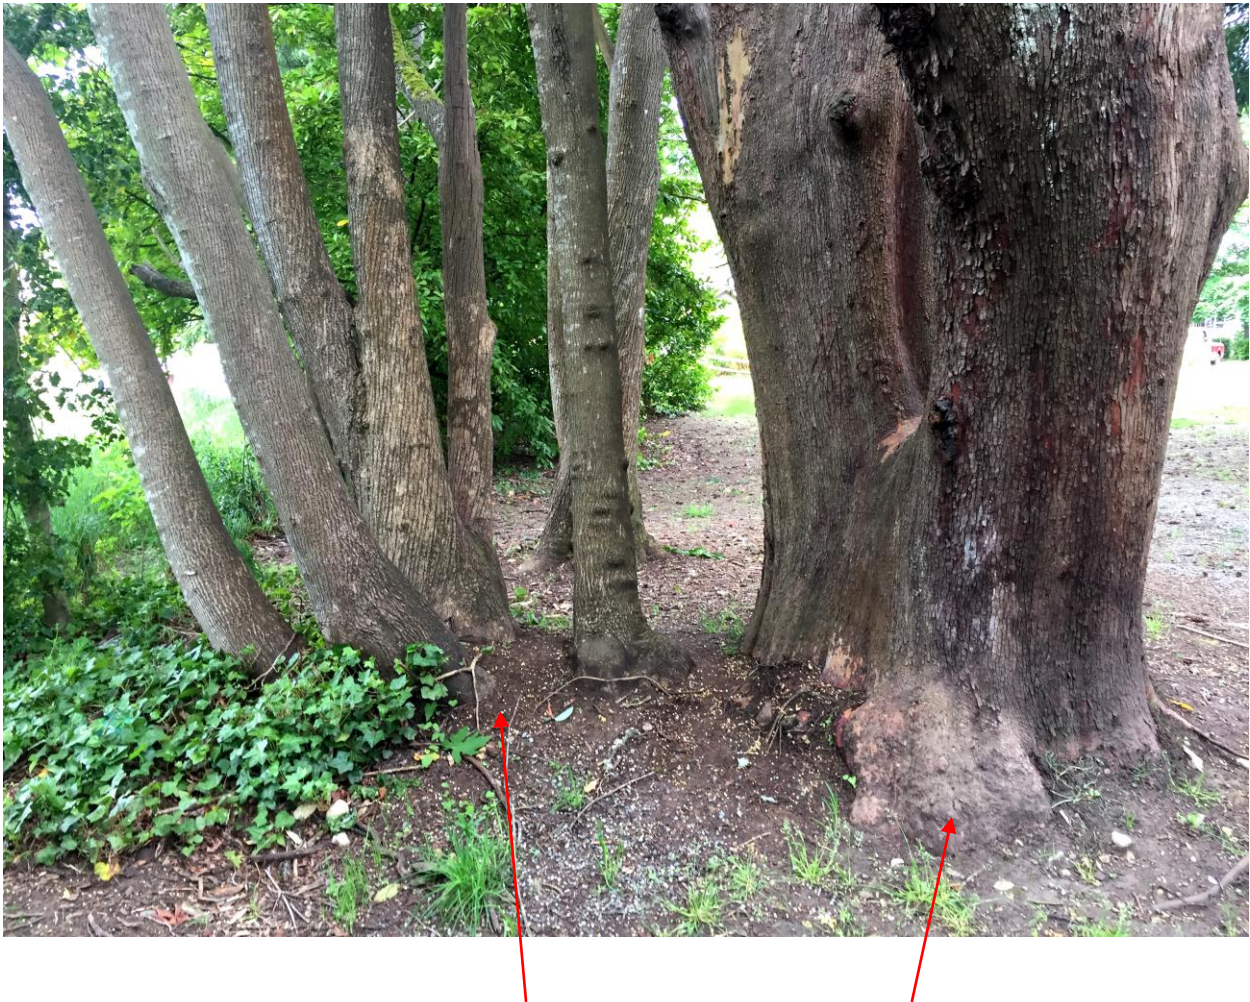
Bigleaf maple clump – Six stems measuring between 4" and 12", one double stemmed tree measuring 11" and 12" growing to the west and one single stemmed tree measuring 11" (Photo 2): All of these stems grow south of the madrone tree. All of the trees lean to the south and are only in average condition. Some have poor structures but as a group they make a contiguous mass that works well as a unit.

Pacific madrone – 30" and 26" DBH (Photo 2): This tree is in fair condition but is declining. A good portion of the crown is dead. One large dead limb extends out to the south from low in its canopy. Its dripline extending to the south is approximately 20'.

Photo 2: Base of the bigleaf maple clump and the single madrone.

Some limbing up can occur to provide clearance into the project area but this likely would not be able to provide more than ten feet of clearance before too much of individual stems canopies would be removed. Stem removal can be evaluated as the project design evolves.

This tree should be expected to continue to decline. If the bigleaf maple clump remains intact, this tree can remain as part of this clump. Dead wood could be pruned out of the canopy to reduce the risk of pieces failing onto the project area. As they can be quite sensitive to being disturbed by development, if this tree remains, a large protection zone would be needed to limit any access or disturbance in the dripline.

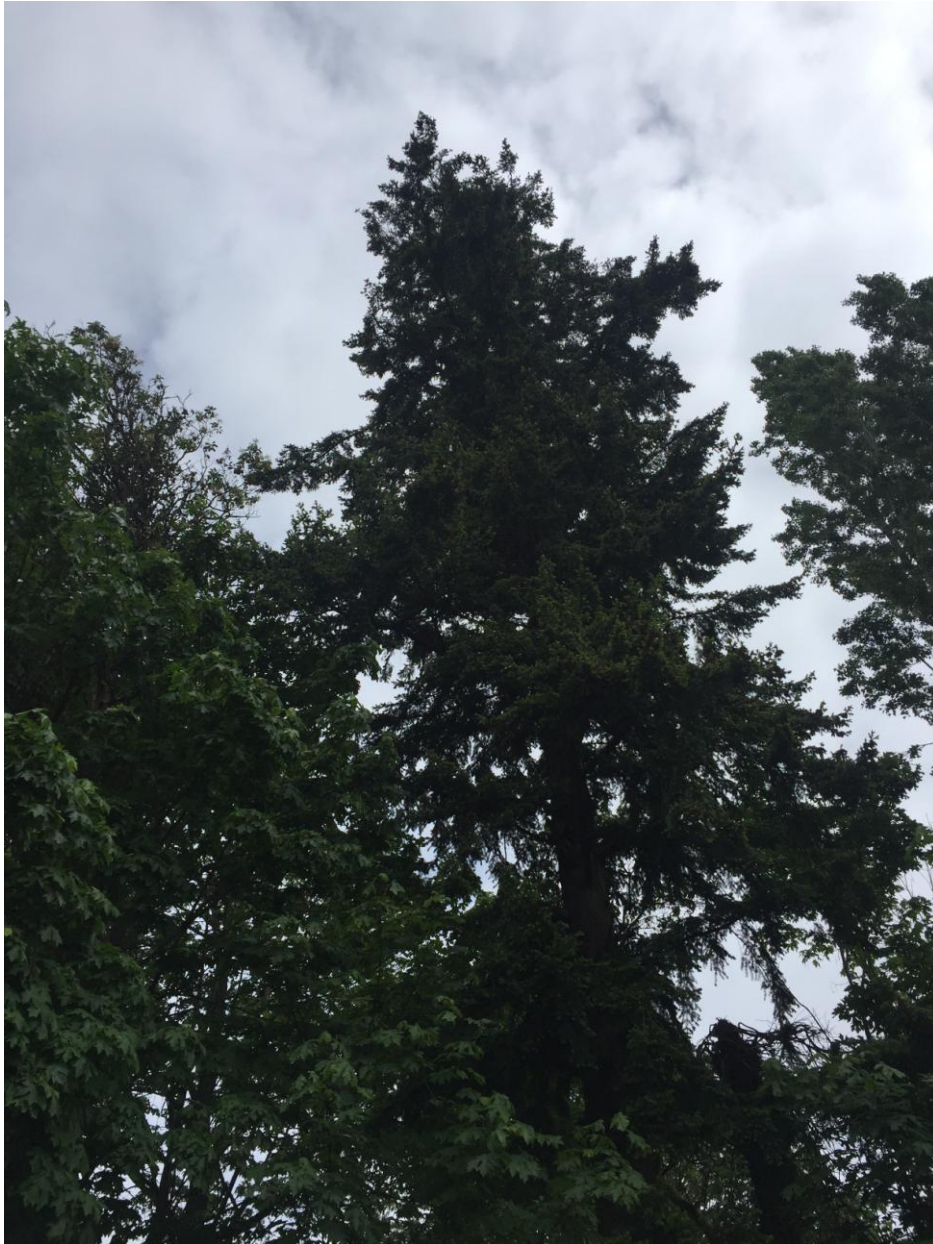
Douglas-fir – Approximately 40" DBH: This large and mature fir is in good condition. Its shape is slightly narrower compared to its average form (Photo 3). The dripline of this tree is approximately 18' in all directions.

Photo 3: Crown of the Douglas-fir tree.

- 18' is the minimum distance I recommend installing tree protection south of the tree.
- If roots greater than 2 inches diameter are encountered further than 18' extending into the project zone they should be cleanly cut with a sharp saw back to 18'.
