Date: January 14, 2020
To: Ellen Fairleigh, Planner
City of Bainbridge Island, Planning Division
From: Peter Leon, Principal Scientist
Subject: Manlowe Bulkhead Replacement
10750 NE Broomgerrie Rd
Request for Emergency Authorization under BIMC 2.16.165.E.2.a

**Subject: Geotechnical Evaluation
 Failing Bulkhead
 10750 Northeast Broomgerrie Road
 Bainbridge Island, Washington**

Subject: Manlowe Bulkhead – Emergency Permit

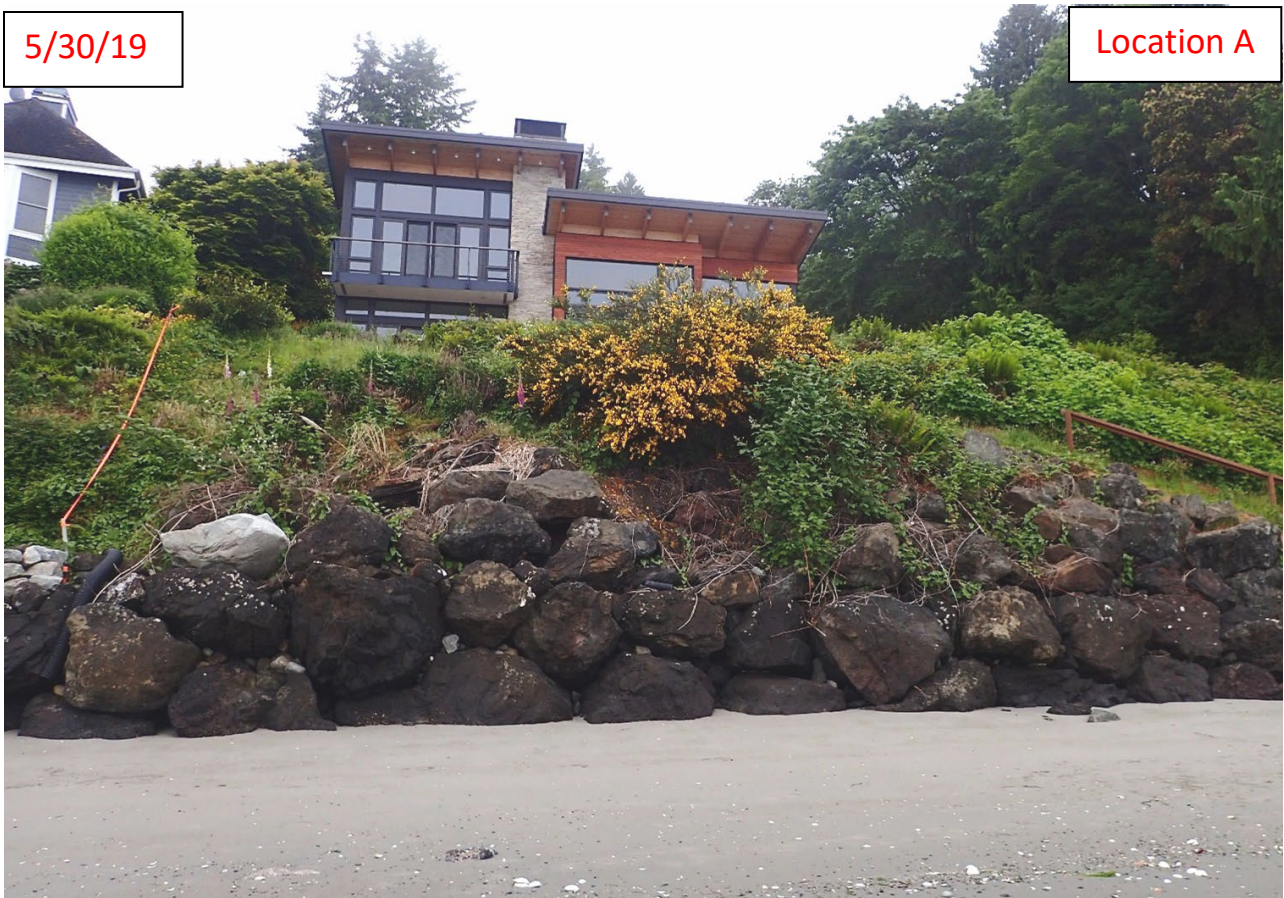
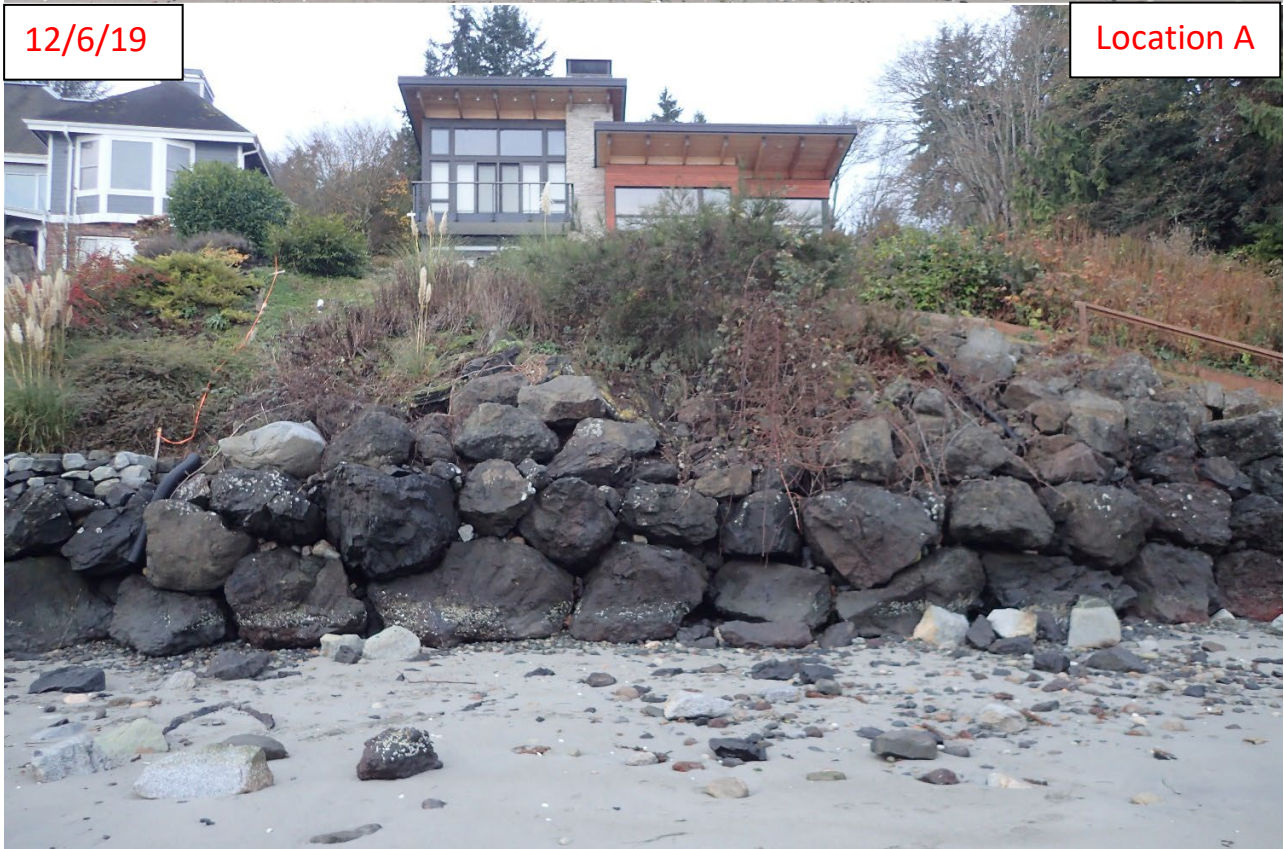
Location A

- The beach sand level has dropped between 18"-24". The base rocks are completely exposed, no longer embedded below beach level. This leaves them prone to sliding.

- The undermined base rocks are moving/settling/tilting/shifting due to tidal/wave action.
- The geotechnical engineer's evaluation discussed the hill "downset" below the trail, resulting from the rock bulkhead movement. He further discusses that failure of the entire bulkhead is "imminent", resulting "in a progressive failure of the descending slope areas, likely resulting in significant impacts to the residential structure above". He recommends that "steps be taken immediately to replace the bulkhead" because "the bulkhead could fail during the current winter storm season."

To address the above issues, the complete rock bulkhead must be replaced through an emergency permit process to protect the Manlowe house and property from further damage. We have provided engineered drawings to support this work.

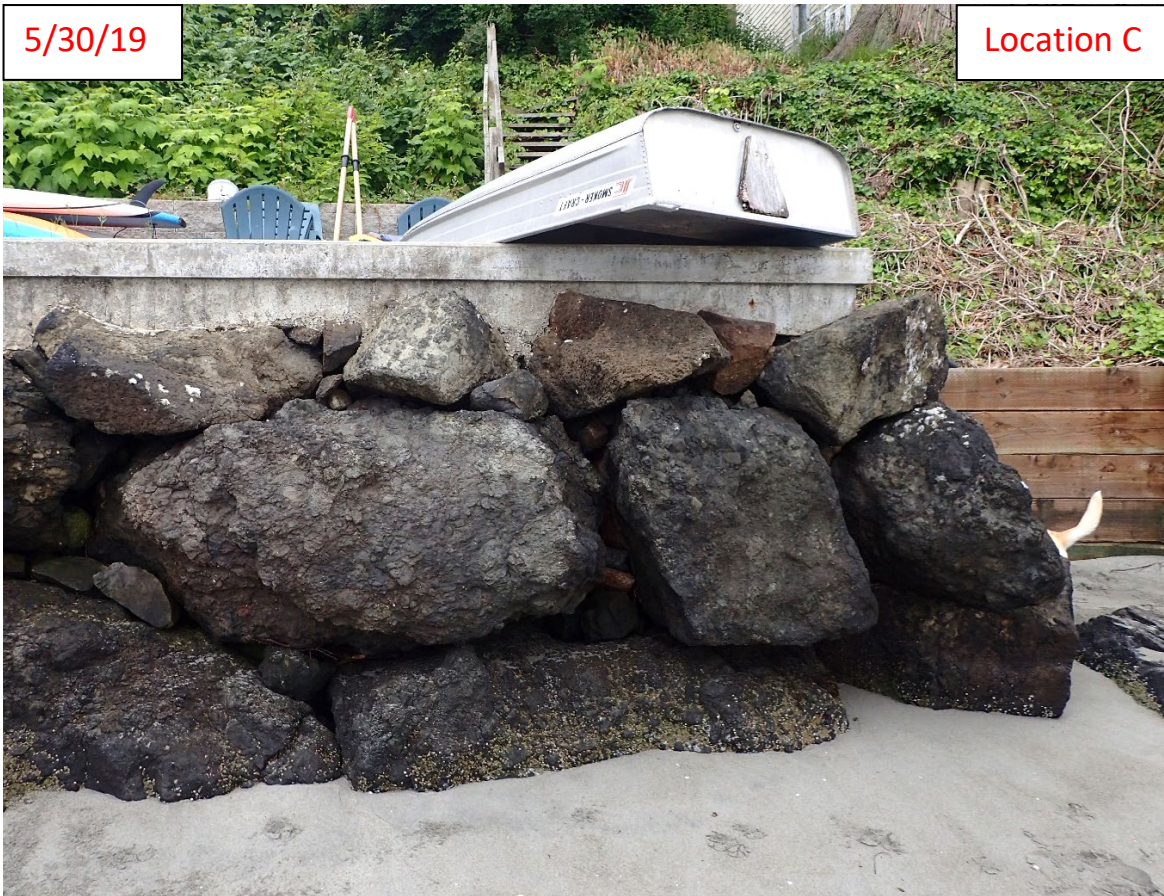
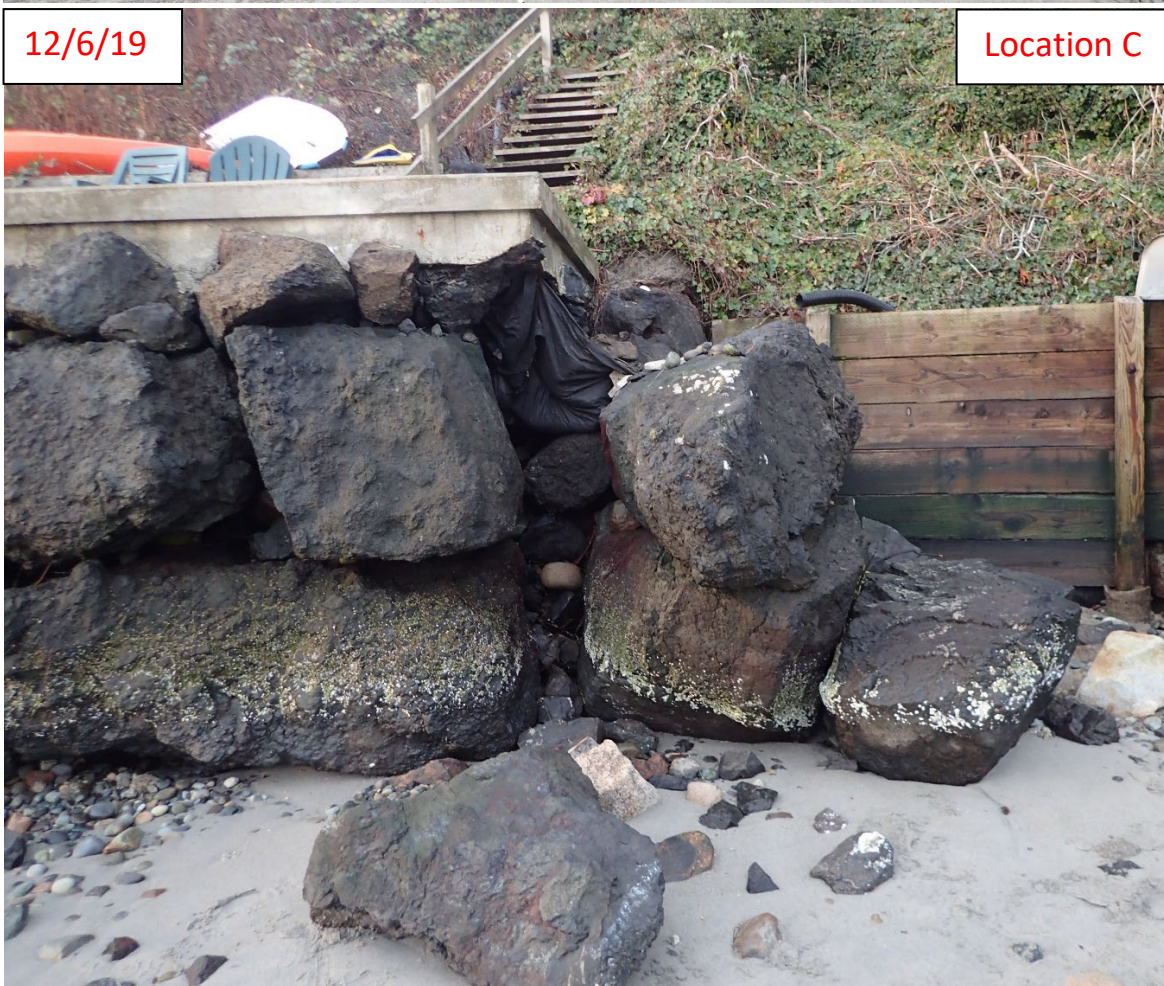
Location C

- The bulkhead has experienced a partial collapse at the northern end. We believe that a primary cause was the loss of beach sands covering the base rock, allowing the rocks to move and topple.

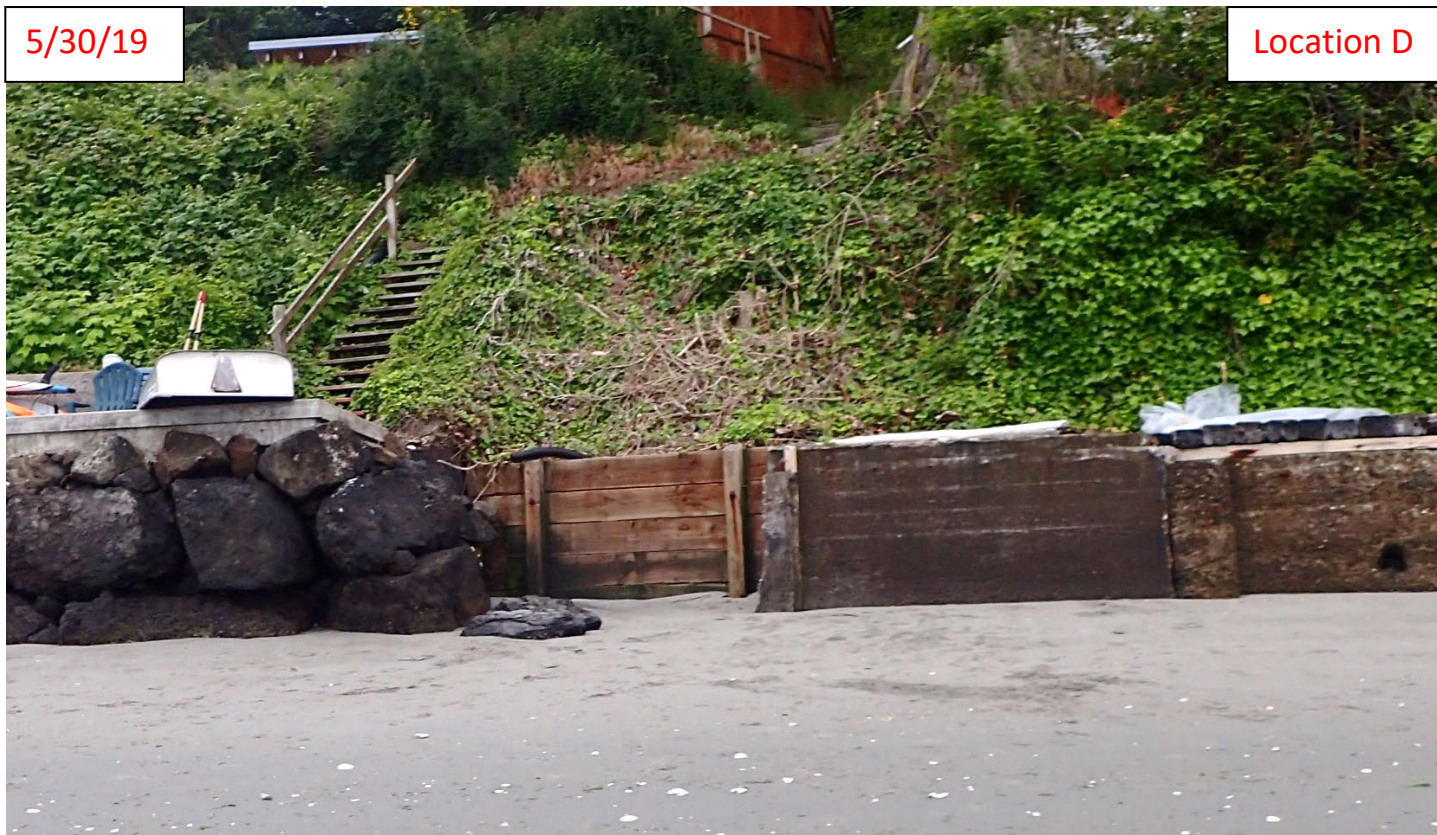
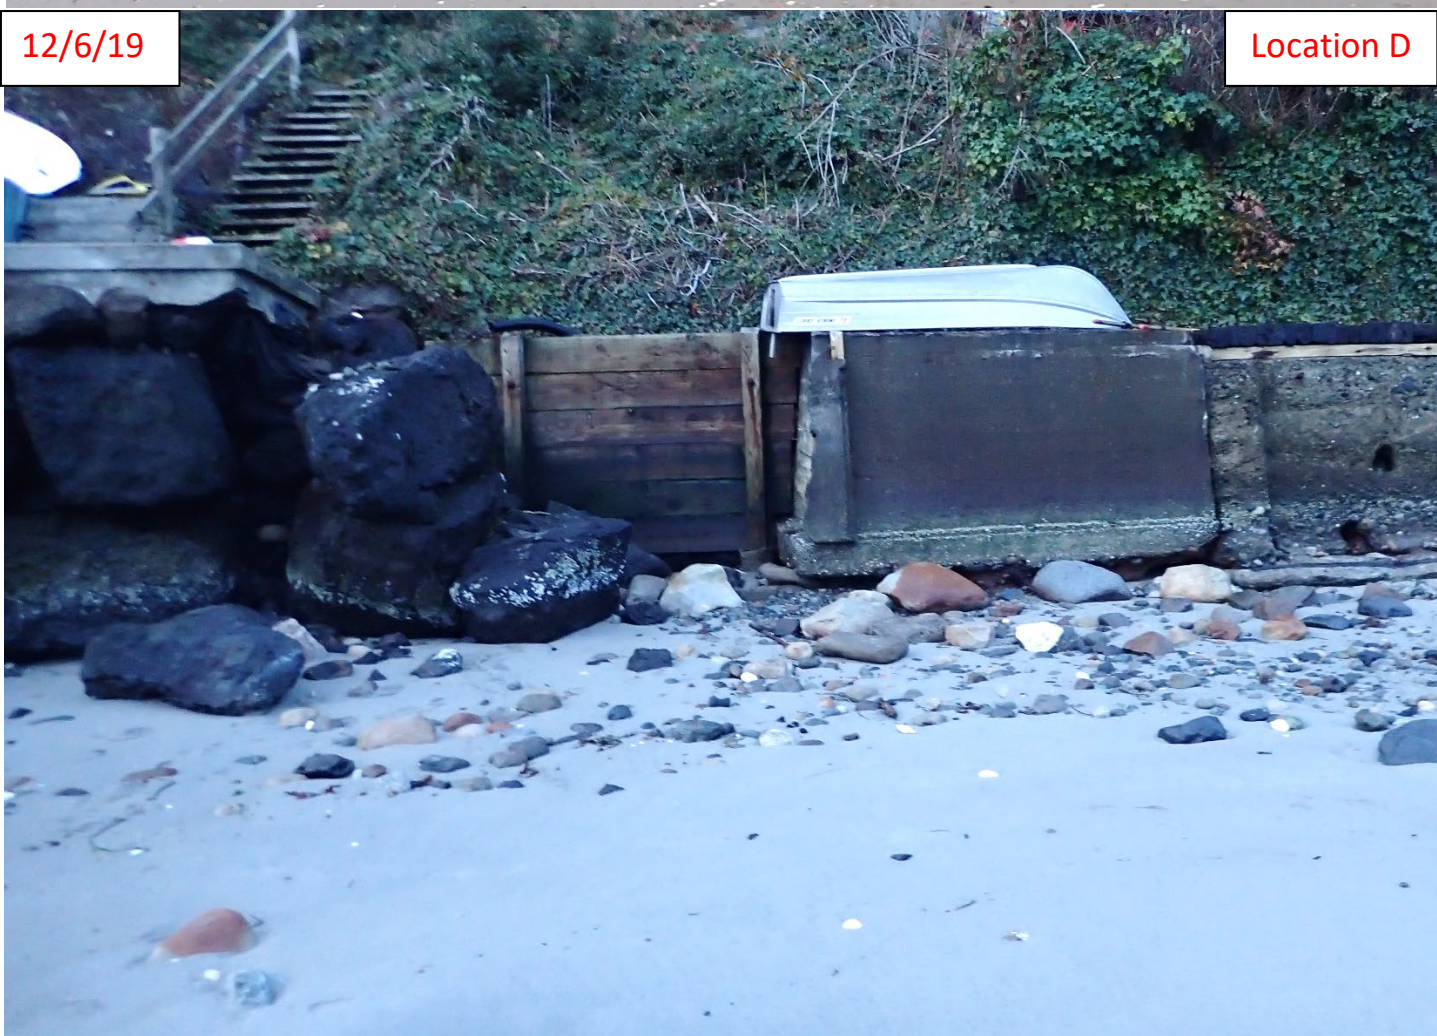
Location D

- We noted additional undermining and rock movement at the existing concrete stairs.
