Explanation of photos of Quitslund Heritage Barn

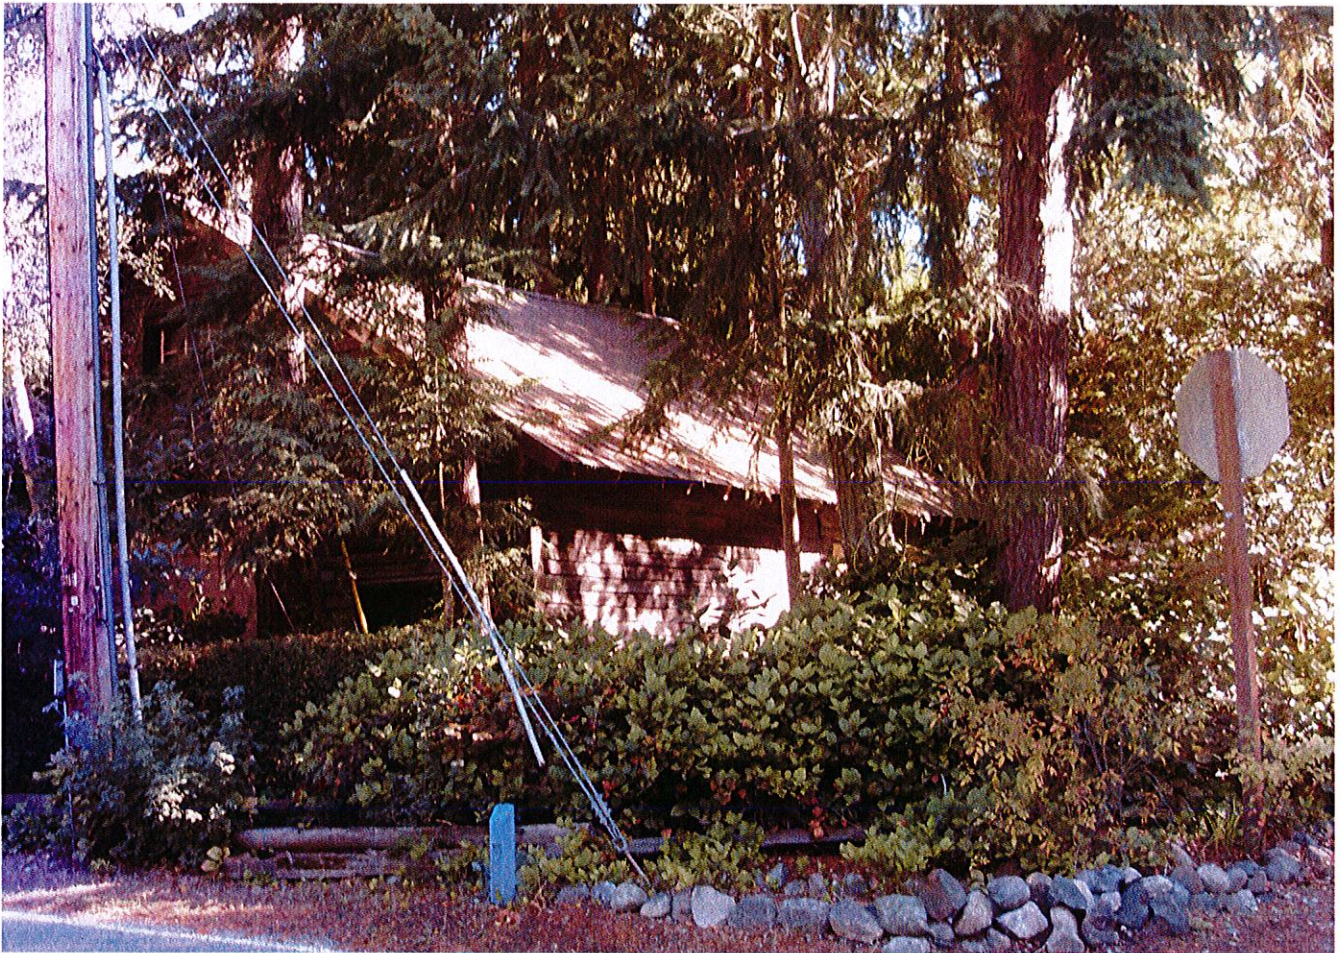
1

1. Taken from intersection of Sunrise and Torvanger, barn in NE corner. Note piece of plywood behind telephone pole-covers main window repeatedly broken by thieves to get into barn. Original entrance to barn as evidenced by hardware above window for sliding door.

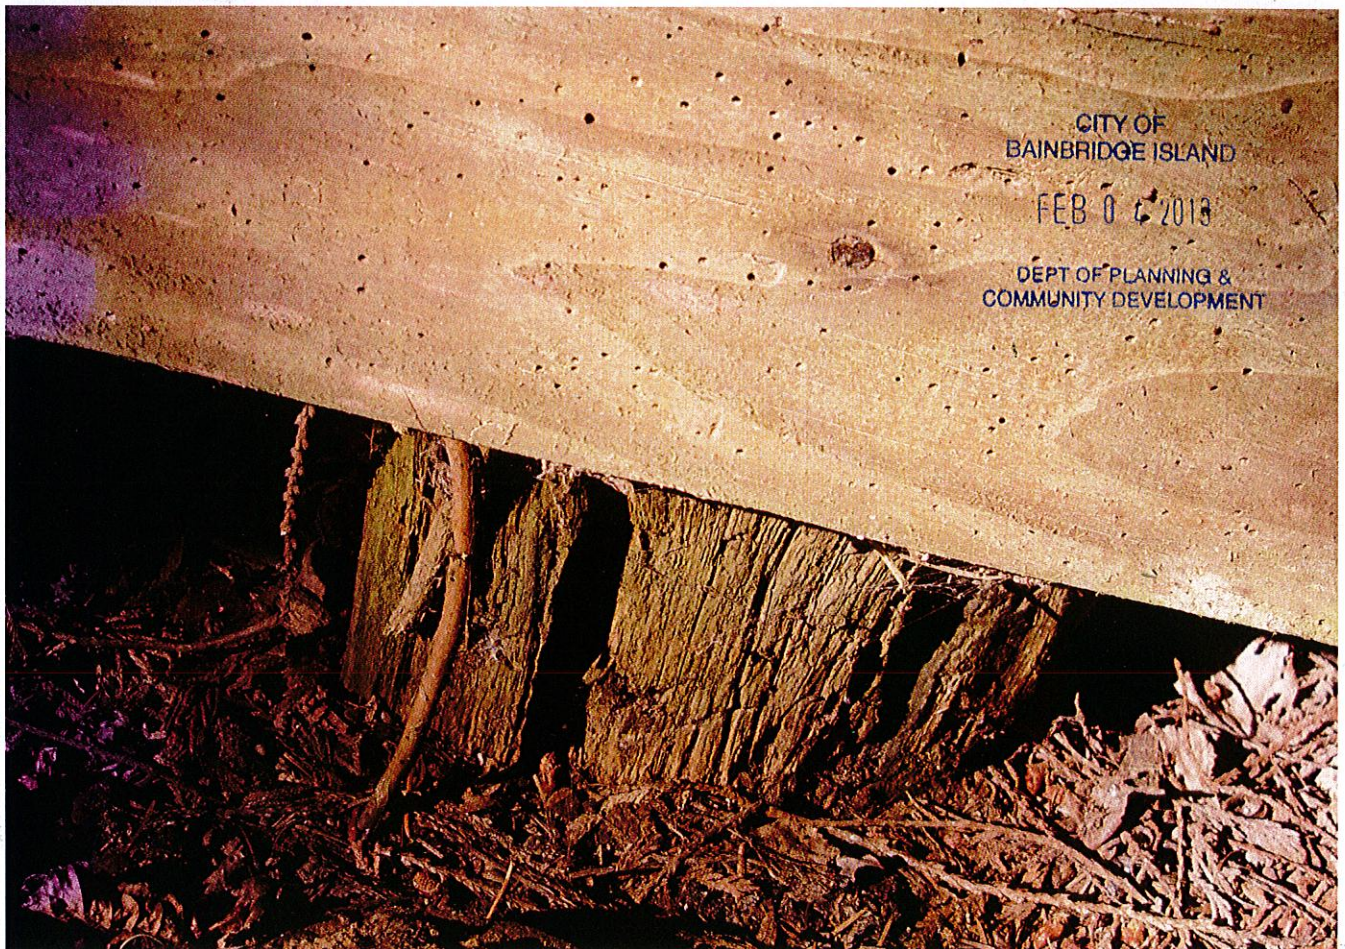
2

2. Barn supported on posts buried in soil. Most badly deteriorated. Replaced with cement piers.
3. Window mentioned in no. 1 above. Now replaced with window matching window in no. 4.

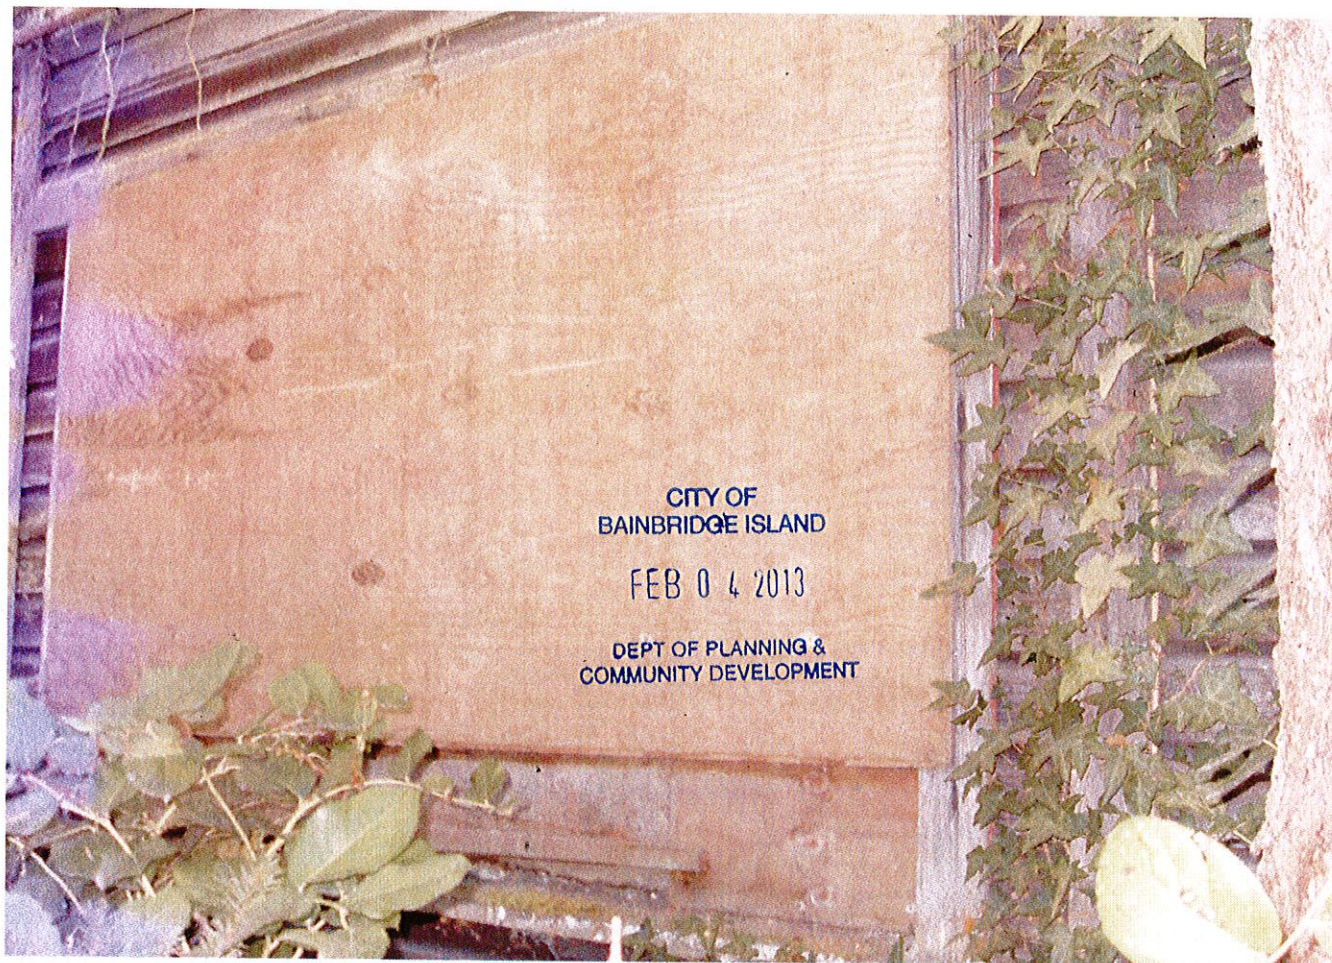
4

4. Tongue and groove feature of barn- on 3 sides, eventually will replace on missing side- east side.
5. Original state of floor. In addition to several different heights, rotten areas such as this one which revealed trove of empty bottles.

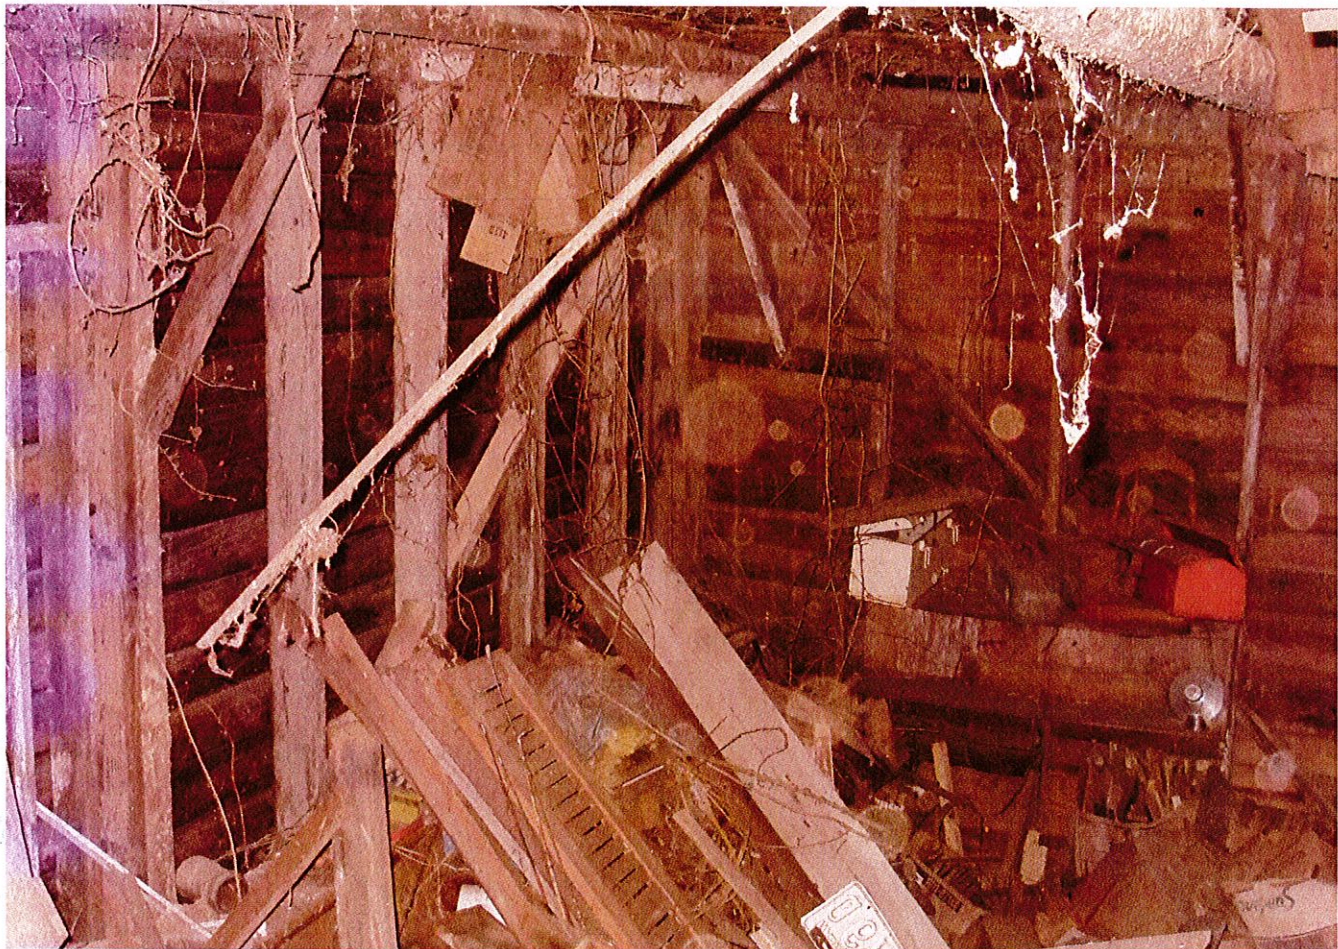
6

6. State of barn when work began- a major mess. Ivy vines too.
7. NW corner of barn where flooring seriously deteriorated due to north side of barn slipping 5-7". It was at ground level, now jacked up so outside is visible.

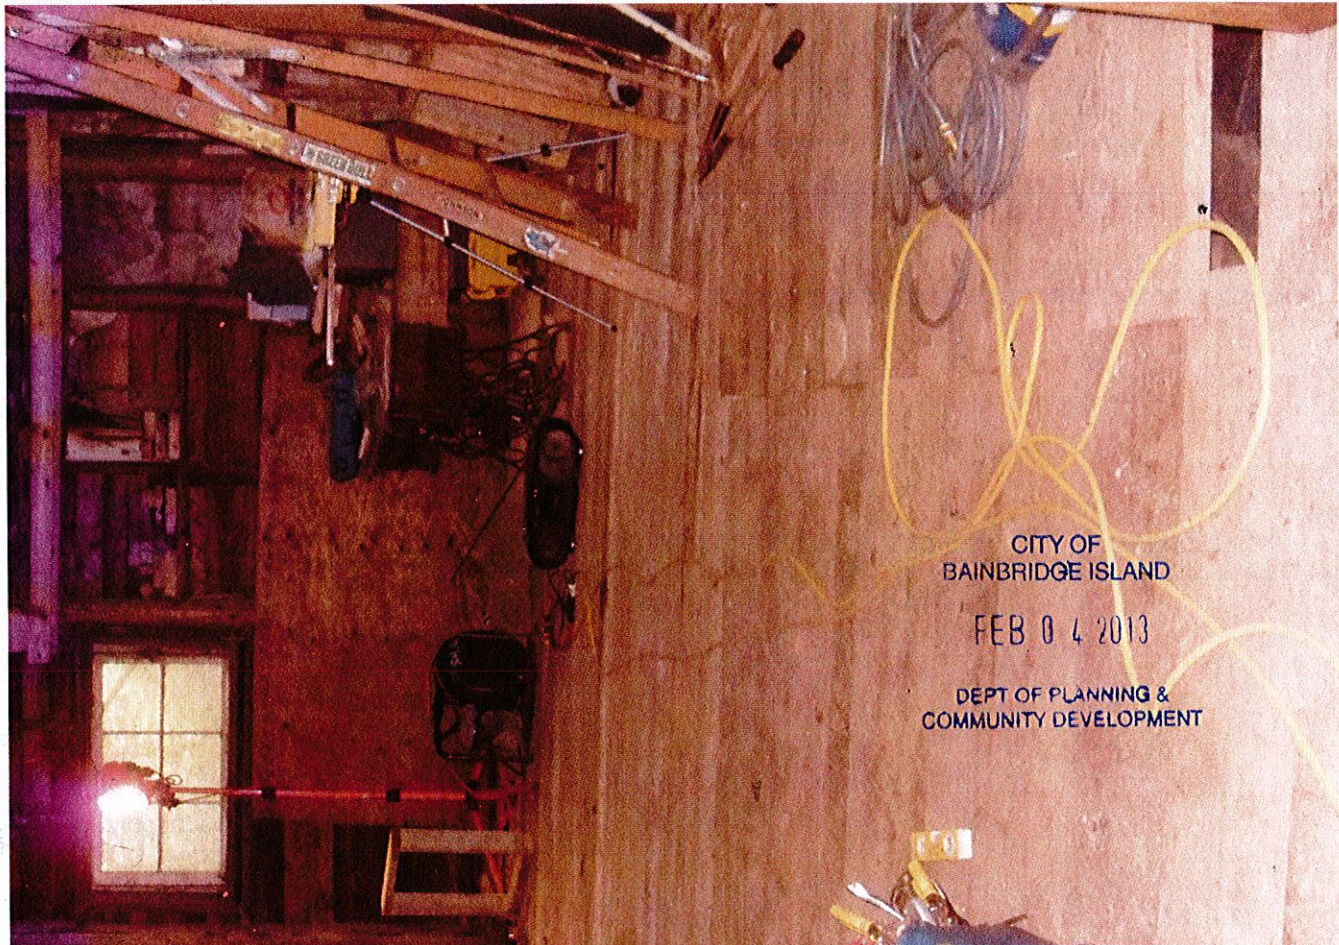
8

8. "New" flooring visible from current entrance. Flooring salvaged from a forestry barn.
9. Entrance to barn, off of Torvanger. Wood for door, sign and framing around all 7 windows in the barn came from trees my mother planted along the south side of the barn to hide it. (she thought it was ugly) Trees on other sides remain. Trees on south side were growing into barn and compromising it, so I had them cut down and milled some years ago in the event I went ahead with restoration. Note the board running along ground level. Formerly there was some open space and carcasses of various animals were found under the floor. To prevent any squatters, wire netting had been fastened to the board and covered with rocks harvested from my garden. Sign to the right of the door designates this as a Heritage Barn, dating from circa 1905.
