October 17, 2018

JN 18485

Subject: **Critical Area Report and Update of Previous Geotechnical Engineering Study**
Proposed New Multi-Family Building
230 Madison Avenue South
Bainbridge Island, Washington

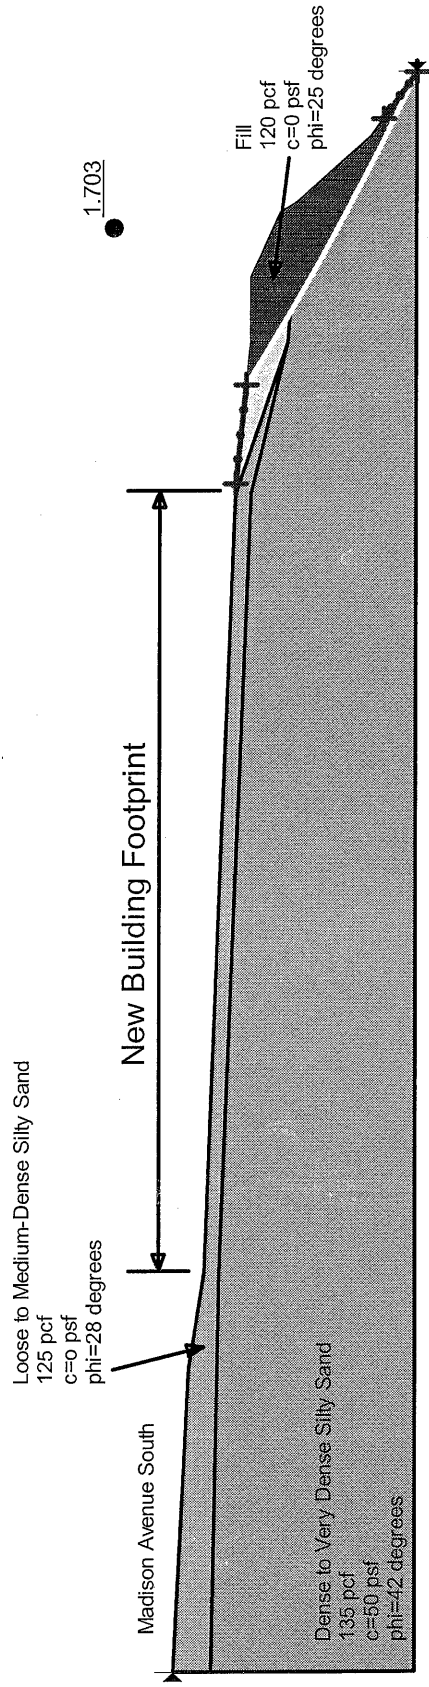
18485 - Cihan Anisoglu
Static

Landslide Hazard Area: The site is underlain at a relatively shallow depth by glacial till, a glacially-compressed mixture of gravel, silt and fine-grained sand. Experienced geotechnical engineers know that this soil has a high internal strength, and is not prone to deep-seated landslides. As a part of our work for this CAR, we completed a slope stability analysis for both static and seismic conditions. The results of these analyses are attached as Appendix B. As expected, the safety factors against slope movement extending into the glacial till soils exceeds 1.5 and 1.1 for static and seismic conditions.
