Huguet-Kroman RUE
PLN51228 RUE

Staff Report

Project Huguet-Kroman RUE
File No. PLN51228 RUE
Date February 25, 2021
To City of Bainbridge Island Hearing Examiner
Project Manager Annie Hillier, Associate Planner

Request	The request is for a reasonable use exception (RUE) to allow development of a single-family residence and garage within a wetland buffer. Onsite wetland buffer enhancement is proposed to compensate for impacts to the critical area.
Address	**no situs address**, Bainbridge Island, WA 98110
Tax Assessor #	34260240332007
Environmental Review	The project is exempt from the State Environmental Policy Act (SEPA) under WAC 197-11-800(6)(a).

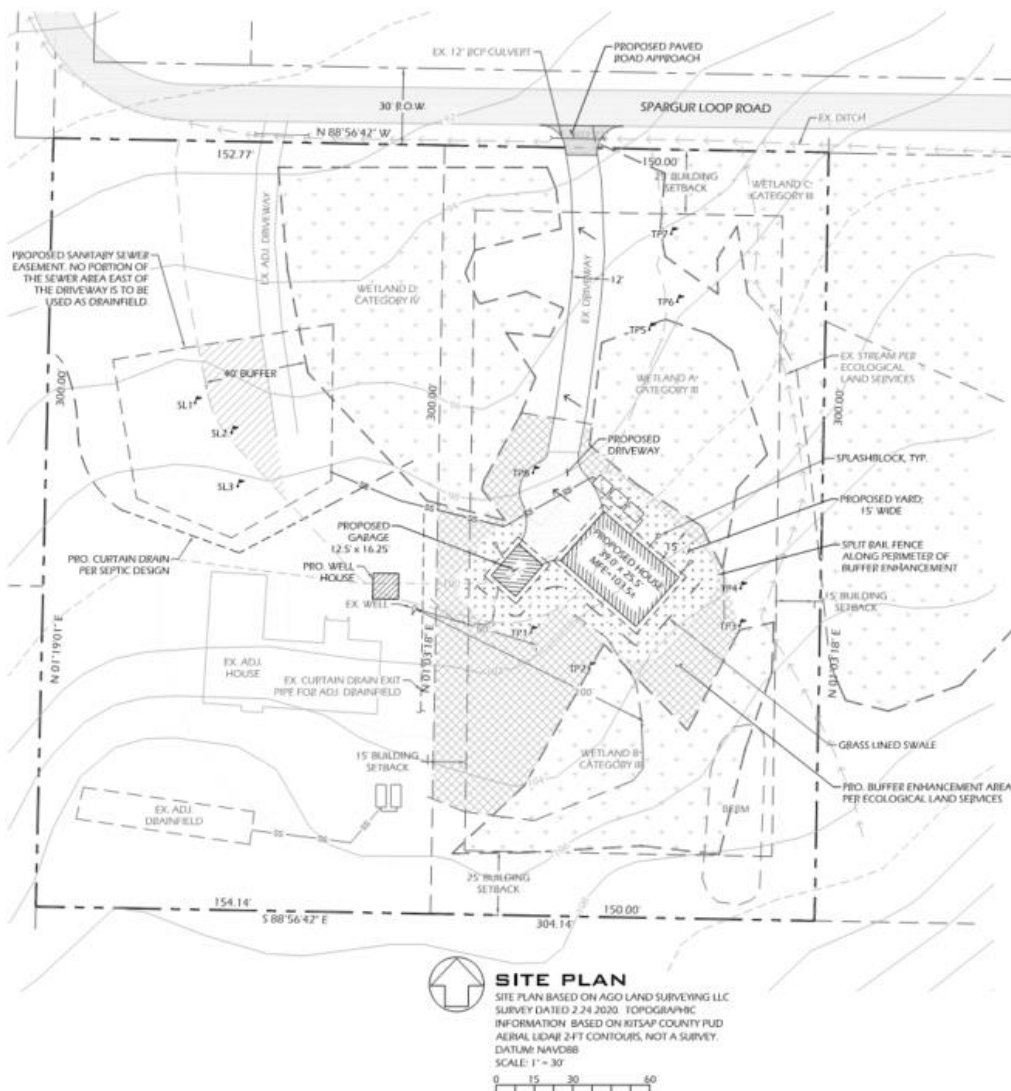
Figure 1 – Site Plan

The proposal is for a single-family residence (SFR) and garage on a lot encumbered with wetlands and wetland buffers. An existing driveway will be utilized to access the SFR, which is proposed in an area currently consisting of mowed grass and invasive blackberries. The septic drainfield is proposed on the adjacent lot to the west, which is under the same ownership, because this is the only area within the vicinity with adequate soils to accommodate a drainfield. The area of the proposed drainfield is also located within a wetland buffer. Mitigation in the form of buffer enhancement is proposed on the subject property, to compensate for impacts to the critical areas from both the drainfield and the SFR/garage. The applicant requests a reasonable use exception (RUE) to develop the property and install the septic drainfield in accordance with BIMC 16.20.080, as the parcel is completely encumbered by wetlands and wetland buffers.

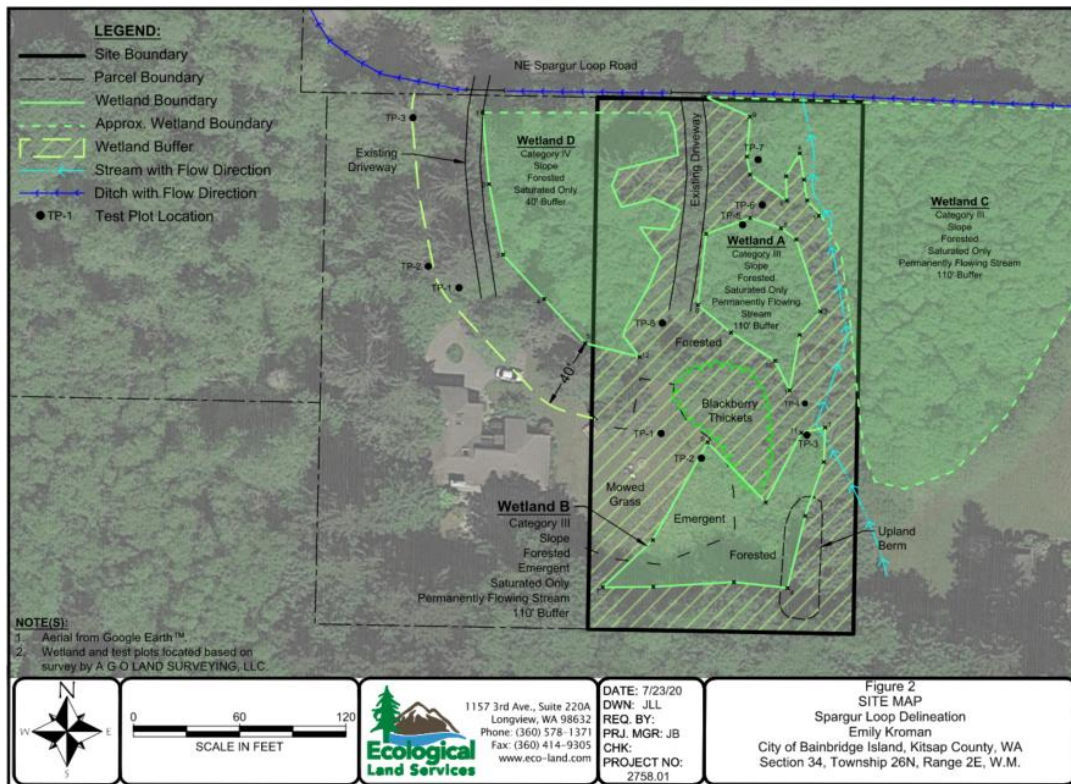
The wetland delineation report and mitigation plan submitted with the application (Exhibit 9) identifies 4 wetlands on the subject property. A small, unmapped stream is also identified on the east side of the property. According to the rating forms, Wetlands A-C are category III wetlands and Wetland D is a category IV wetland (note: page 2 of the report states that all wetlands are category III, but this appears to be an error). The buffers extending between these wetlands completely encumber the site. A buffer from the small stream is not identified; restrictions on the property related to an unmapped stream buffer would be the same as for the wetland buffers which overlap in the same area, so additional information about the unmapped stream was not requested. All development is located outside of the stream.

Figure 3 – The subject property is encumbered by 4 wetlands and their corresponding buffers.

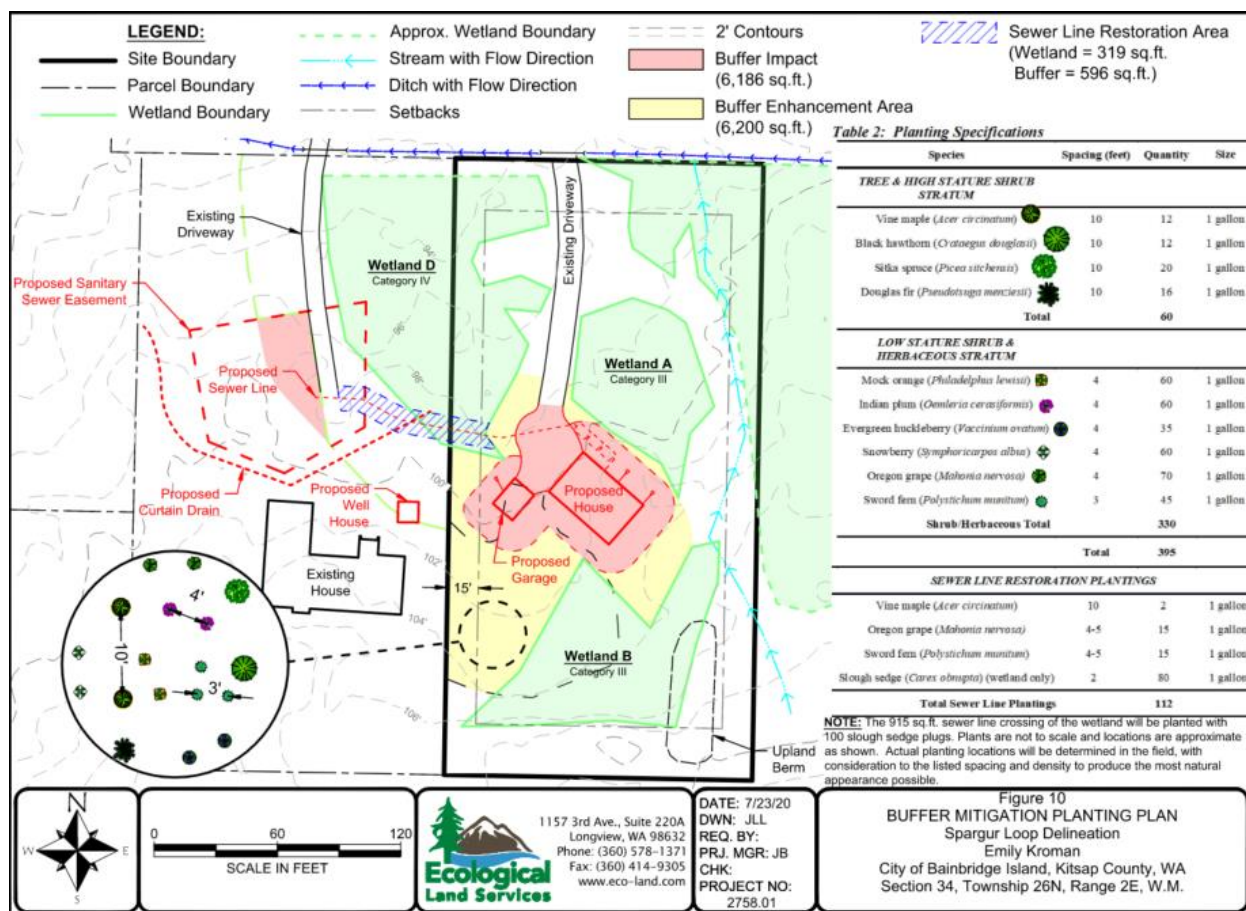
Figure 4 – Mitigation proposal

Note: The septic drainfield is proposed on the adjacent lot, within the category IV wetland buffer that extends onto both parcels. Initially staff indicated to the applicant that a separate critical areas permit would be required to install the drainfield, since it is proposed on a separate property. However, because mitigation for impacts from the drainfield will be provided on the subject property and the drainfield is part of a development that requires an RUE, staff finds it acceptable to only require a single land use application for the entire scope of the proposal; nothing would be gained by requiring a second land use application for the drainfield. If the drainfield were proposed within a wetland buffer without an associated RUE, then a critical areas permit would be required.

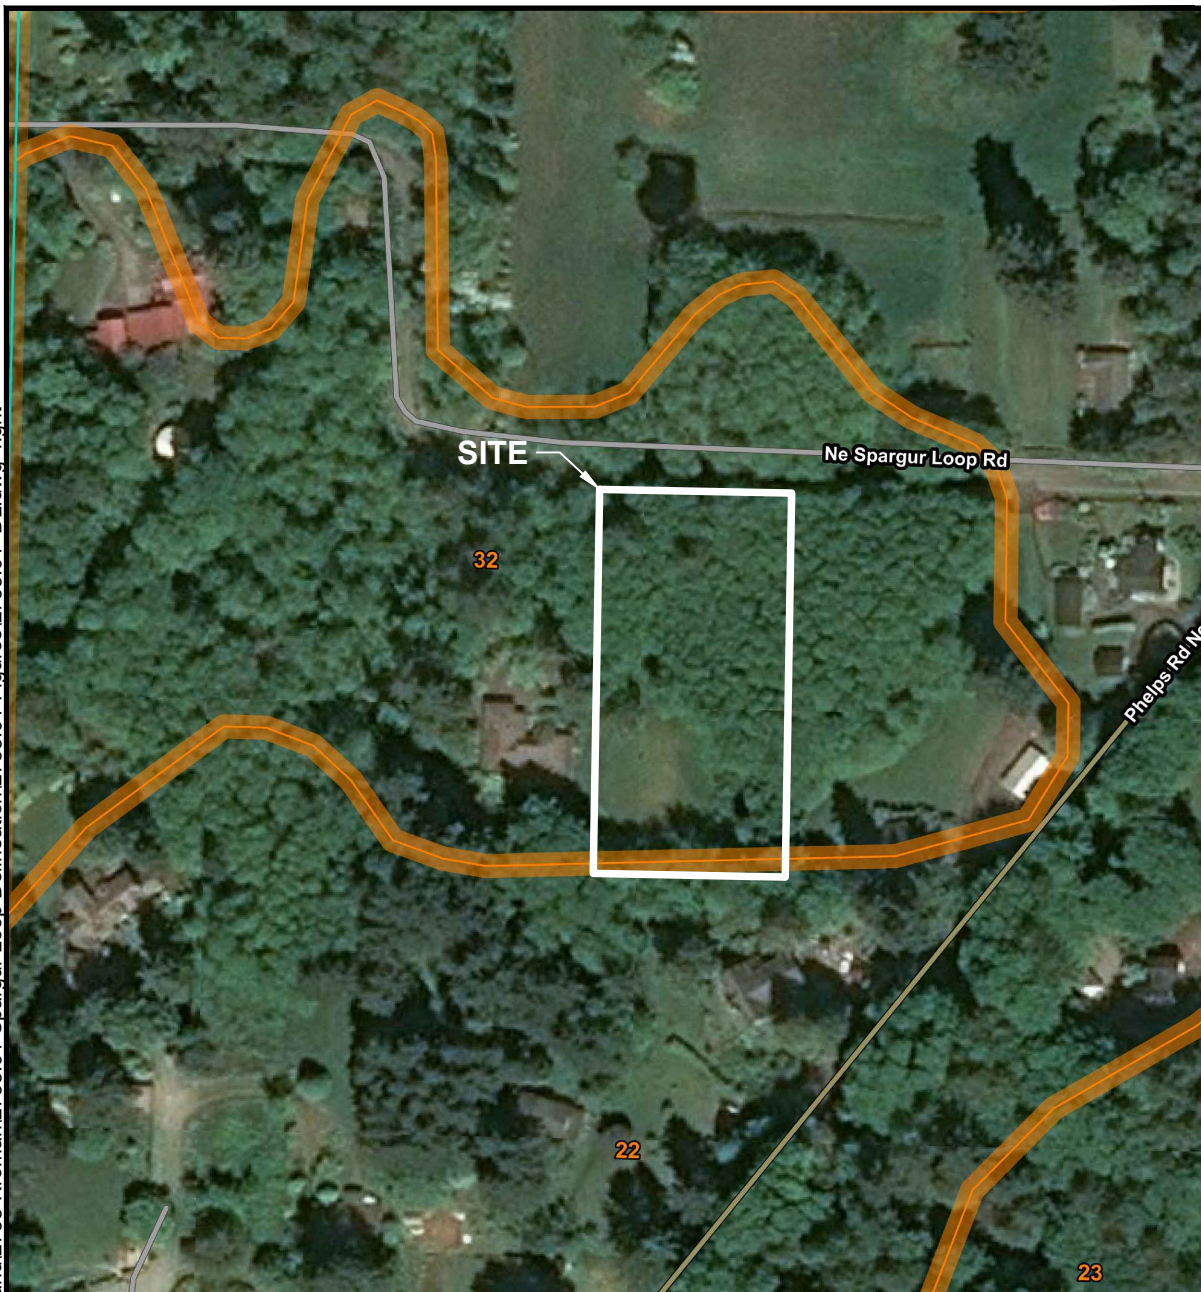
Figure 4
SOIL SURVEY MAP
Spargur Loop Delineation
Emily Kroman
City of Bainbridge Island, Kitsap County, WA
Section 34, Township 26N, Range 2E, W.M.

- 22** Kapowsin gravelly ashy loam, 0 to 6 percent slopes. Not hydric.
- 32** McKenna gravelly loam. Hydric.

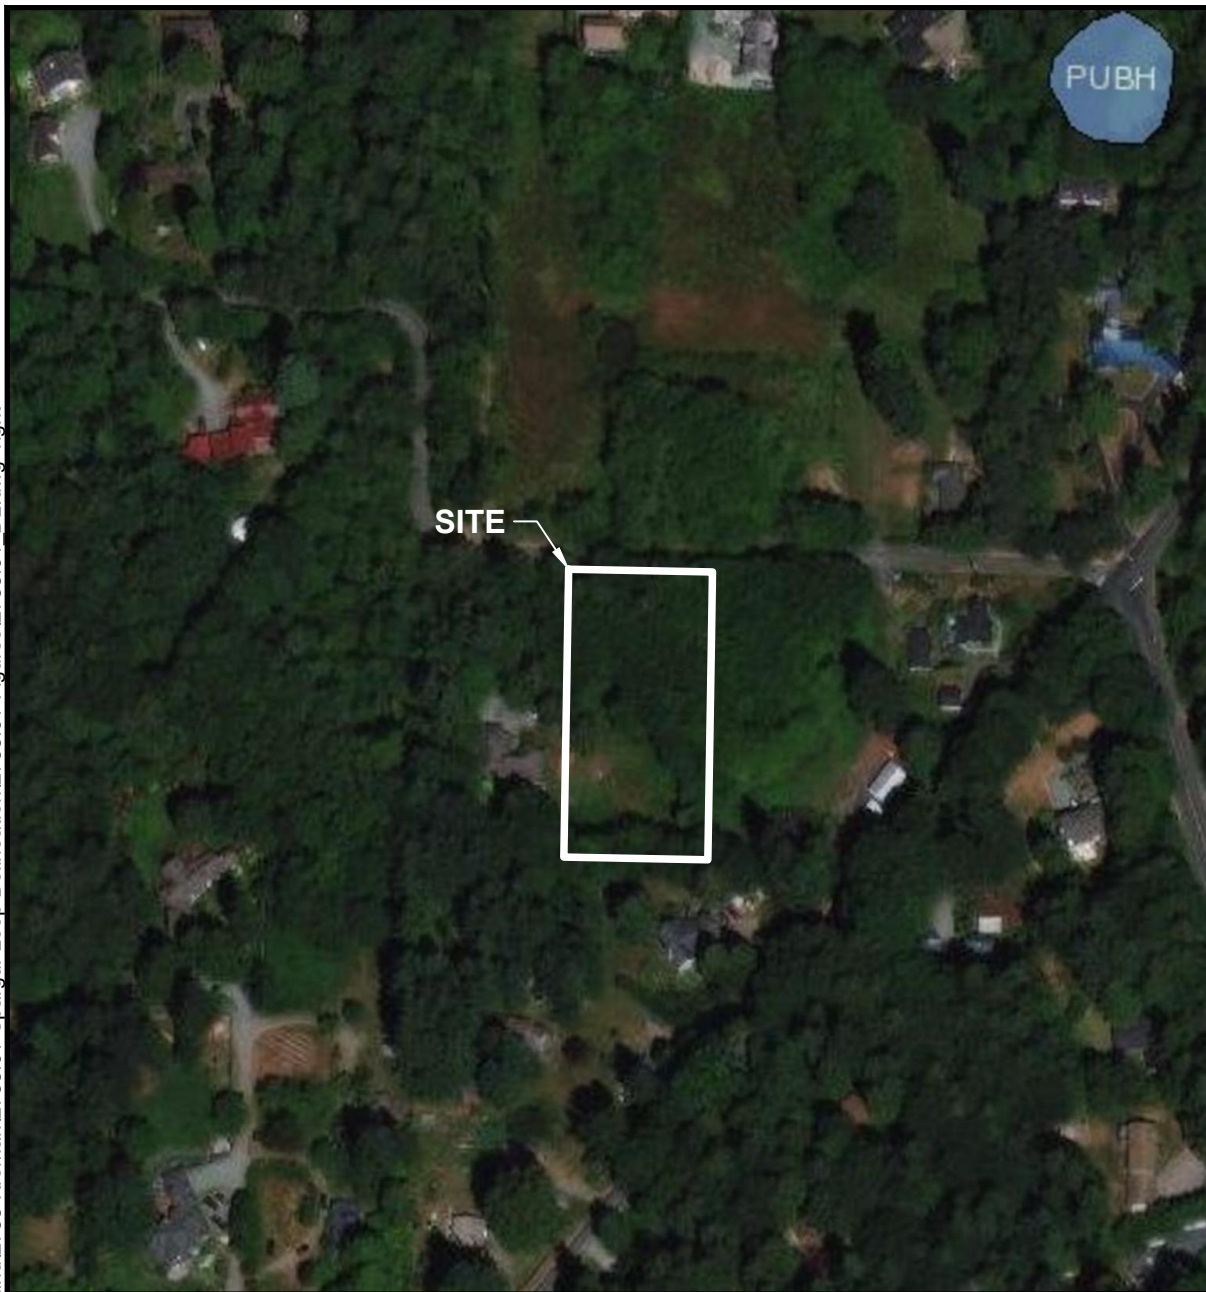
Figure 5

No mapped wetlands indicated onsite by US Fish & Wildlife Service.

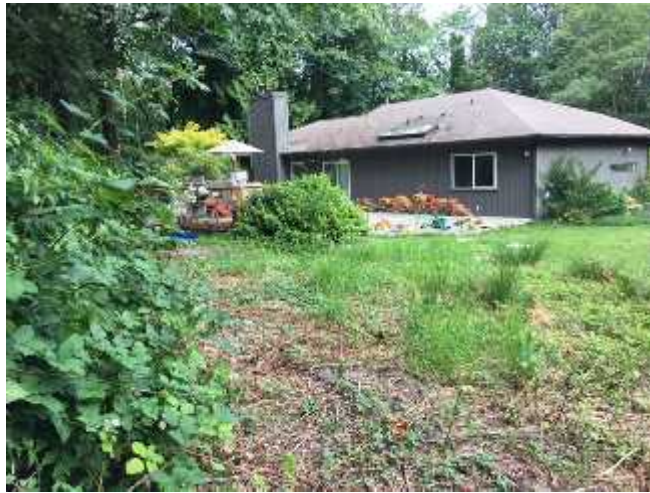
Photo 1 was taken near the southwest corner of the property and looks northwesterly at the neighboring home.

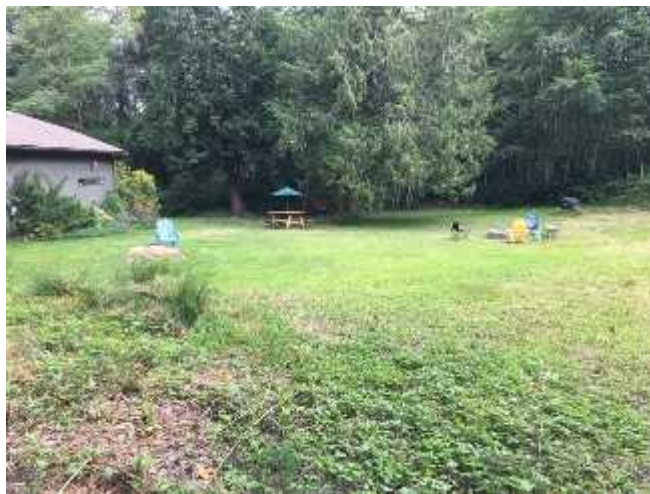
Photo 2 was taken from the same location as Photo 1 and looks north along the west property line. The future homesite will be situated near the west line in the clearing to the right.

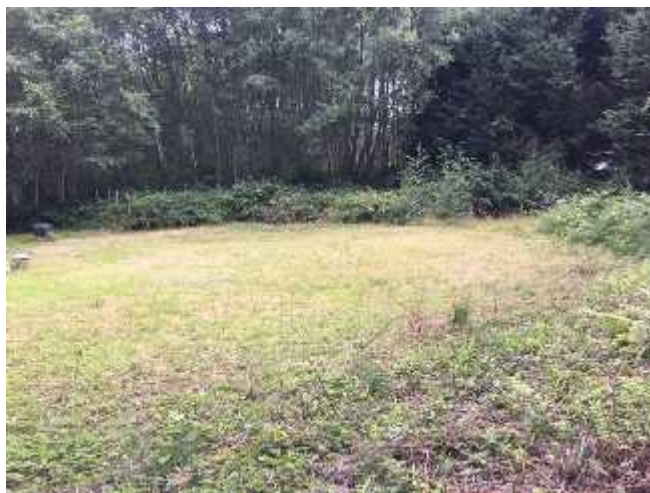
Photo 3 was taken from the same location as Photos 1 and 2 northeasterly across the emergent portion of Wetland B. Enhancement of the buffer as well as the wetland is proposed to compensate for the house within the buffer.

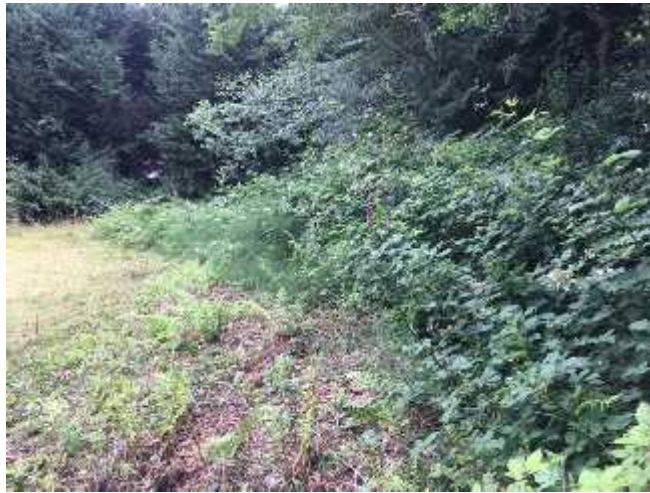
Photo 4 was taken from the same location as Photos 1, 2, and 3 (Photoplate 1) and looks easterly along the south property line. Dense blackberries beneath the red alder canopy dominate this area.

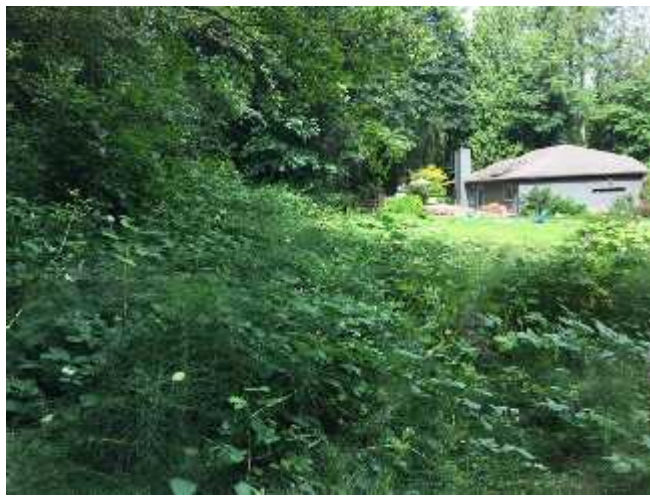
Photo 5 was taken from about midway along the south property line. It looks westerly back toward the home offsite to the west.

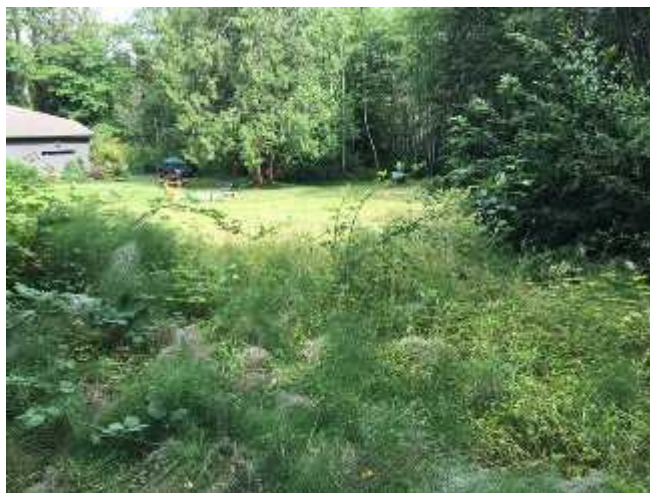
Photo 6 was taken from the same location as Photo 5 and looks northwesterly across Wetland B. The tree on the right has fallen from the forest along south boundary of Wetland B.

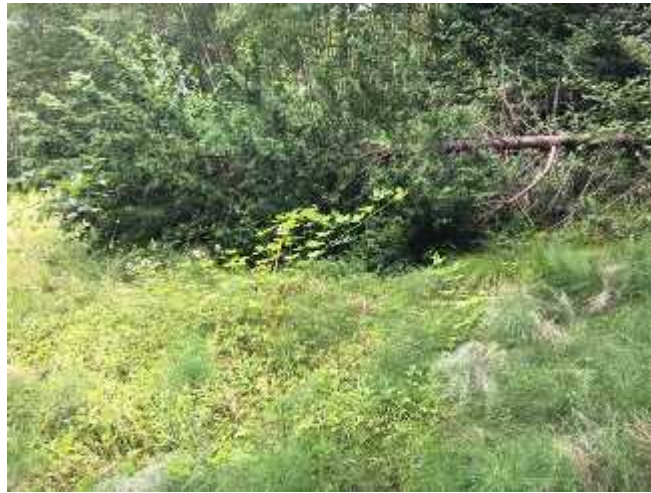
Photo 7 was taken from the same location as Photos 5 and 6 (Photoplate 2). This photo looks northeasterly toward the east end of Wetland B. The fallen tree is more easily seen in this photo.

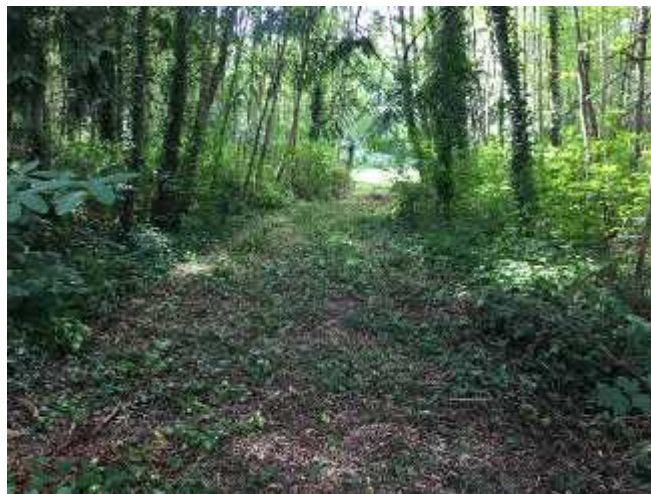
Photo 8 was taken from the north end of the existing driveway. It looks south toward the future building site, which is proposed in the sunny area in the background.

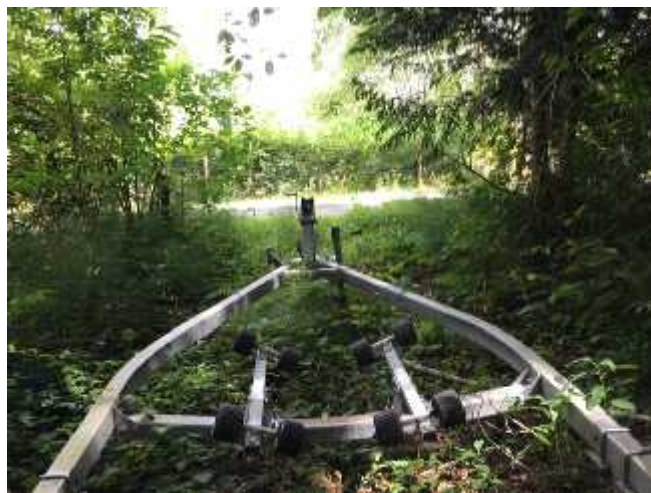
Photo 9 was taken from the same location as Photo 8 and looks northerly along the driveway. Spargur Loop Road is in the sunny area in the background.

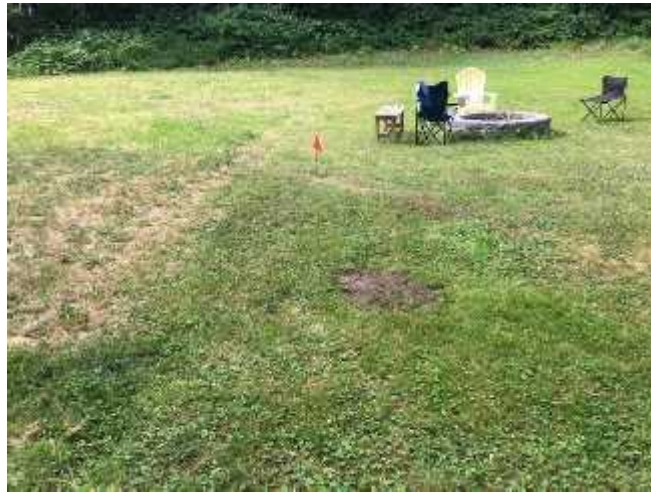
Photo 10 was taken of the area where Test Plot 1 was conducted. It is located in the proposed homesite area. This area was upland because of the dry soils and lack of wetland hydrology indicators. Hydrology was present in the other wetlands in contrast to this area.

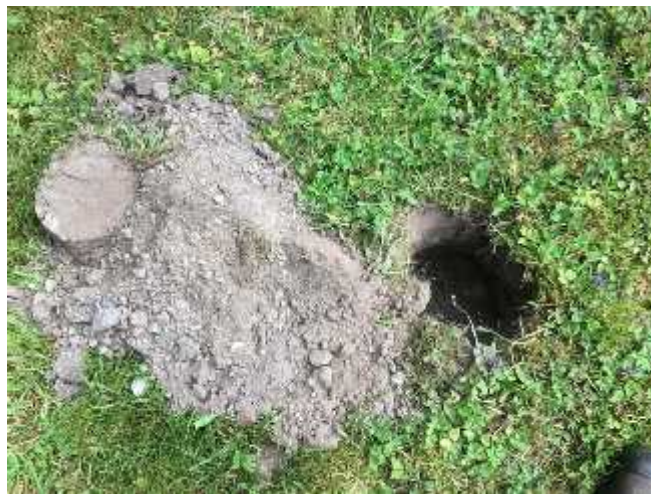
Photo 11 was taken of the soil hole completed at Test Plot 1. It demonstrates the lack of wetland hydrology in contrast to the delineated wetlands all of which contained surface water or a shallow water table.

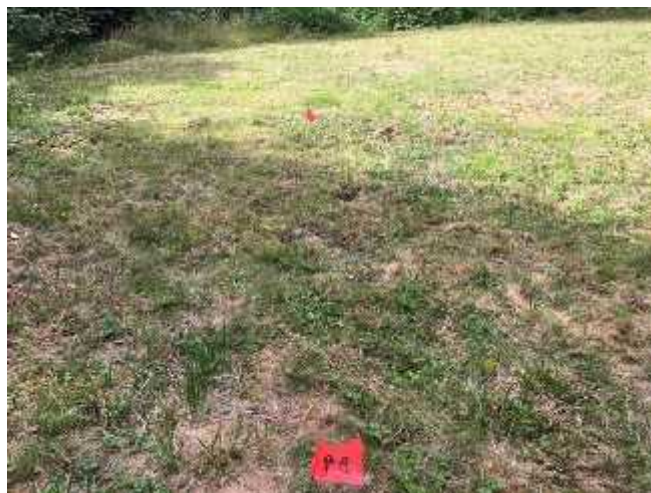
Photo 12 was taken of the area where Test Plot 2 was conducted. This area is similar to the area sampled at Test Plot 1 with regard to vegetation, but the soil exhibited a gleyed layer and a shallow water table. This area was determined to be part of Wetland B because there were positive indicators present for all three wetland parameters.

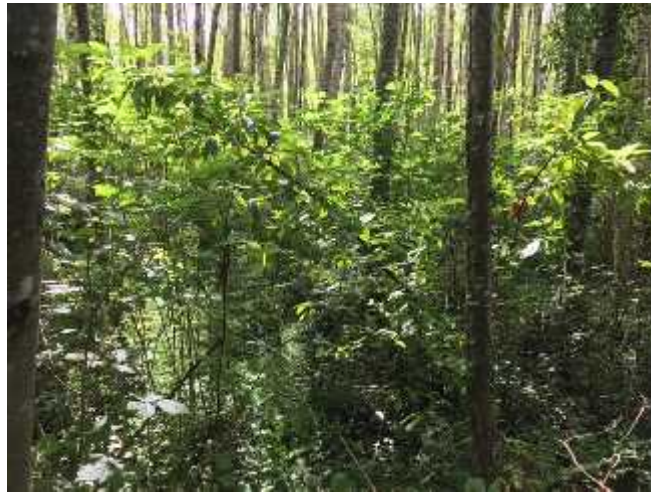
Photo 13 was taken from the existing driveway and looks southeasterly into Wetland A. This wetland is forested and dominated by red alder in the canopy and salmonberry in the shrub layer. There was surface water in portions of this wetland with a shallow water table throughout.

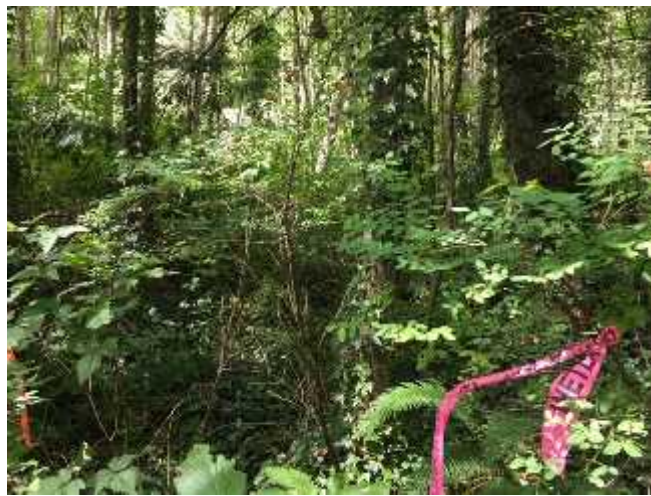
Photo 14 was taken of the north end of Wetland A. It looks westerly across the end near a pink wetland boundary flag and an orange test plot flag (in the lower left corner).

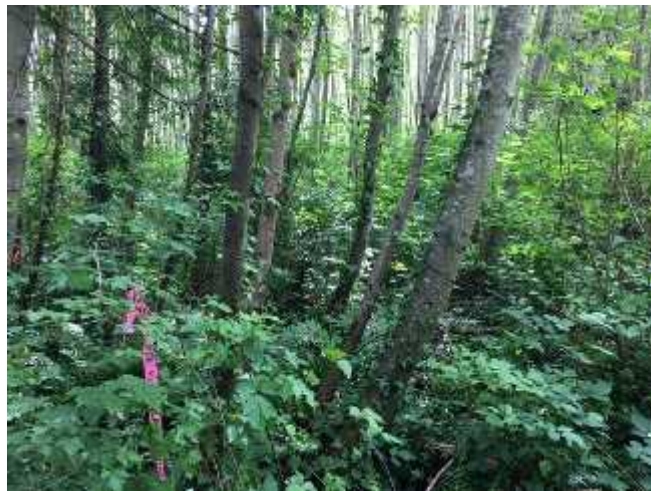
Photo 15 was taken from the same location as Photo 14 and looks southerly into Wetland A.

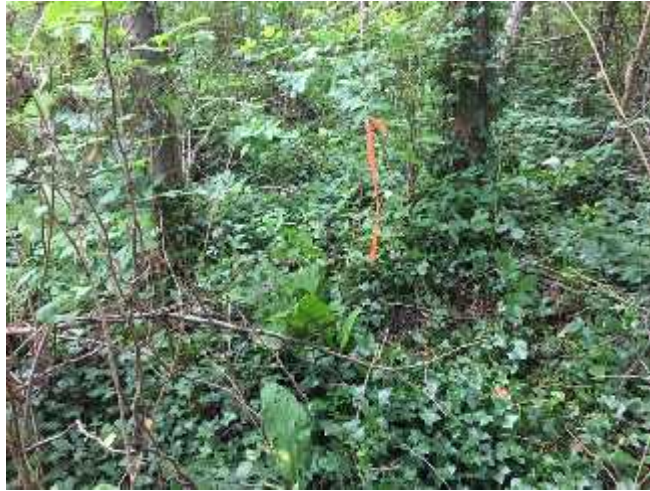
Photo 16 was taken of the area of Wetland A where Test Plot 5 was conducted. The orange test plot flag was placed just above several skunk cabbages growing through the dense ivy cover.

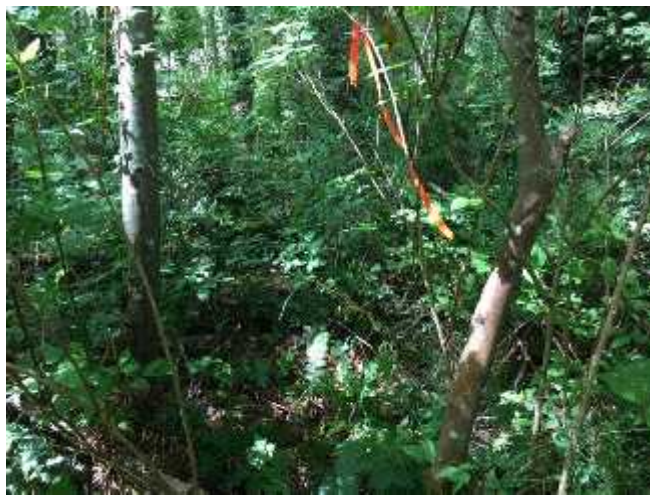
Photo 17 was taken of the upland area where Test Plot 6 was conducted. This upland forest lies between the north end of Wetland A and the western tip of Wetland C.

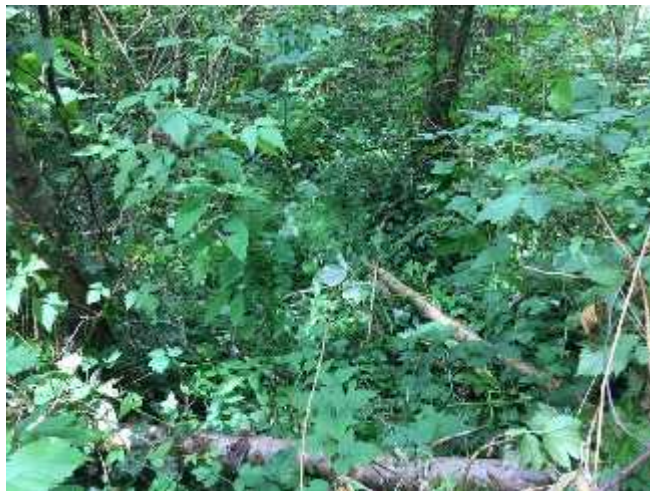
Photo 18 was taken of the area of Wetland C where Test Plot 7 was conducted.
