WETLAND DELINEATION REPORT AND BUFFER MITIGATION PLAN FOR FORT WARD LOTS 5 & 6

Fort Ward Lots 5 & 6 RUE
Bainbridge Island, Washington

Prepared for
Inhabit LLC
330 Madison Avenue South,
Suite 108
Bainbridge Island, Washington 98110
(206) 550-9004

Prepared by
Ecological Land Services
1157 3rd Avenue South, Suite 220A • Longview, WA 98632
(360) 578-1371 • Project Number 2405.01

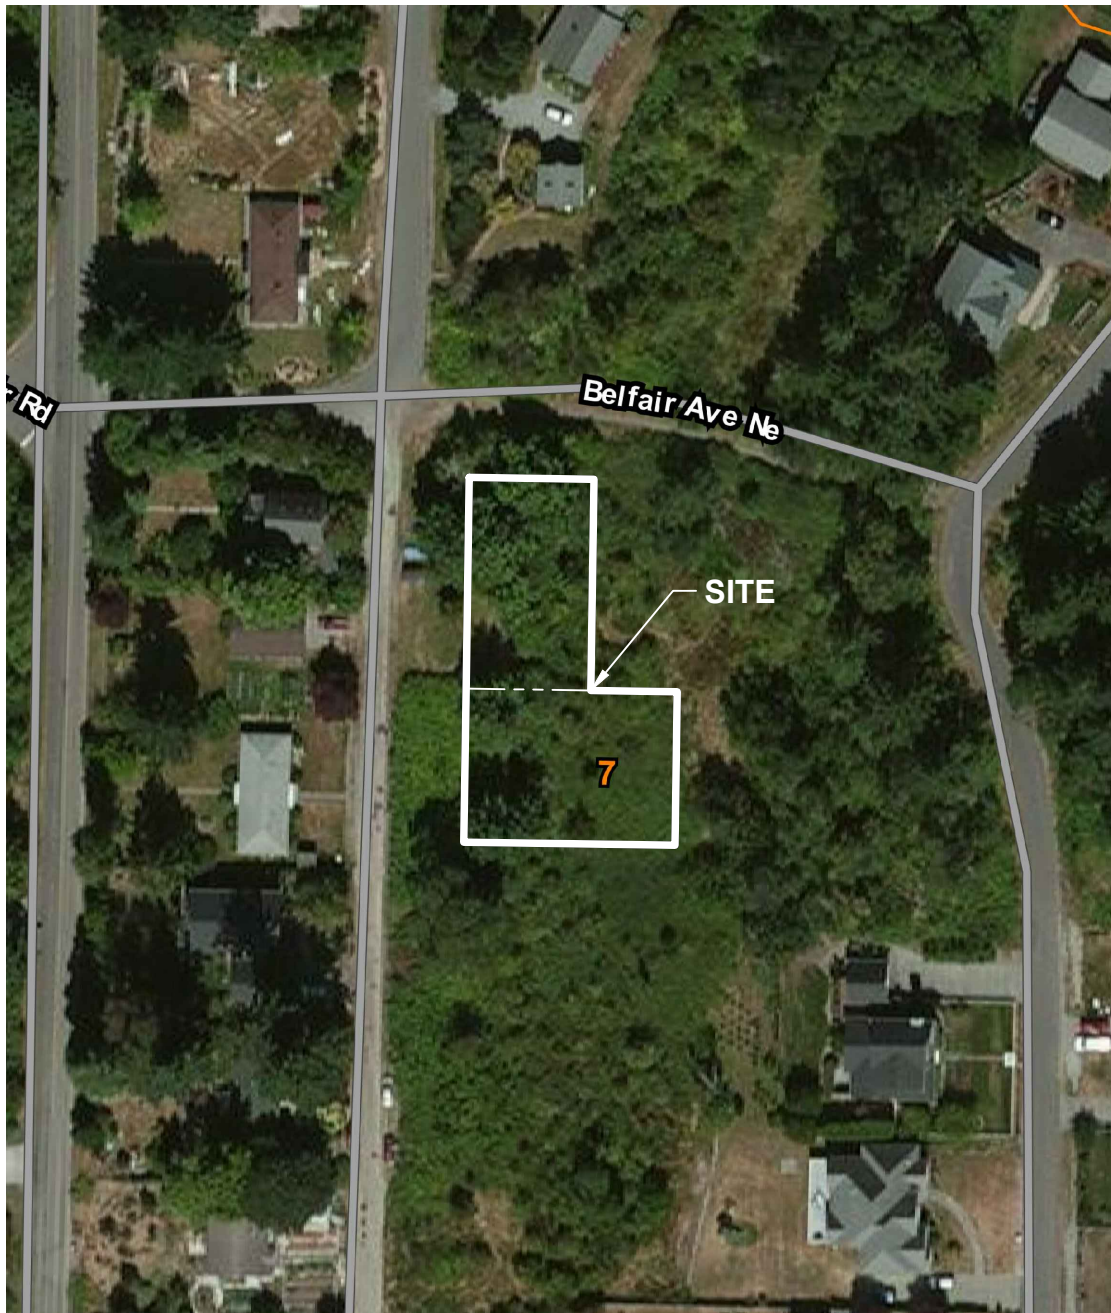
- 7 Cathcart silt loam, 2 to 8 percent slopes. Not hydric.

Figure 4
SOIL SURVEY MAP
Fort Ward Lots 5 & 6 RUE
Julian Prosser
City of Bainbridge Island, Kitsap County, WA
Section 11, Township 24N, Range 2E, W.M.

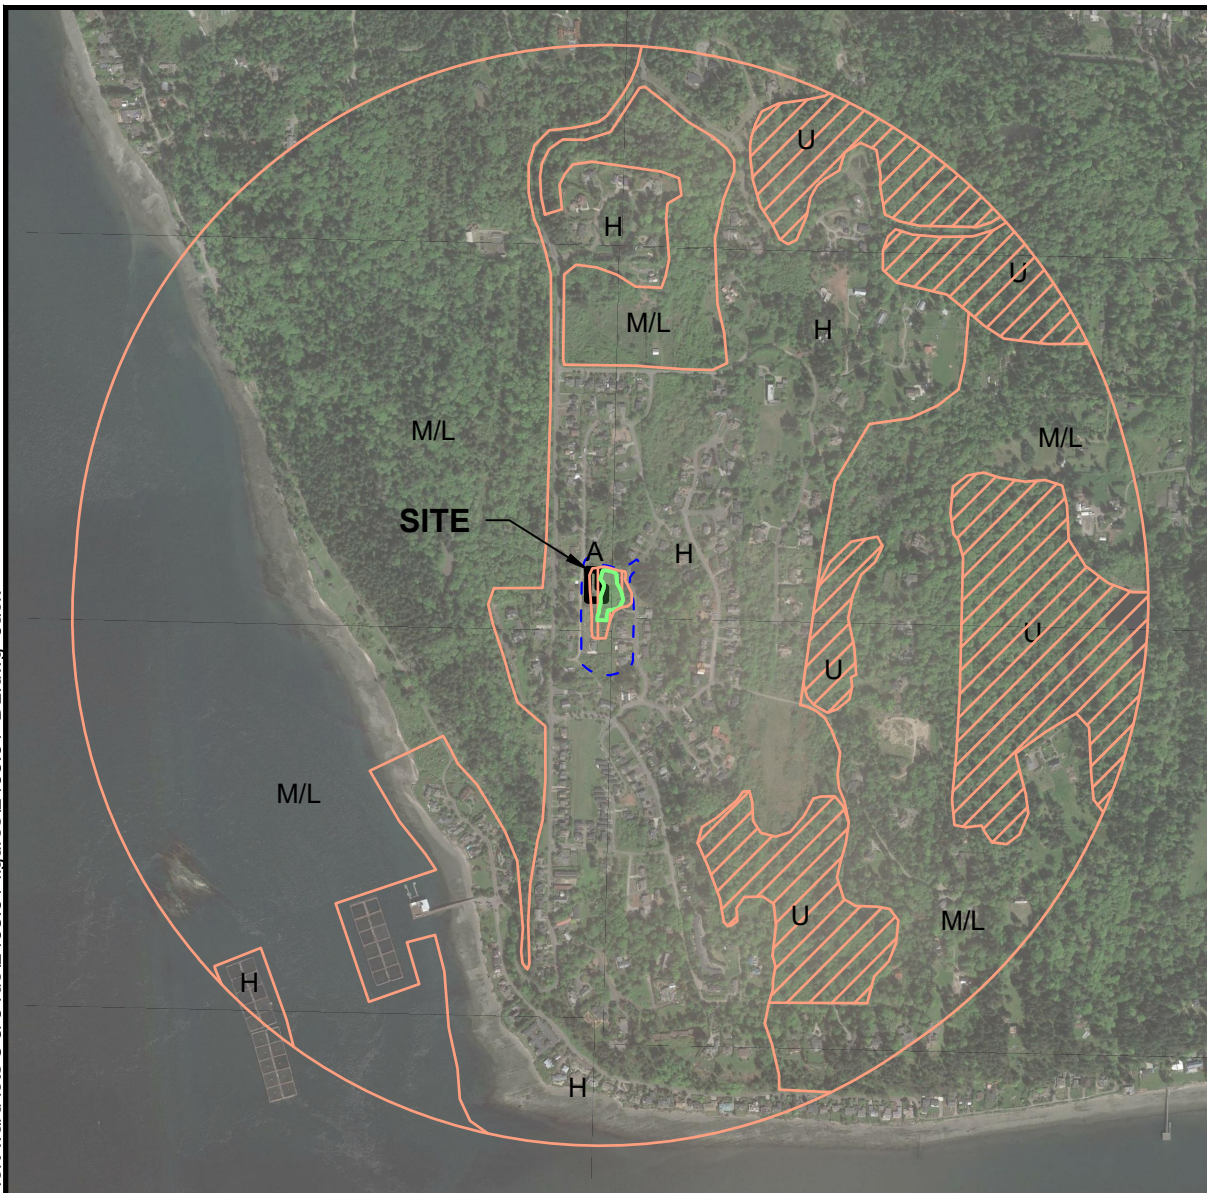
- Wetland Unit Boundary
- Contributing Basin
- A Accessible Habitat (0.1%)
- U Undisturbed Habitat (12.0% *Includes Accessible Habitat)
- H High Intensity Land Use (33.9%)
- M/L Moderate/Low Intensity Land Use (54.1%)

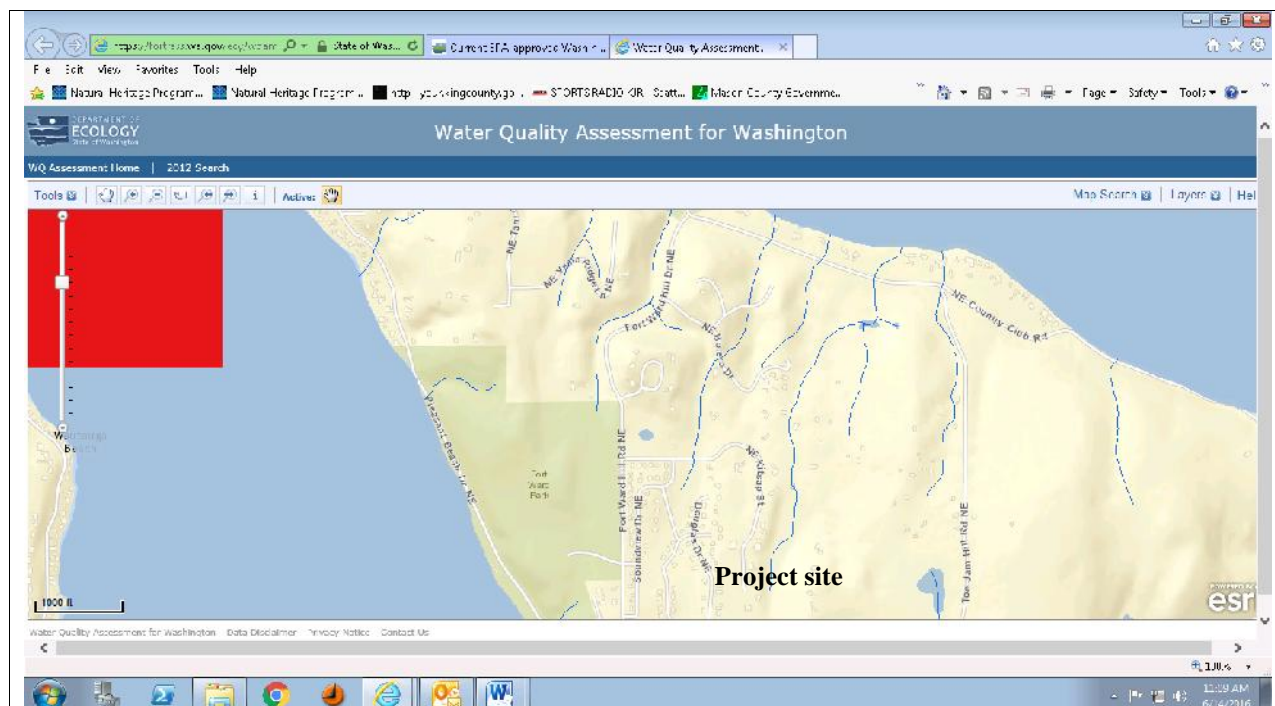
Figure 11b: TMDL List for Kitsap County. There are no TMDLs for the drainage basin of the rated wetland.

Figure 11-Wetland Rating
Figure-303(d)/TMDL
Project Name: Fort Ward
Lots 5 and 6
Client: Prosser
Kitsap County, Washington

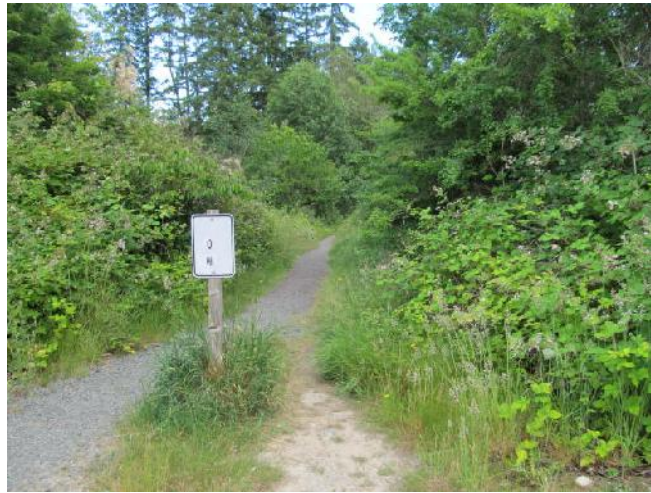
Photo 1 was taken from the northwest corner of Lot 5 facing east. It looks down Belfair Avenue, which is an unimproved right-of-way that is currently used as a pedestrian path. This path borders the north property boundary of Lot 5.

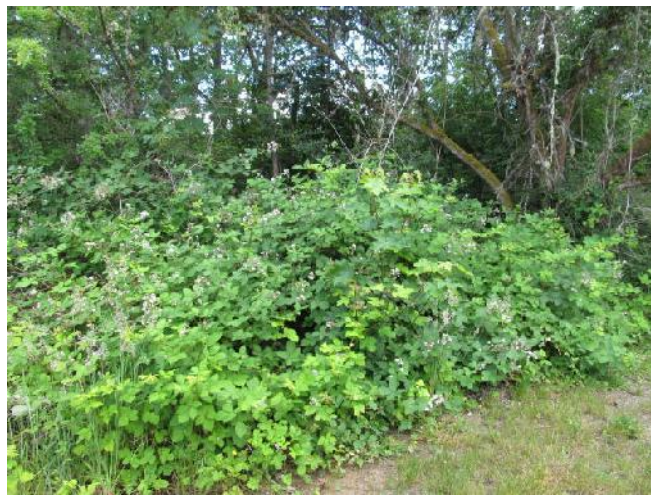
Photo 2 was taken from the same location as Photo 1 and looks southeast at the upland vegetation that occurred near the mowed, level area of Lot 5.

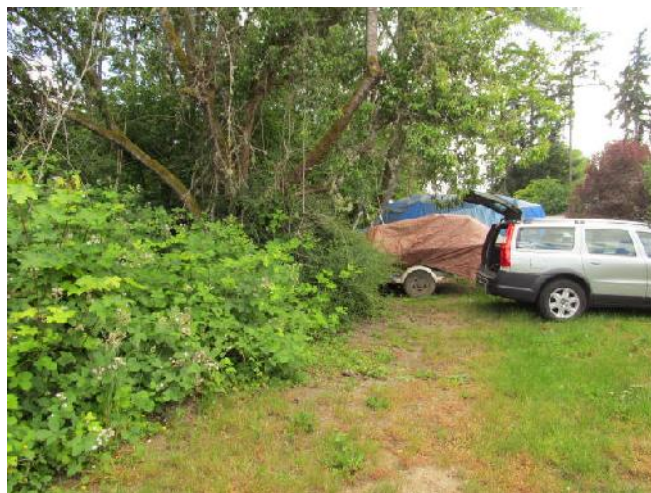
Photo 3 was taken from the same location as Photos 1 and 2 facing south. It shows some of the boats that had been parked on the Soundview Drive right of way, which is currently unimproved. This Soundview Drive NE lies to the right of the frame.

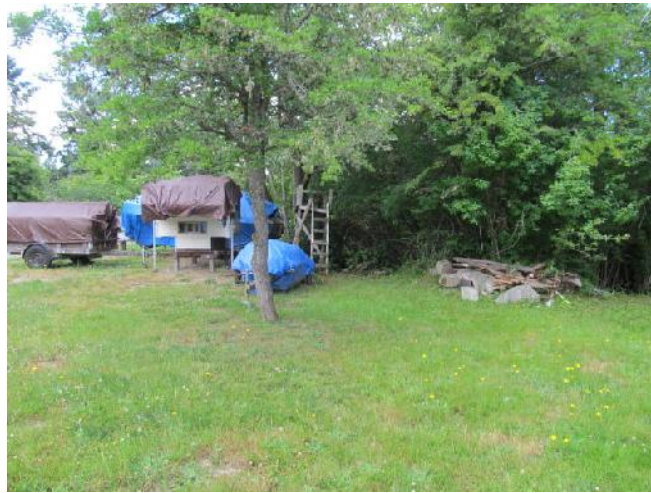
Photo 4 was taken near the middle of the mown area on the west side of Lot 5 facing north. It looks at the same boats pictured in Photo 3 (Photoplate 1).

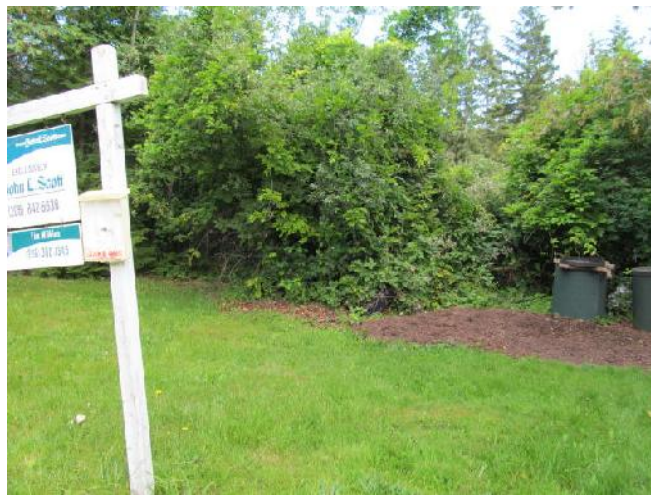
Photo 5 was taken from the same location as Photo 4 and looks east at the upland vegetation and another example of the neighbors using the vacant lots.

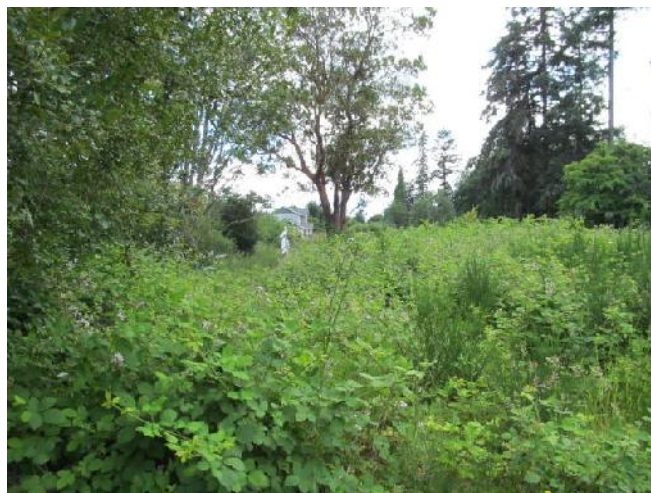
Photo 6 was taken from the same location as Photos 4 and 5 facing south. It looks at the thick shrub layer that began at the boundary of Lots 5 and 6 and continued to the southern boundary of Lot 6.

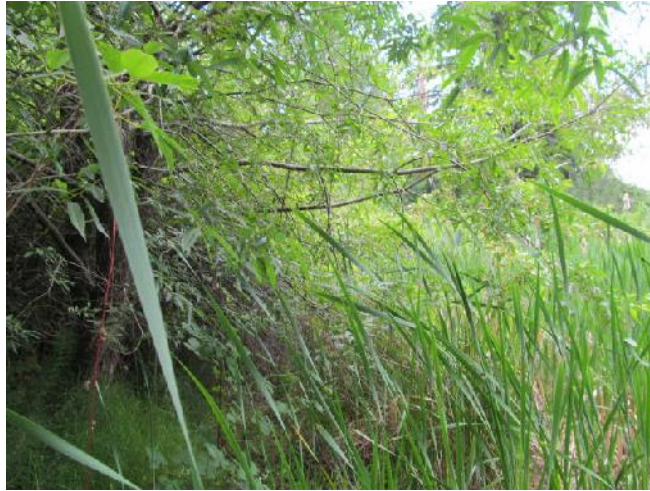
Photo 7 was taken from the northern extent of Wetland A facing southeast. It demonstrates the vegetation that was growing in this area of wetland.

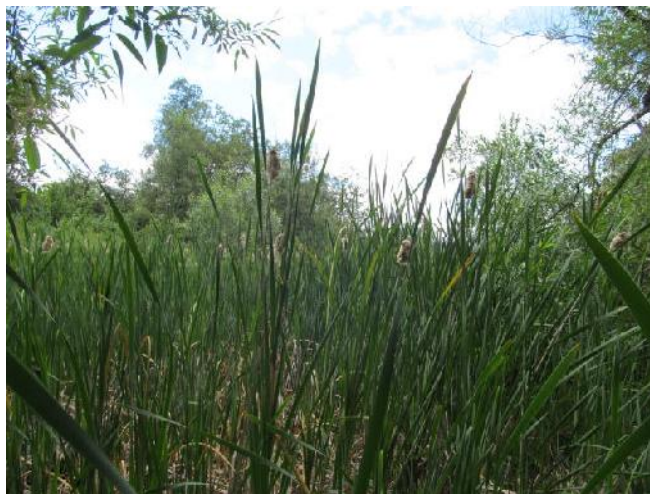
Photo 8 was taken from the same location as Photo 7 and looks south at the wetland vegetation. This portion of Wetland A was emergent only.

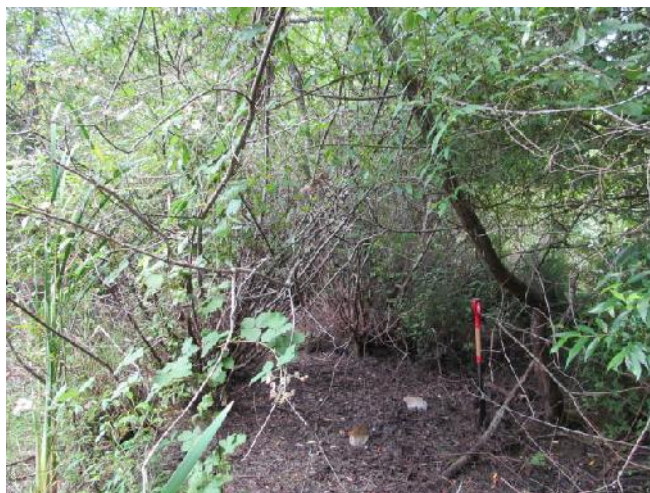
Photo 9 was taken from the same location as Photos 7 and 8 facing west. It looks toward the forested portion of Wetland A, which was dominated by Pacific willows.

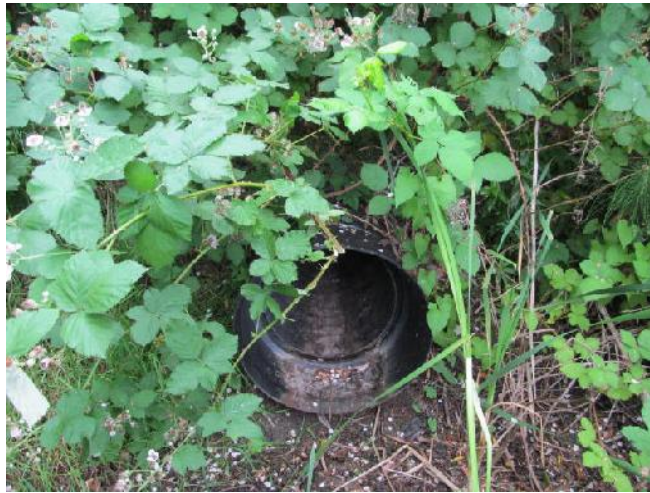
Photo 10 was taken of the culvert that outlets Wetland A to the north. It was positioned at the very north end of the wetland and conveys water under the pedestrian path picture in Photo 1 (Photoplate 1).

The mitigation plan also includes specifications for replacement of the culvert under Belfair Avenue to provide a better hydrologic connection between the wetlands that lie within Fort Ward

The wetlands in Fort Ward Estates were historically part of one larger system that upon development of the area were divided into somewhat individual wetlands by roads (Belfair Avenue to the north of these lots and Richardson Street to the northeast). During construction, culverts were placed beneath the roads but the one at Belfair was placed too high in elevation so did not allow the continued flow of water into the northern wetland areas. Due to the lack of hydrological continuity caused by the improperly installed culvert, the original area of wetland south of Belfair Avenue has expanded considerably (Figure 9). It appears that a larger culvert was installed several years ago but it remains slightly higher in elevation than the bottom of the wetland south of Belfair so has not restored hydrologic continuity. The wetland does not appear to have expanded as a result of the new culvert but it has not allowed the wetland to restore to its original limits.

By improving the connection between the onsite wetland and the wetlands to the north, there will be improvements in hydrologic connectivity, wildlife passage, and increased diversity within the northern wetlands. When water is allowed to spread across both wetlands there will be an increase in the ability of each wetland to function as one system for water quality improvement and water quantity storage. It is recommended that the culvert be at least 24 inches across and is either partially buried or bottomless. This will improve wildlife connectivity between the wetlands and allow small animals such as frogs to move across the historic range. The wetland north of Belfair Avenue is dominated by a dense community of soft rush. The increase in plant species diversity as a result of seed sources reaching more areas will improve the water quality of the runoff that enters the wetlands. The onsite wetland has greater plant species diversity and once the culvert is replaced, the seeds from these plants will spread into the northern wetlands and thereby increase the vegetation diversity.

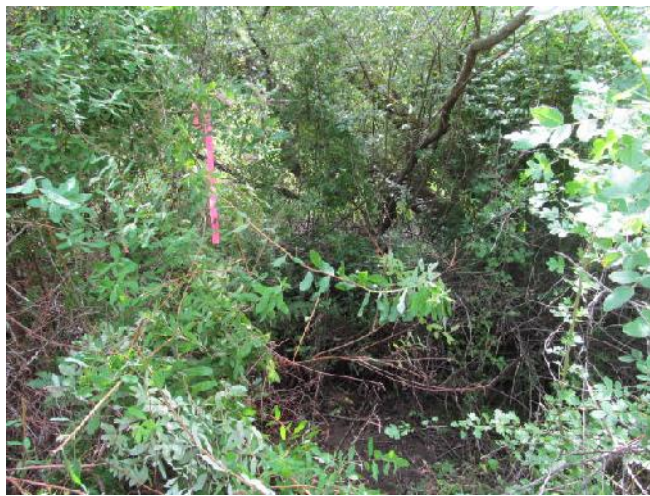
Photo 11 was taken of the area where Test Plot 1 was conducted. It was located inside the northern wetland boundary where the vegetation was thick with tall shrubs.

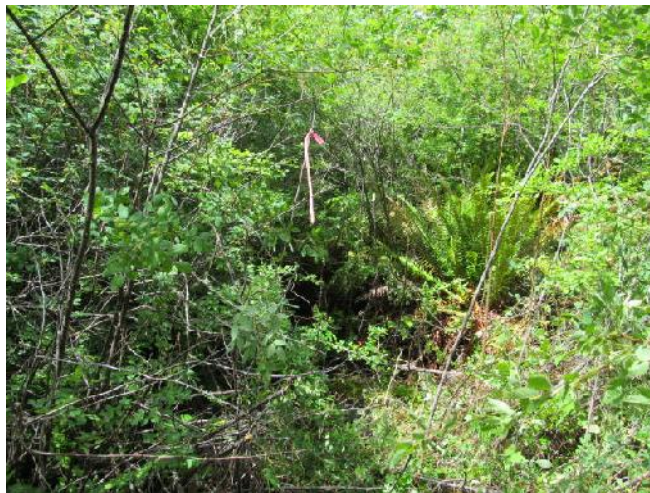
Photo 12 was taken of the area where Test Plot 2 was conducted. It was located upslope of Test Plot 1 in the forested upland.

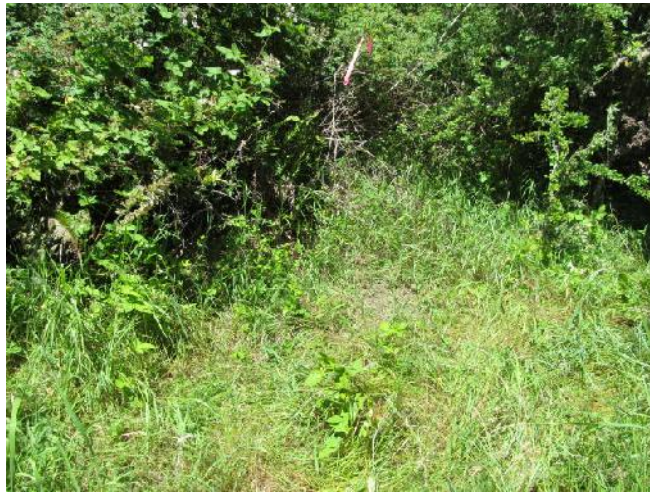
Photo 13 was taken of the area where Test Plot 3 was conducted. It was located in an open area of upland west of the boundary.

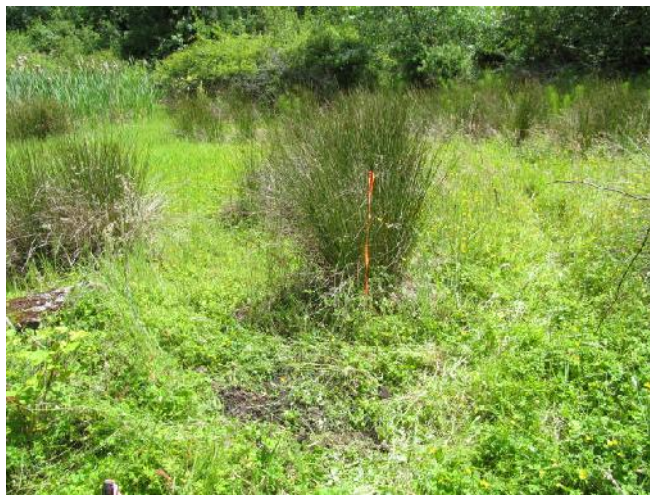
Photo 14 was taken of the area where Test Plot 4 was conducted. It was located inside the western wetland boundary where the vegetation was dominated by emergent species.

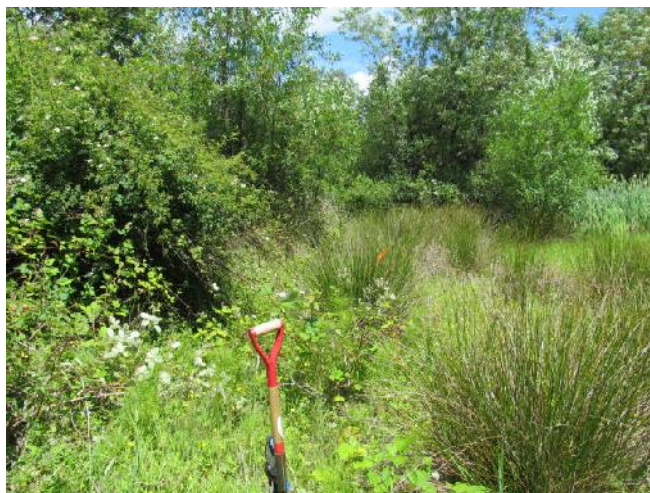
Photo 15 was taken from the middle of the wetland facing north. Test Plot 4 is visible in the foreground and the forested portion from Photo 11 (Photoplate 4) is visible in the background.

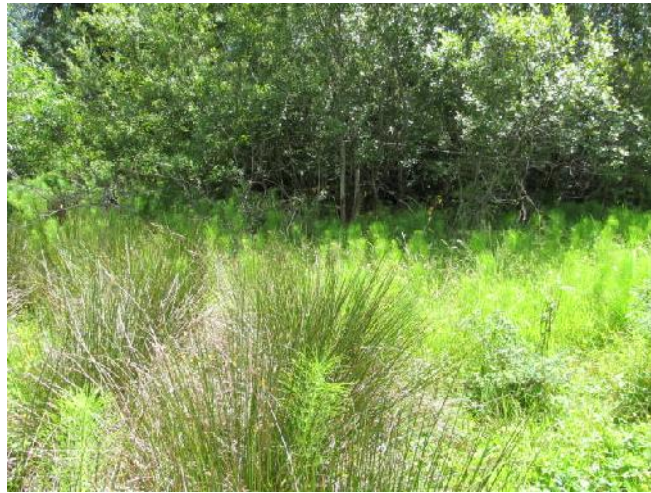
Photo 16 was taken from the same location as Photo 15 (Photoplate 5) facing east. It shows the emergent portion of the wetland in the foreground and the forested portion in the background.

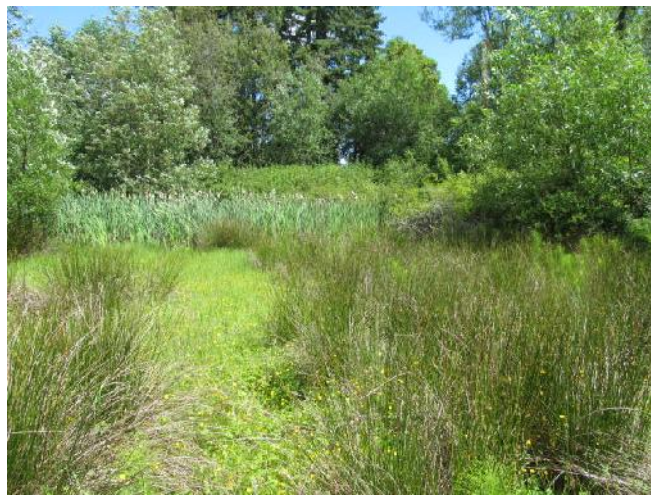
Photo 17 was taken from the same location as Photos 15 and 16 facing southeast. The center of the depression had no woody vegetation present.

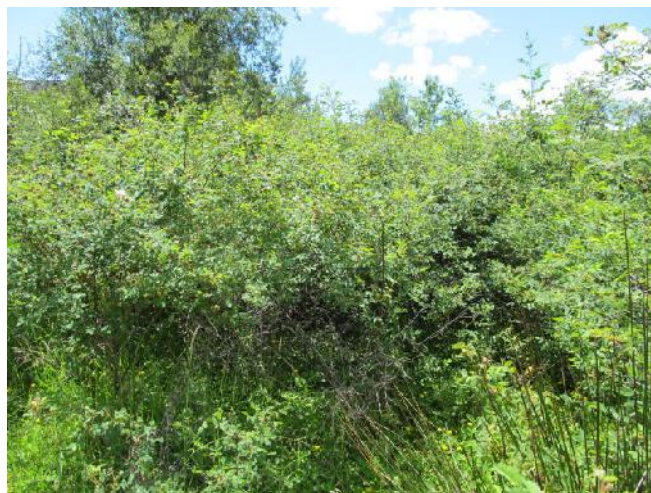
Photo 18 was taken from the same location as Photos 15, 16, and 17 facing west. It looks towards the thick shrub area of Wetland A.
