# CRITICAL AREAS REPORT AND STREAM BUFFER MITIGATION PLAN

**Phelps Road Property**  
*City of Bainbridge Island,  
Washington*

Prepared for  
**Fidalgo Bay Homes**  
PO Box 2913  
Silverdale, WA 98383  
360-551-5392

Prepared by  
**Ecological Land Services**

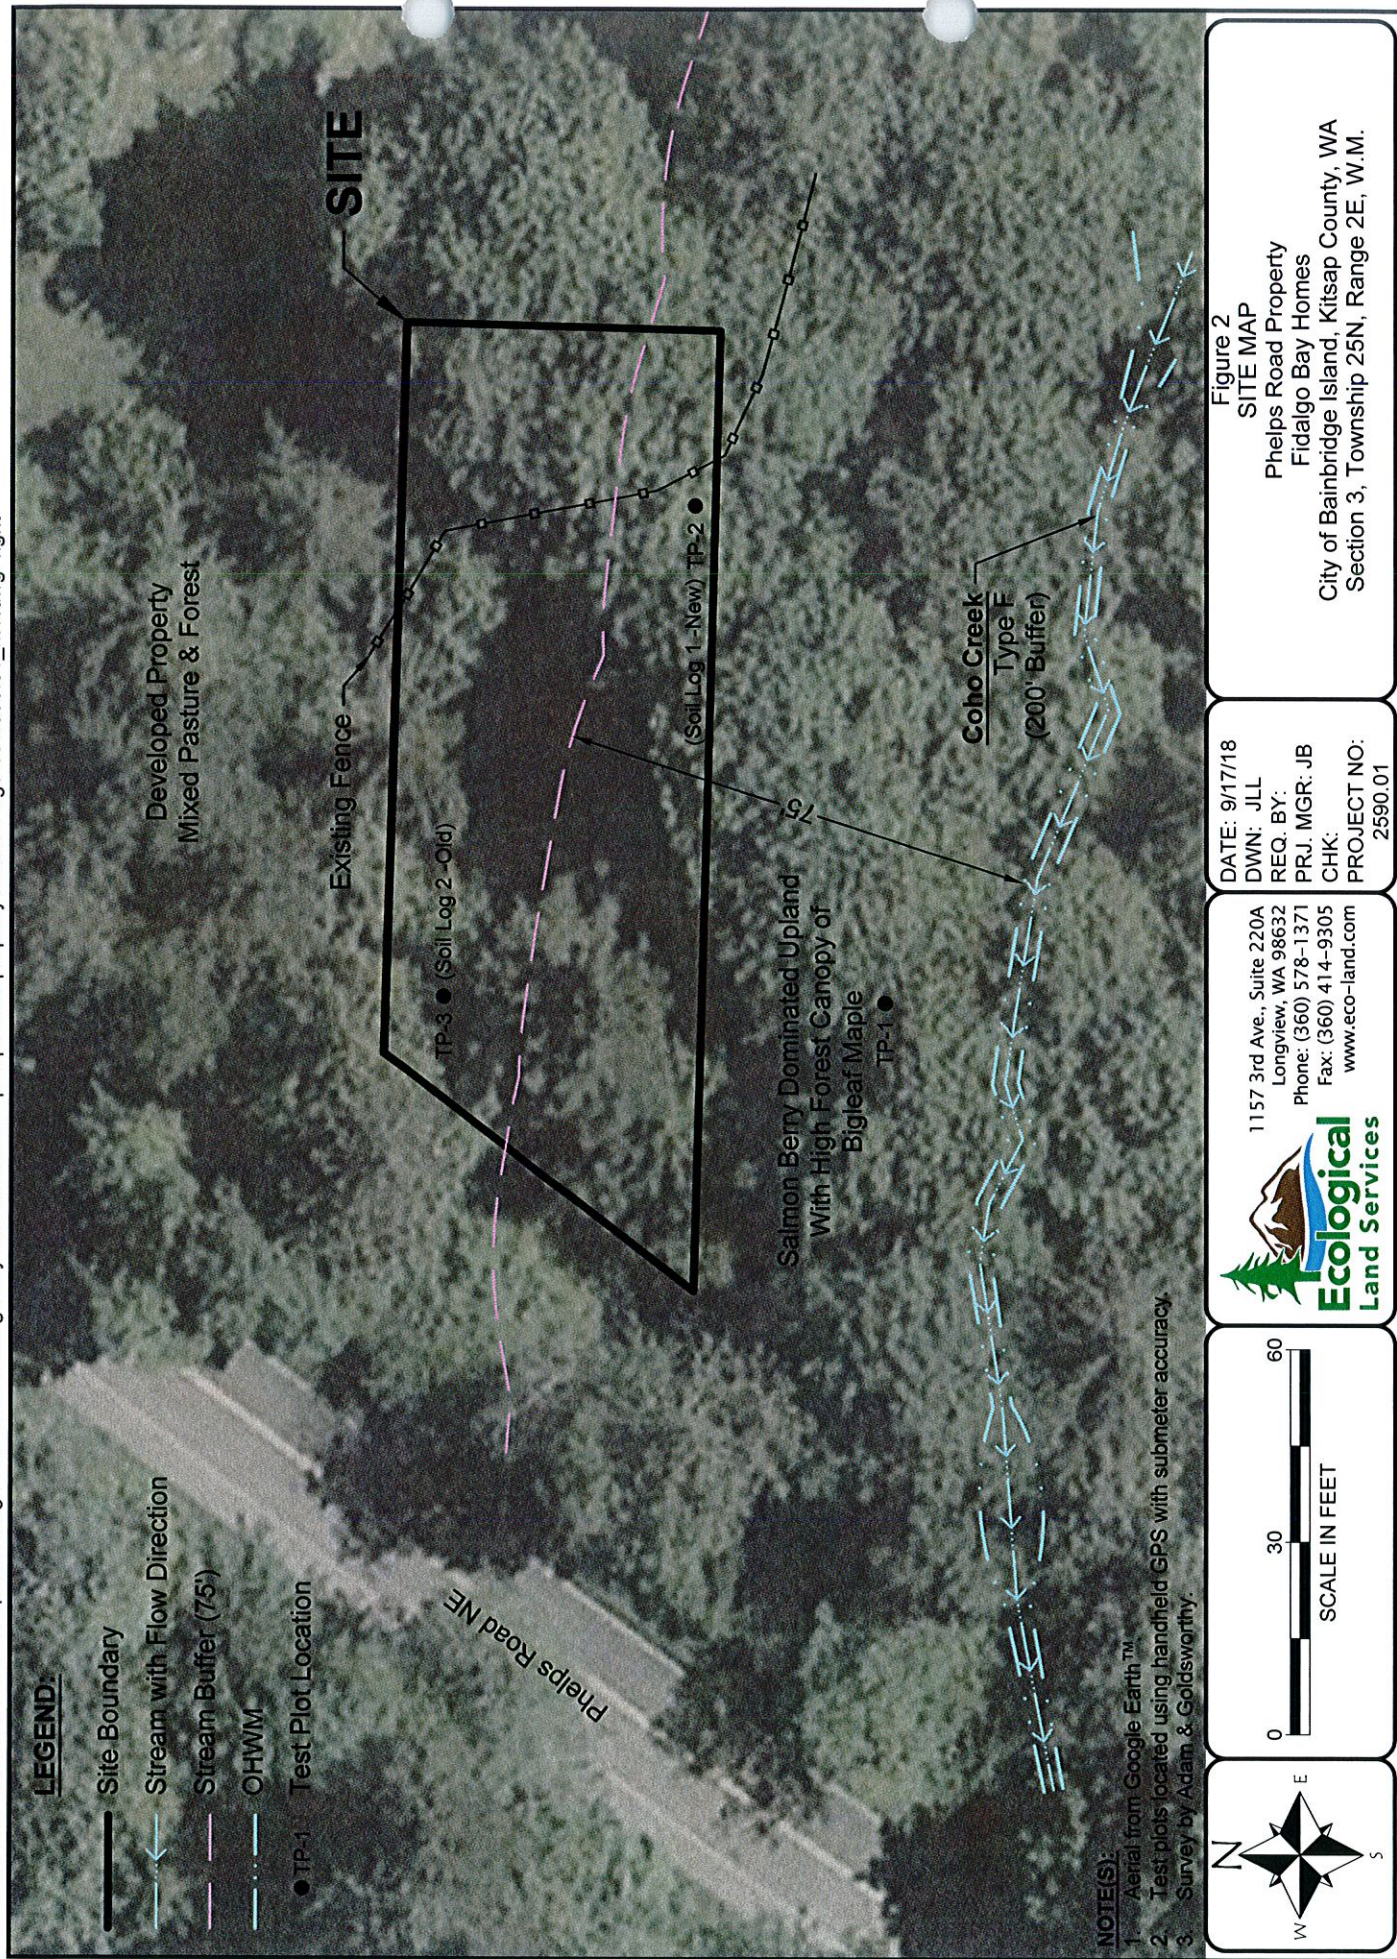
**Figure 3**  
**SITE PLAN**  
 Phelps Road Property  
 Fidalgo Bay Homes  
 City of Bainbridge Island, Kitsap County, WA  
 Section 3, Township 25N, Range 2E, W.M.

A single-family home and septic drainfield is proposed on the property with a driveway across the road right-of-way from Phelps Road (Figure 3). The project will require clearing most of the property to construct the house and install the drainfield.

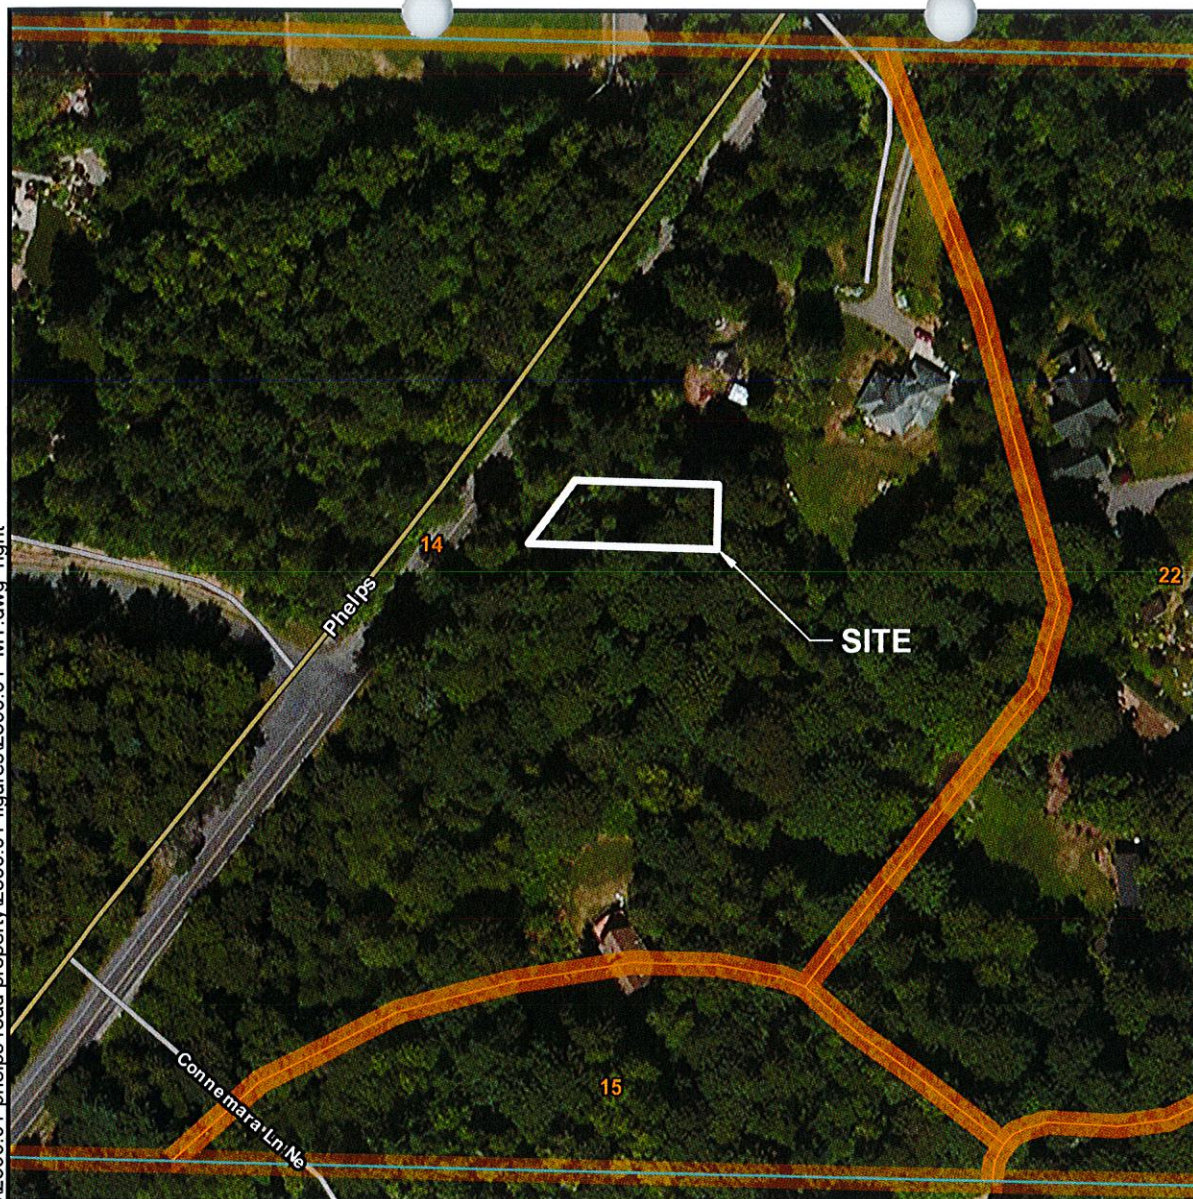
Figure 4  
SOIL SURVEY MAP  
Phelps Road Property  
Fidalgo Bay Homes  
City of Bainbridge Island, Kitsap County, WA  
Section 3, Township 25N, Range 2E, W.M.

- 14 Harstine gravelly ashy sandy loam, 0 to 6 percent slopes. Not hydric.

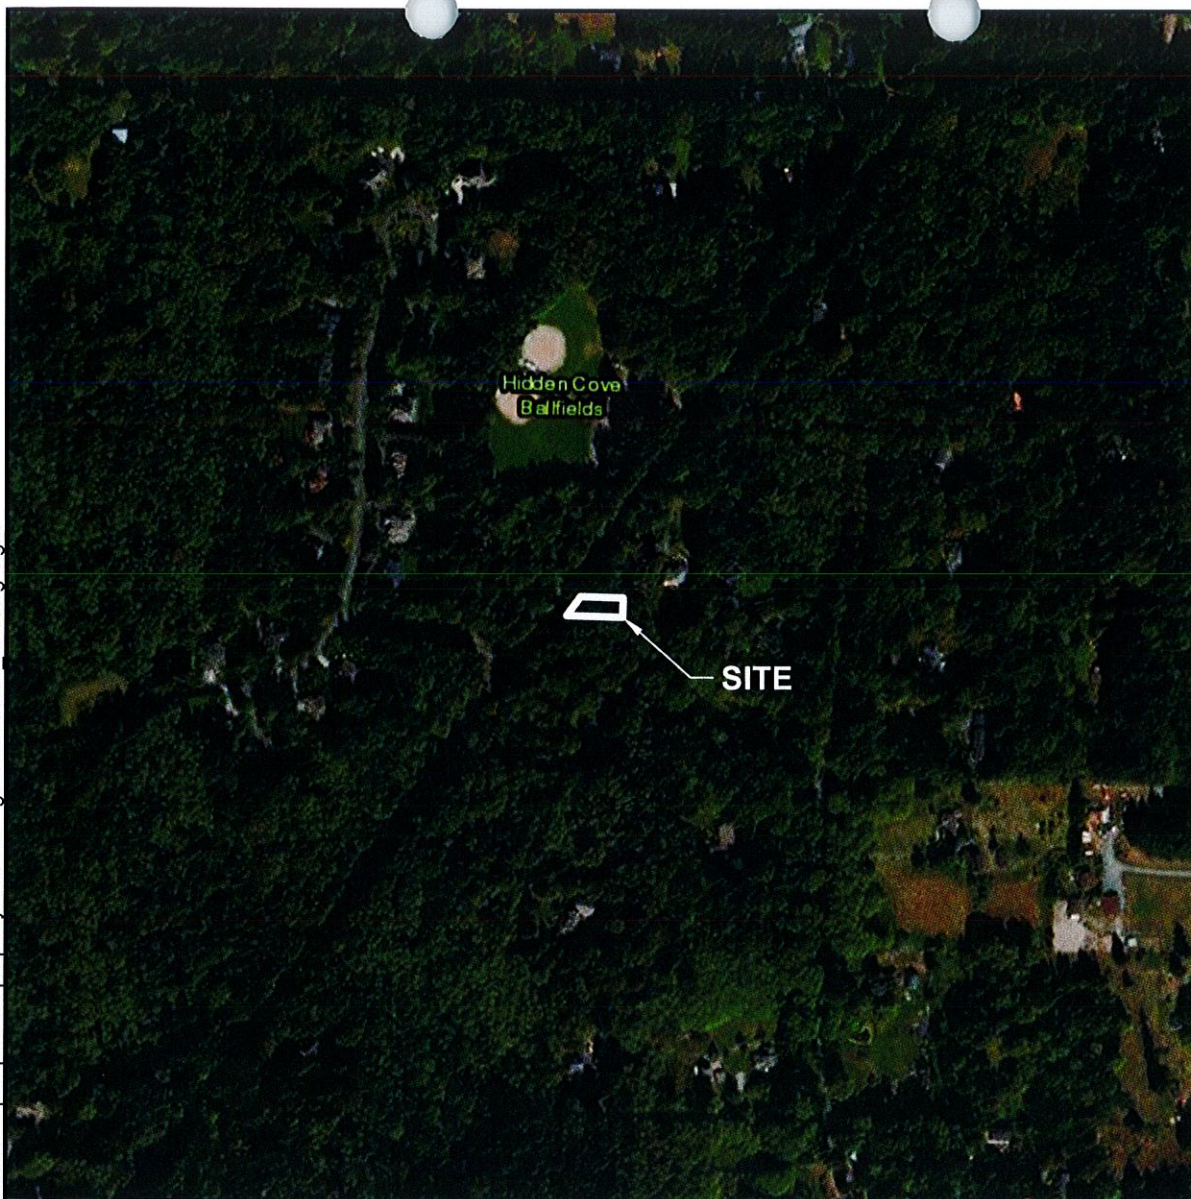
Figure 5  
NATIONAL WETLANDS INVENTORY MAP  
Phelps Road Property  
Fidalgo Bay Homes  
City of Bainbridge Island, Kitsap County, WA  
Section 3, Township 25N, Range 2E, W.M.

No mapped wetlands indicated onsite by US Fish & Wildlife Service.

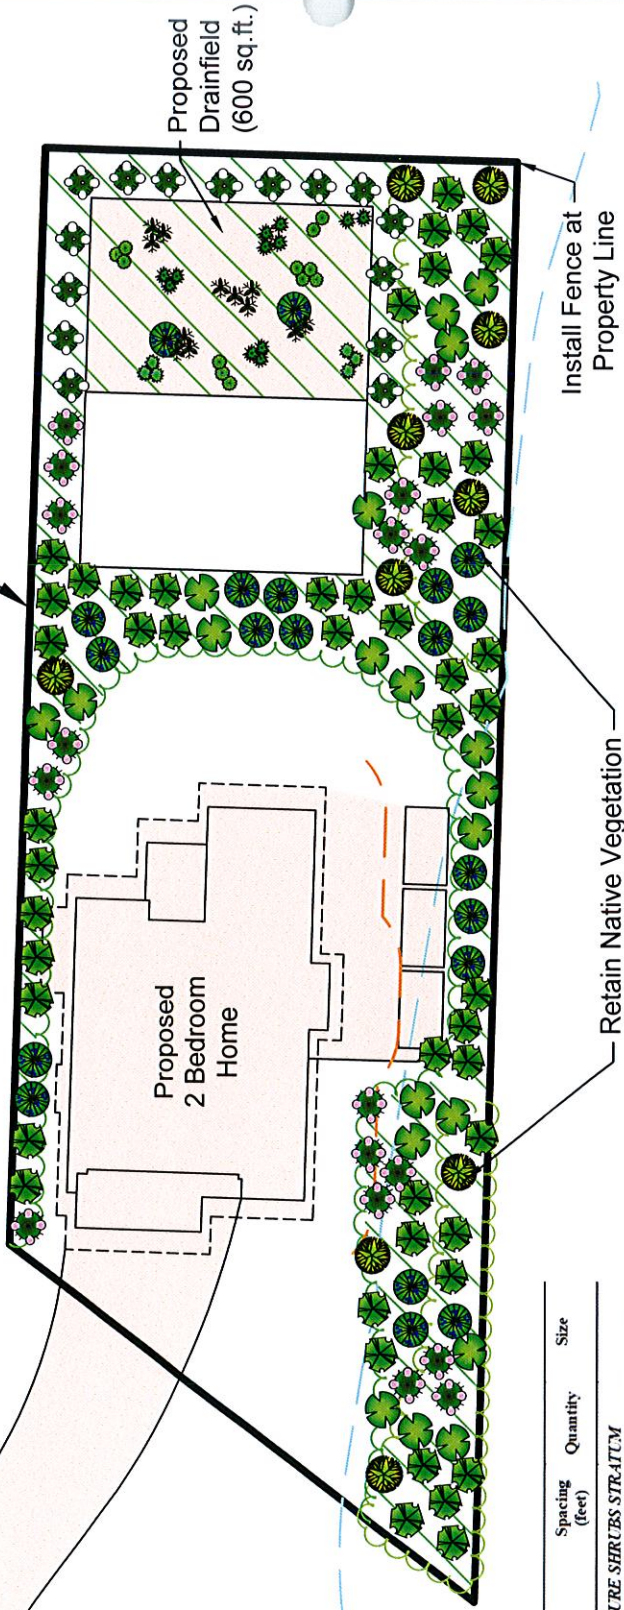
**MITIGATION PLANTING PLAN**

**NOTE:** Plants are not to scale and locations are approximate as shown. Actual planting locations will be determined in the field, with consideration to the listed spacing and density to produce the most natural appearance possible.

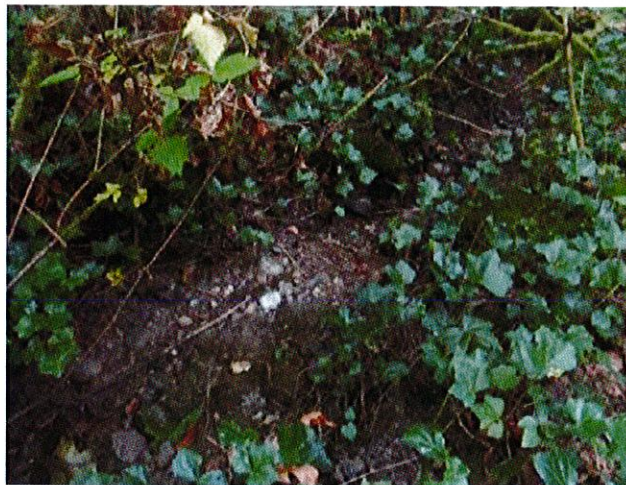
**Photo 1** shows the dry stream bed of Coho Creek, which is a Type F stream that runs east to west approximately 50 feet south of the property.

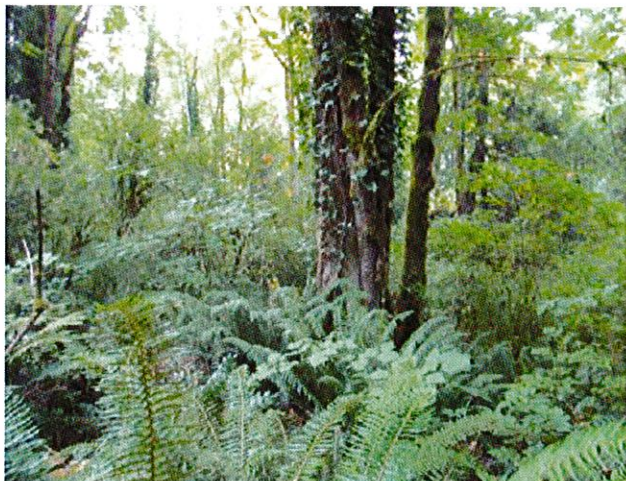
**Photo 2** was taken from the top of the slope at the south end of the property, looking south east at the forest that dominates the buffer that lies between Coho Creek and the property. The area has a tall canopy of big leaf maple and semi-dense understory of shrubs and herbaceous plants.

The buffer is composed of mixed forested and understory vegetation (Photoplates 1 and 2). The proposed reduction will allow for construction of the house, driveway and septic system on this small property. Onsite buffer plantings will increase the function of the onsite portion of buffer so that the house is not visible from the stream and more of the noise and light generated on the developed site will be screened. The forest offsite to the south will remain and will be sufficient

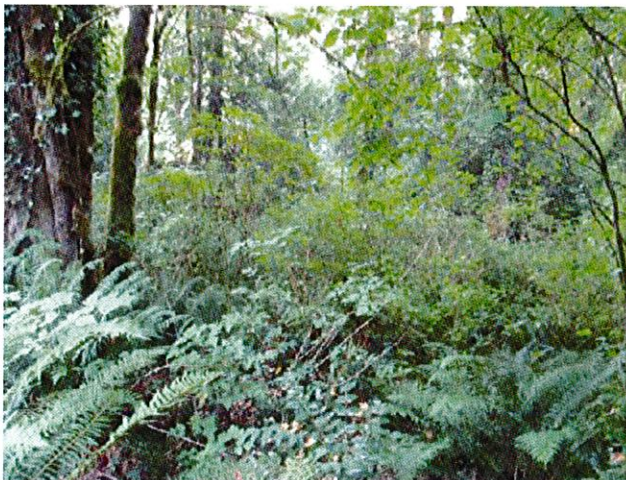
**Photo 3** was taken from the same location as Photo 2, looking south at the forested buffer conditions between Coho Creek and the property.

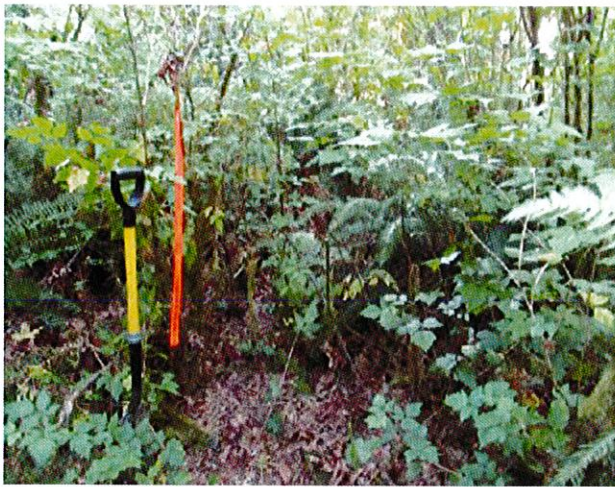
**Photo 4** shows the area where Test Plot 1 was conducted. This area is located on the slope between Coho Creek and the property.

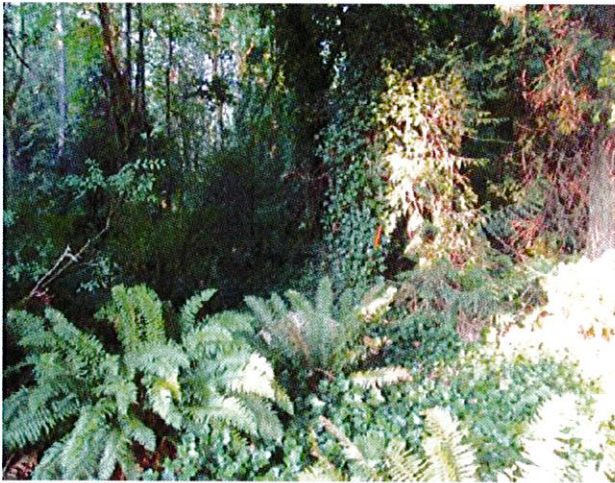
**Photo 5** shows the area where Test Plot 2 was conducted. This area is in the southeast part of the property, close to the southern property line and the existing fence. Soil Log 1 was used to examine the soil colors and texture.

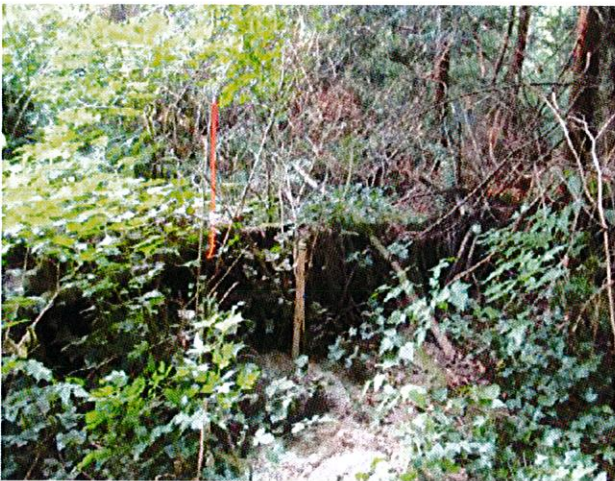
**Photo 6** shows the area where Test Plot 3 was conducted. This area is close to the northwest corner of the property. Old Soil Log 2 was used to examine the soil colors and texture.

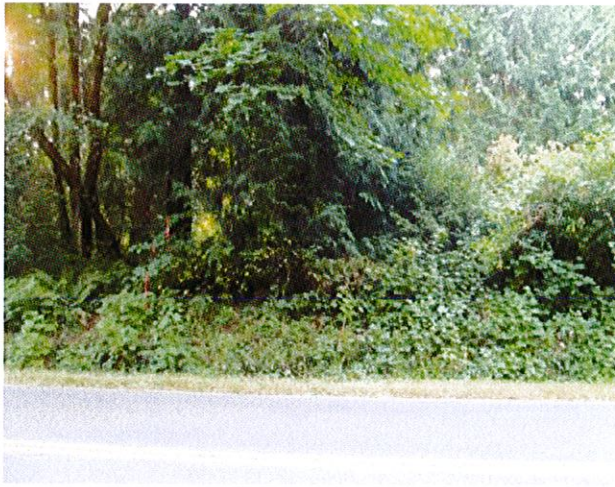
**Photo 7** was taken from across Phelps Road, looking east toward the northwest corner of the property.

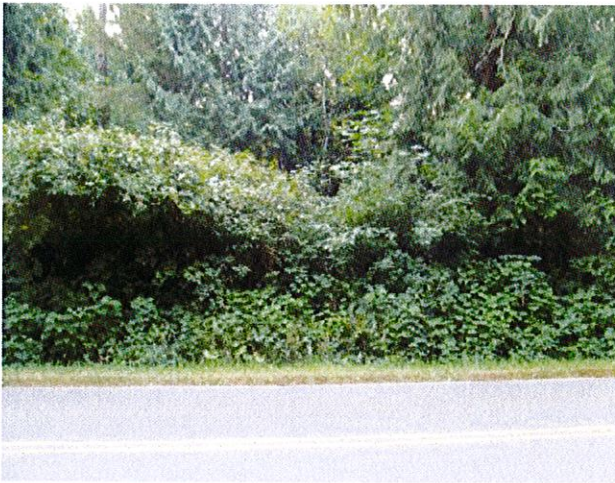
**Photo 8** was taken from the same location as Photo 7, showing the southwest corner of the property closest to Phelps Road. The proposed driveway would enter the property here.

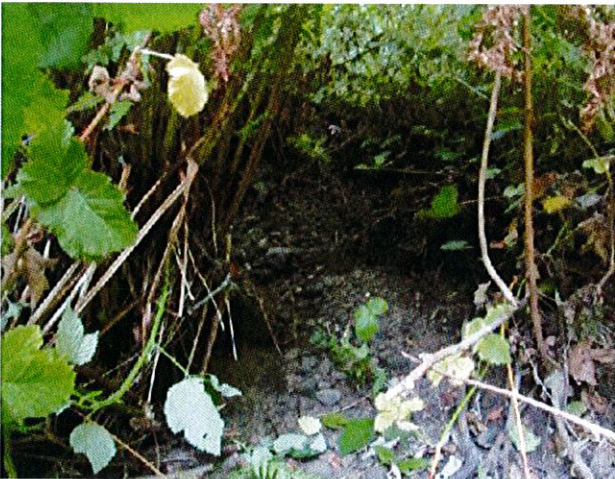
**Photo 9** shows the dry roadside ditch along Phelps Road, near where the dry stream channel enters the ditch.

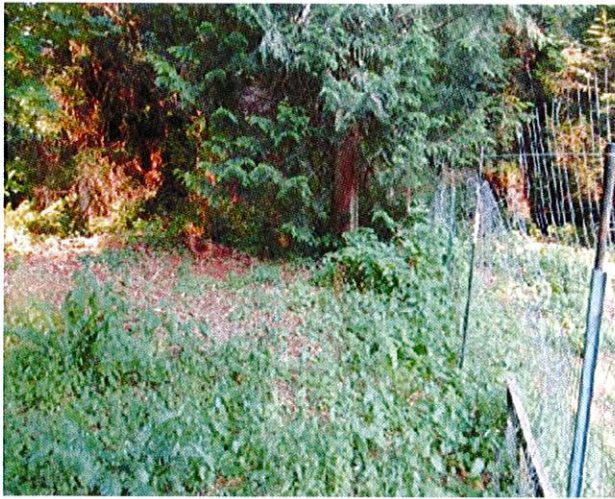
**Photo 10** was from along the north property line, which is represented by the fence on the right side. This photo looks west along the north line with the onsite area to the left and offsite pasture to the right.

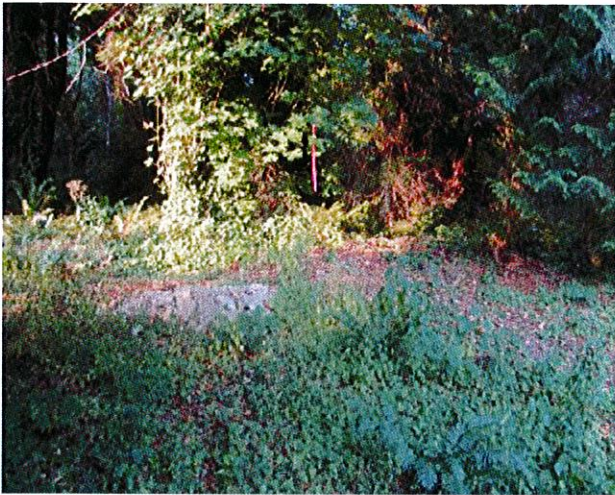
**Photo 11** was taken from the same location as Photo 10 and looks south back onto the property from the fence line.

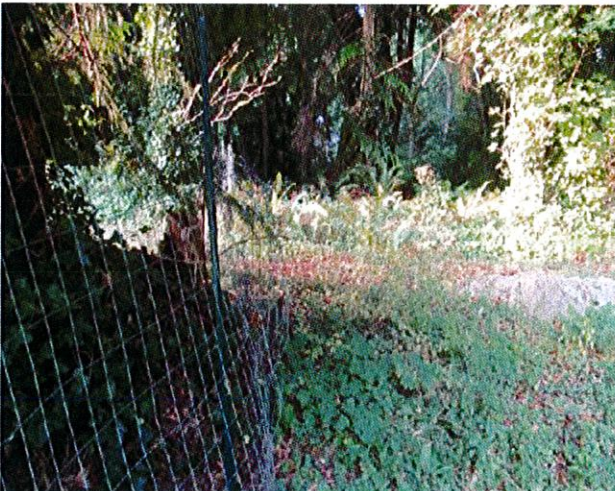
**Photo 12** was taken from near the northwest corner and looks east along the property line, which is represented by the fence on the left.
