**Wetland Delineation Report  
And  
Buffer Mitigation Plan  
for the  
Soundview Drive Properties  
Bainbridge Island, Washington**

Ecological Land Services, Inc.  
1157 3<sup>rd</sup> Avenue, Suite 220A  
Longview, Washington 98632  
(360) 578-1371  
Project Number 2447.01

December 12, 2016

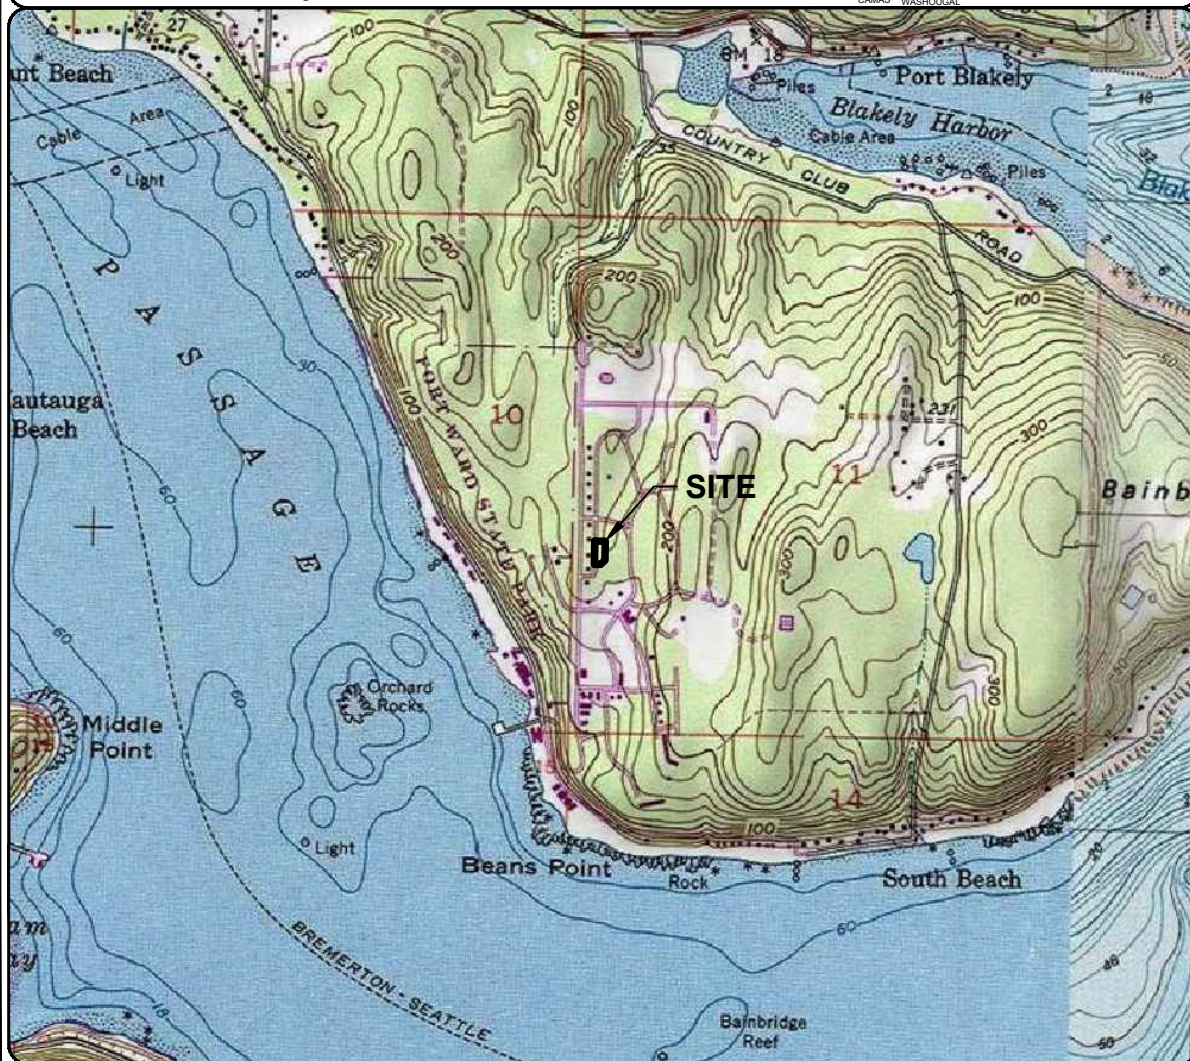
- Site Boundary
- Wetland Boundary
- - - - Approximate Wetland Boundary
- Wetland Buffer
- TP-1 Test Plot Location
- 01 x Wetland Flag

**Wetland**  
Category III  
Depressional  
Forested  
Scrub/Shrub  
Emergent  
Seasonally Flooded

To verify the wetland boundary on these lots, ELS biologists collected data on vegetation, hydrology, and soils. The delineation site visit was conducted on September 13, 2016 during which, one wetland was delineated along the east side of the lots. The boundary of the wetland was delineated using consecutively numbered fluorescent flagging labeled “WETLAND BOUNDARY.” Wetland boundaries were determined through breaks in topography, changes in vegetation, and evidence of surface hydrology. The wetland boundary on these lots represents a continuation of the delineation conducted by ELS on the lots immediately to the north. The flags on the adjacent lots are numbered from 1 to 9 and the flags on these lots are delineated from 10 to 15. Vegetation, hydrology, and soil data was collected at two test plots to verify the wetland boundary delineation on these lots and four test plots were completed for the delineation on the adjacent lots (Appendix A). The wetland boundaries were mapped using a Trimble handheld Global Positioning System (GPS) unit to show the extent of the wetland on the site map (Figure 2).

The wetland was identified and delineated along the east edge of the three lots (Figures 2 and 3). Wetland A is situated in a depressional trough bordered by residential development on the southeast and south sides (Photoplates 1 and 2). It is a depressional system dominated by a combination of forested, scrub/shrub, and emergent vegetation communities (Photoplates 3 and 4). The wetland has a seasonally flooded hydroperiod with northerly water flow into a culvert at the north end that conveys water into wetlands north of Belfair Avenue. The culvert was not installed at the proper elevation and is angled up to the north so water only leaves the wetland during periods of high precipitation events.

The Bainbridge Island Critical Areas map (BI 2015) maps wetland along the east boundary of the three lots (Figure 6), which represents Wetland A. The ELS biologists agree with the general mapping of wetland (Figure 2).

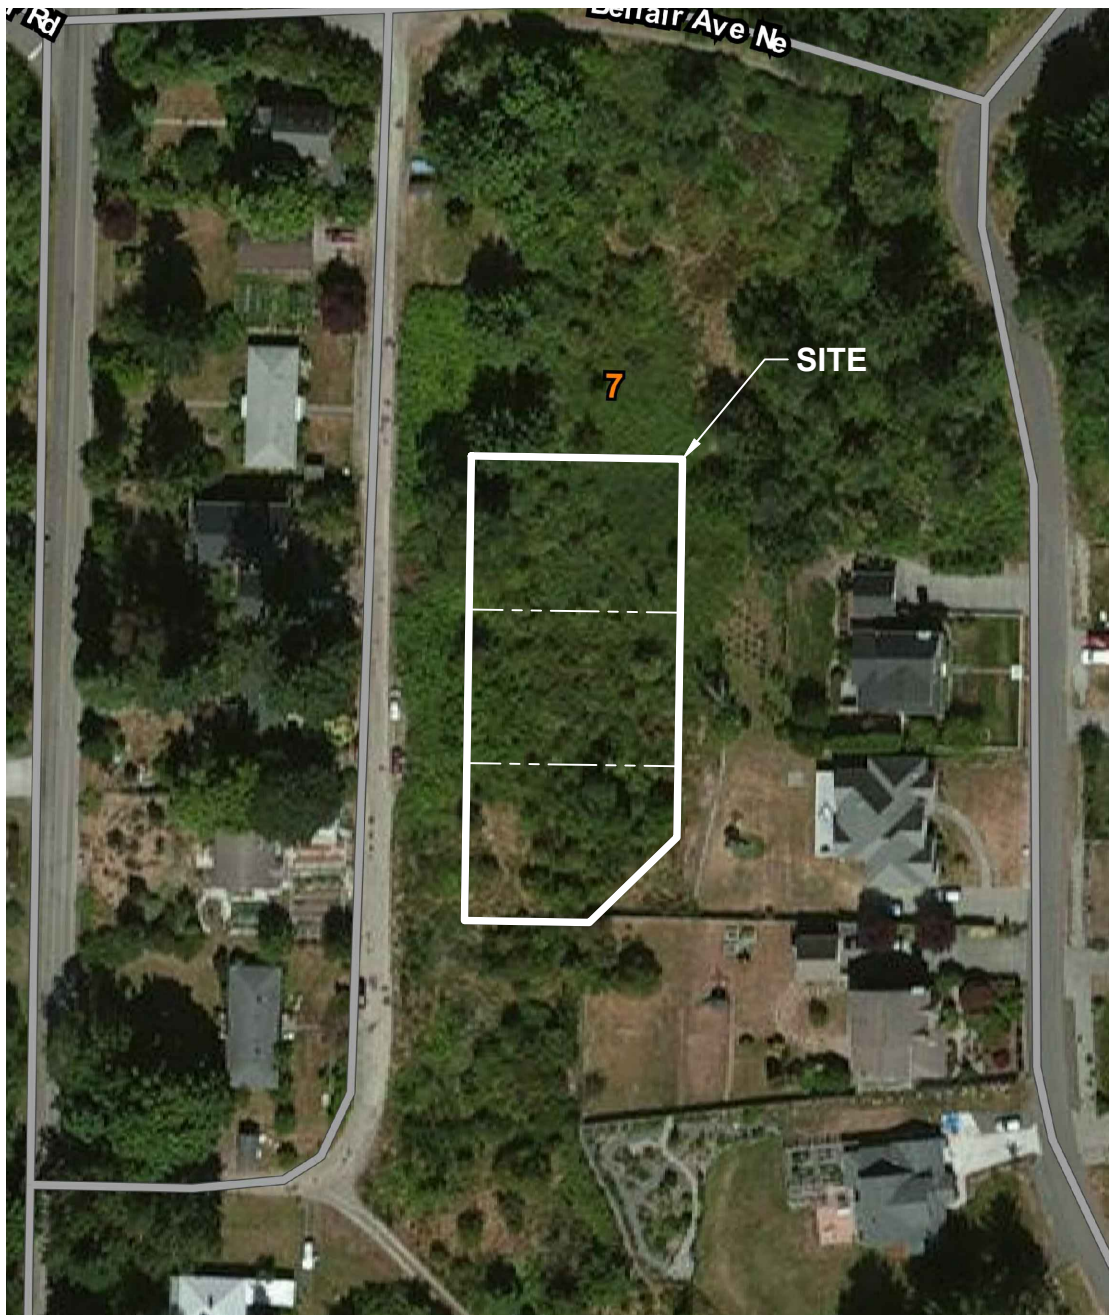
Figure 4  
SOIL SURVEY MAP  
Soundview Boulevard Properties  
Rural American Properties  
City of Bainbridge Island, Kitsap County, WA  
Section 11, Township 24N, Range 2E, W.M.

- 7 Cathcart silt loam, 2 to 8 percent slopes. Not hydric.

As referenced on the U.S.D.A. Natural Resources Conservation Service (NRCS 2015) website, Cathcart silt loam, 2 to 8 percent slopes (7) is mapped across the lots (Figure 4). Cathcart soils are not classified as hydric (NRCS 2014) and do not have inclusions of hydric soil map units. Areas mapped as hydric soils do not necessarily mean that an area is or is not a wetland—hydrology, hydrophytic vegetation, and hydric soils must all be present to classify an area as a wetland.

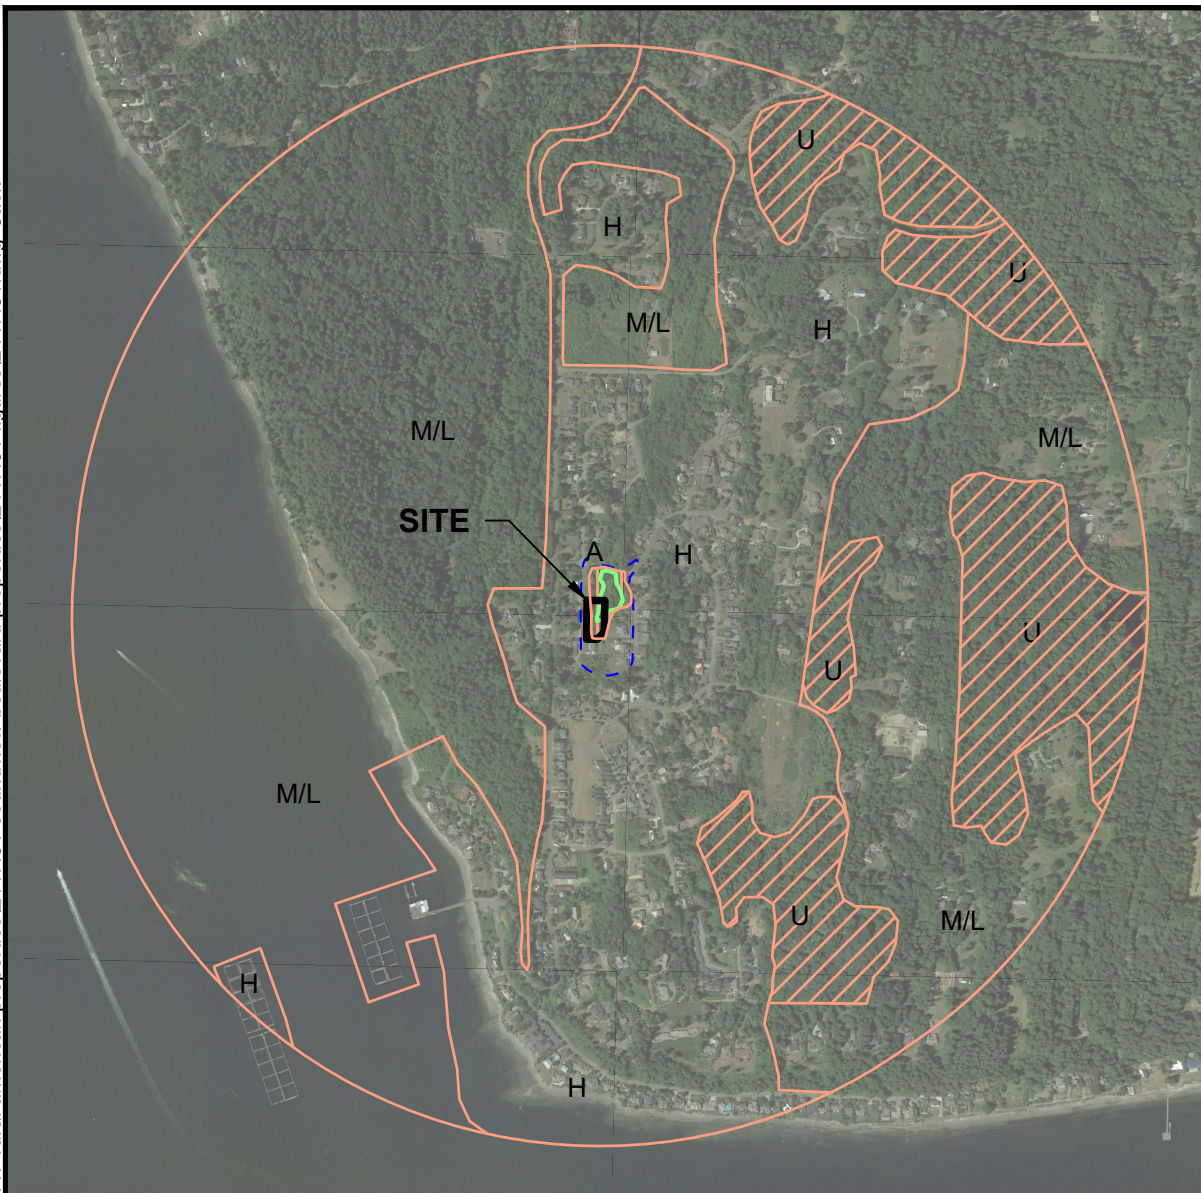
Figure 8  
WETLAND RATING FORM-1 KM OFFSET  
Soundview Boulevard Properties  
Rural American Properties  
City of Bainbridge Island, Kitsap County, WA  
Section 11, Township 24N, Range 2E, W.M.

- Wetland Unit Boundary
- Contributing Basin
- A Accessible Habitat (0.1%)
- U Undisturbed Habitat (12.0% \*Includes Accessible Habitat)
- H High Intensity Land Use (33.9%)
- M/L Moderate/Low Intensity Land Use (54.1%)

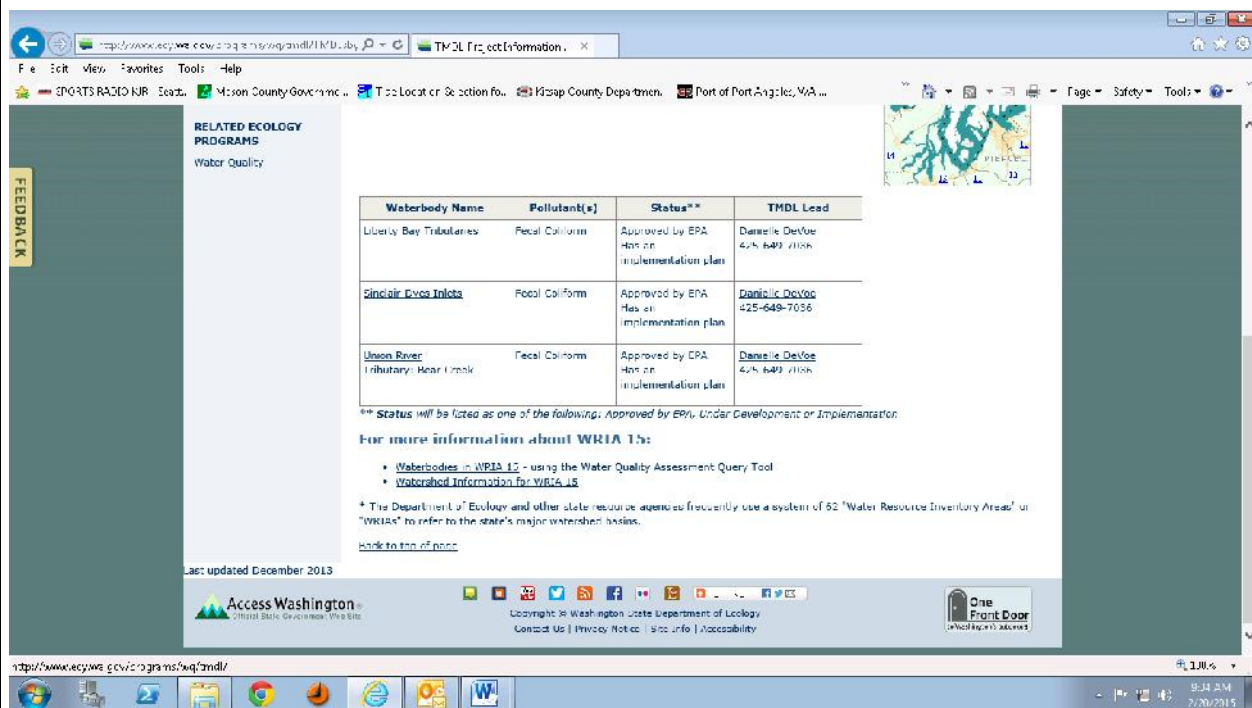
Figure 9b: TMDL List for Kitsap County. There are no TMDLs for the drainage basin of the rated wetland.

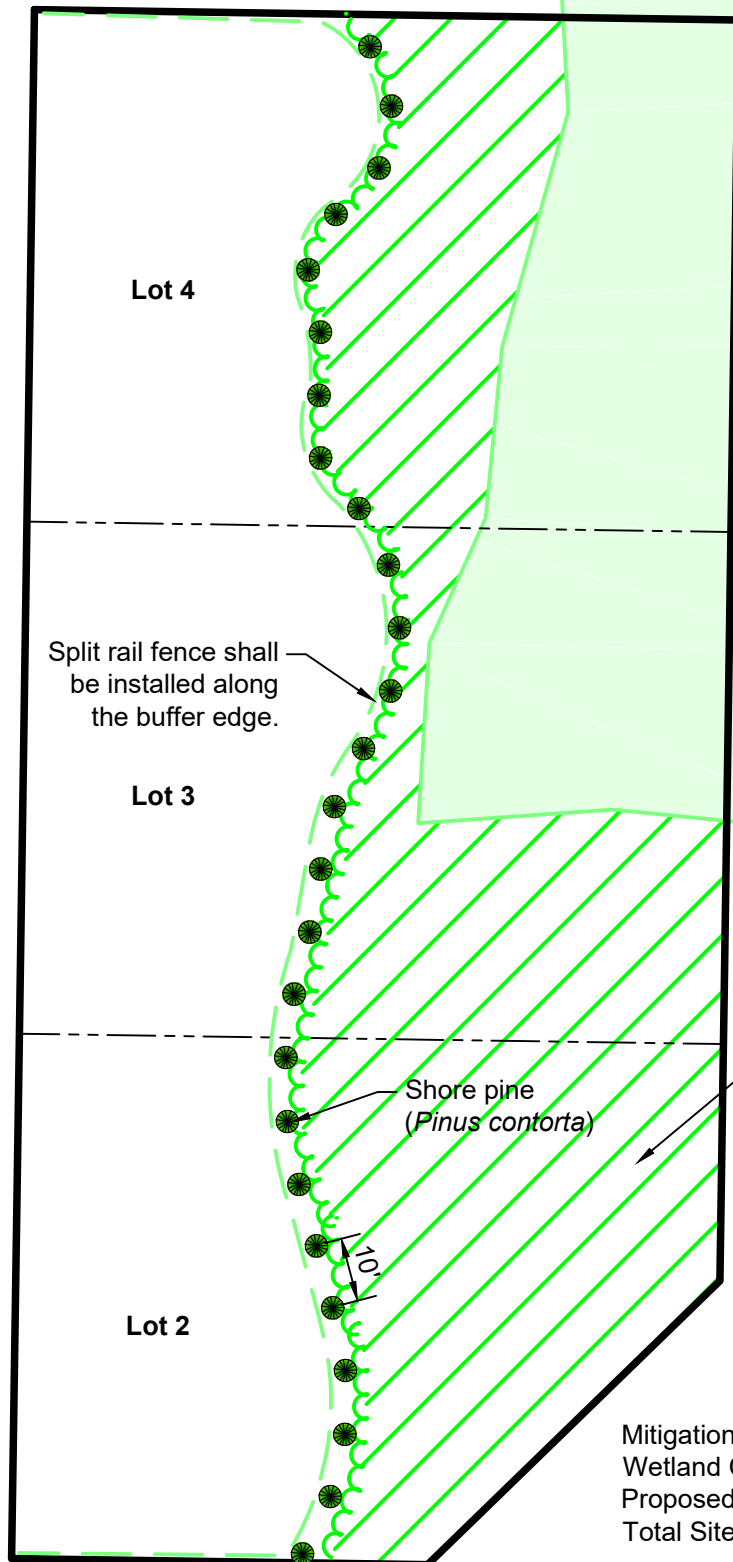
**Figure 10**  
**BUFFER MITIGATION PLAN**  
Soundview Boulevard Properties  
Rural American Properties  
City of Bainbridge Island, Kitsap County, WA  
Section 11, Township 24N, Range 2E, W.M.

**Wetland**  
Category III  
Depressional  
Forested  
Scrub/Shrub  
Emergent  
Seasonally Flooded

Split rail fence shall be installed along the buffer edge.

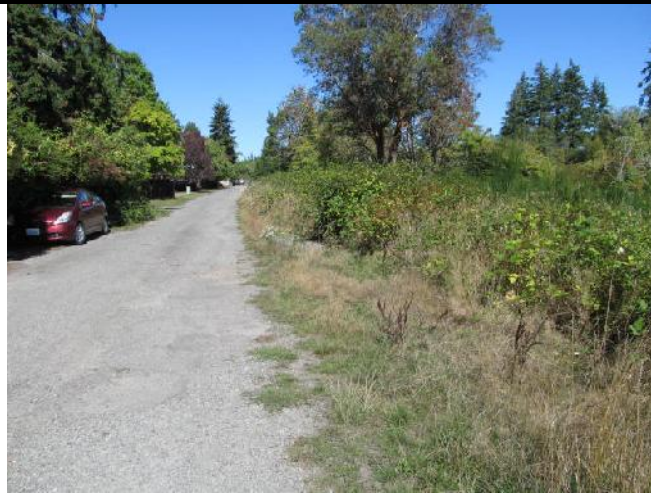
**Photo 1** was taken from Soundview Drive looking north along the west property line of the three lots. It shows the low growing, non-native vegetation that makes up the front half of the lots.

The lots are located on the east side of Soundview Drive NE (Photoplate 1) in the Fort Ward Estates area of Bainbridge Island (Figure 1). They are rectangular-shaped lots oriented west to east (Figure 2). The lots are level on the west side and slope gradually into a shallow depression on the east half. The lots are undeveloped. The three lots are composed mainly of disturbed upland vegetation (Photoplates 2, 3, and 4) with areas of dense shrub and short deciduous trees occurring in places. The adjacent lots to the south, east and west are residentially developed, including the lots across Soundview Drive and the lots to the north are currently undeveloped.

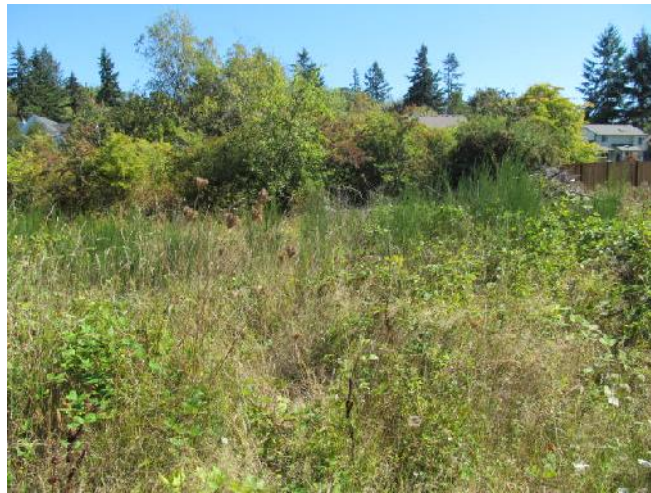
**Photo 2** was taken from the same location as Photo 1 and looks east toward the fruit trees that vegetate the south end of the lots.

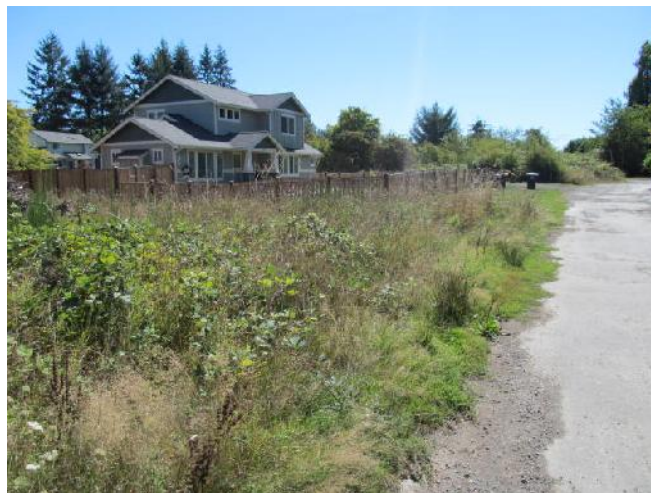
**Photo 3** was taken from the same location as Photos 1 and 2 facing south. It shows the south end of the lots (Lot 2) and the adjacent residential development.

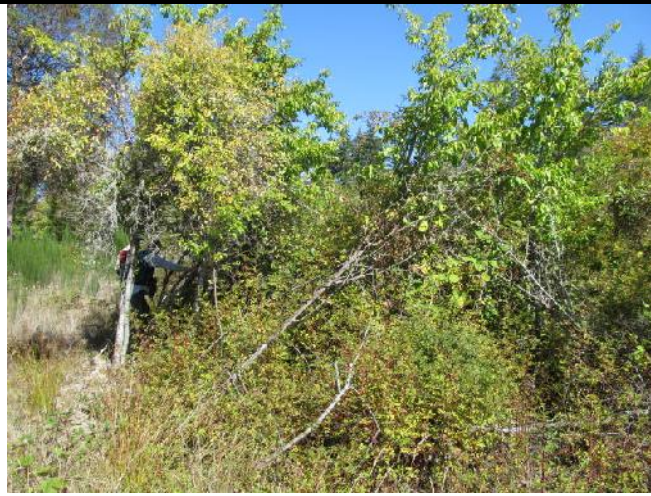
**Photo 4** was taken from the edge of the woody vegetation that begins about halfway to the east property line from Soundview Drive. The tree layer was made up of non-native fruiting trees and hawthorns.

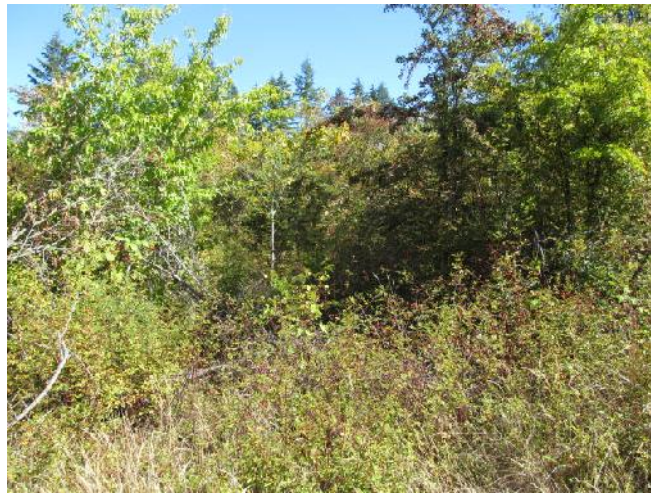
**Photo 5** was taken from the same location as Photo 4 and looks east toward the fruit trees and other woody vegetation that makes up the lots. A dense shrub layer of Nootka rose dominates the understory of the short stature tree community.

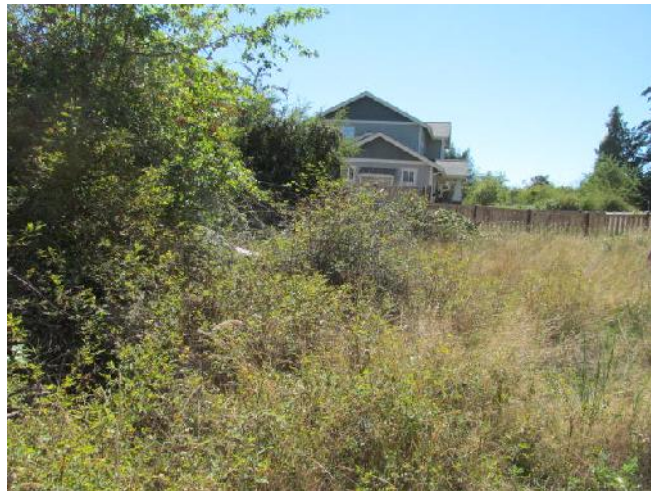
**Photo 6** was taken from the same location as Photos 4 and 5 facing south. It shows the outer edge of the small tree/dense shrub vegetation area at the back of the lots. A row of conifer trees will be installed along this edge of the buffer with a fence placed along the reduced buffer line.

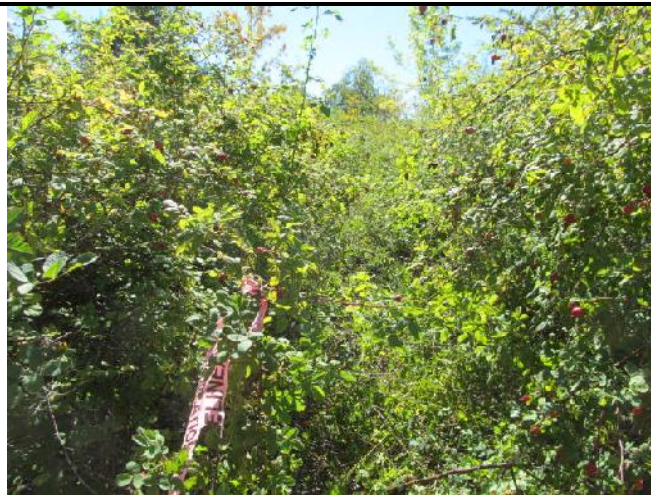
**Photo 7** was taken of Wetland Boundary Flag A-9 looking south. The delineation flags placed on these lots are a continuation of the offsite delineation that was performed on the lots to the north. This portion of the wetland was dominated by very dense thickets of Nootka rose.

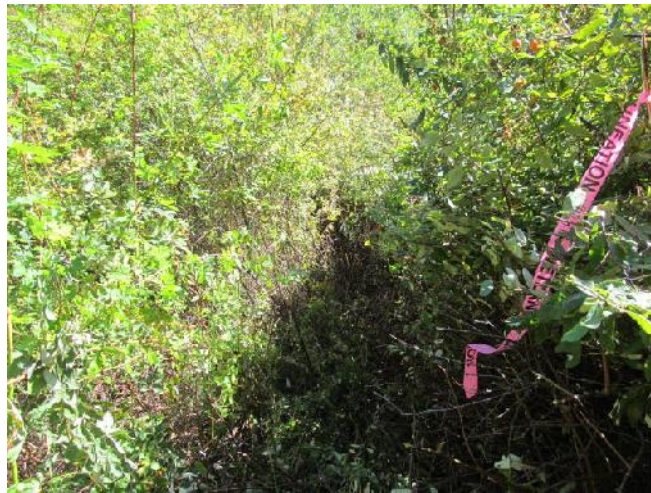
**Photo 8** was taken of Wetland Boundary Flag A-10 facing northeast. The boundary was primarily determined by the topographical dip observed within the dense shrubs.

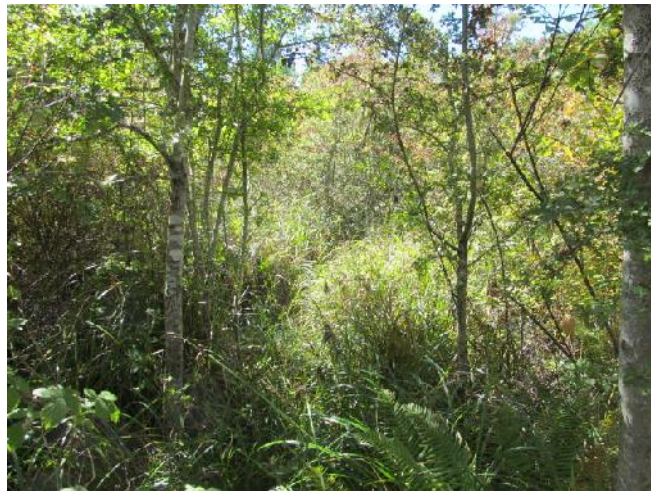
**Photo 9** was taken from the southern portion of the wetland looking southwest where the vegetation had more developed layering. This location had a dense herbaceous layer beneath the short stature trees because the shrub layer was nearly non-existent..

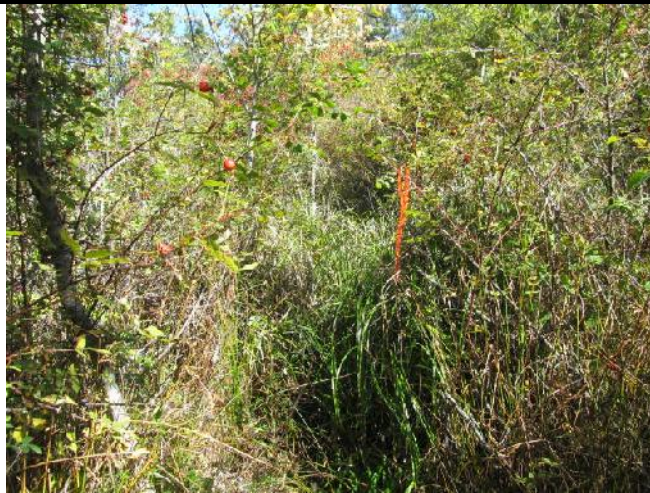
**Photo 10** was taken of the area where Test Plot 6 was conducted. It was located inside the southern tip of Wetland A where the herbaceous understory was thickly vegetated with slough sedge.

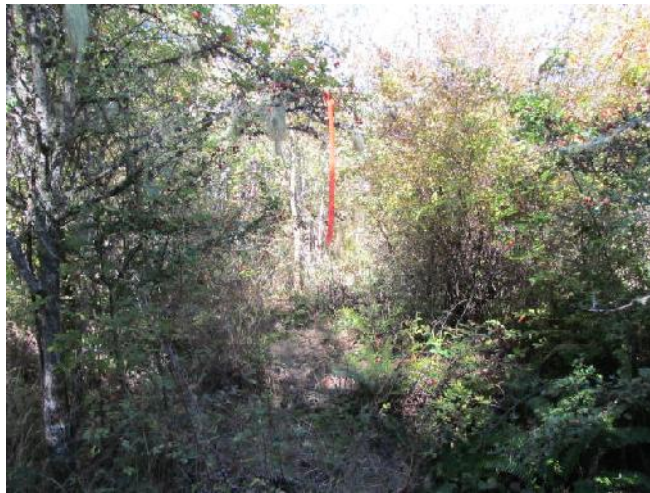
**Photo 11** was taken of the area where Test Plot 5 was conducted. It was located in the upland just outside the southern tip of Wetland A. The area was dominated by hawthorn and apple trees with a sparse shrub layer and a somewhat dense herbaceous layer.

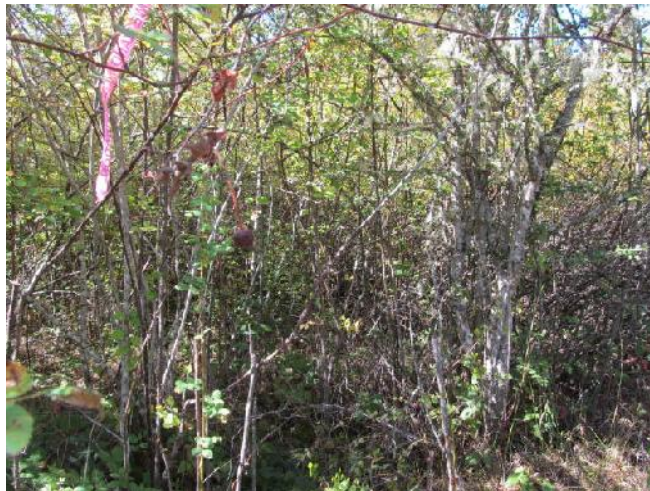
**Photo 12** was taken of Wetland Boundary Flag A-12. This was the last flag hung at the very southern tip of the wetland.
