CRITICAL AREAS REPORT AND MITIGATION PLAN

November 4, 2019, Revised April 14, 2021

Lytle Road Property
Bainbridge Island, Washington

Prepared by
Ecological Land Services
1157 3rd Avenue, Suite 220A • Longview, WA 98632
(360) 578-1371 • Project Number 2429.02

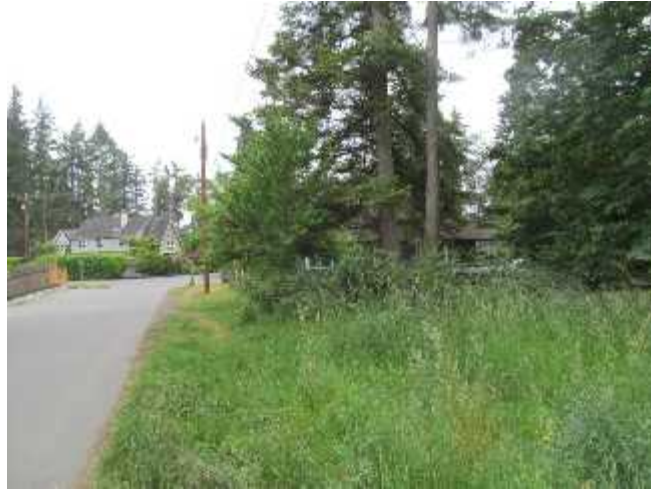
Photo 1 was taken from Lytle Road, which lies along the east property line. This photo looks south along the road with the property on the right.

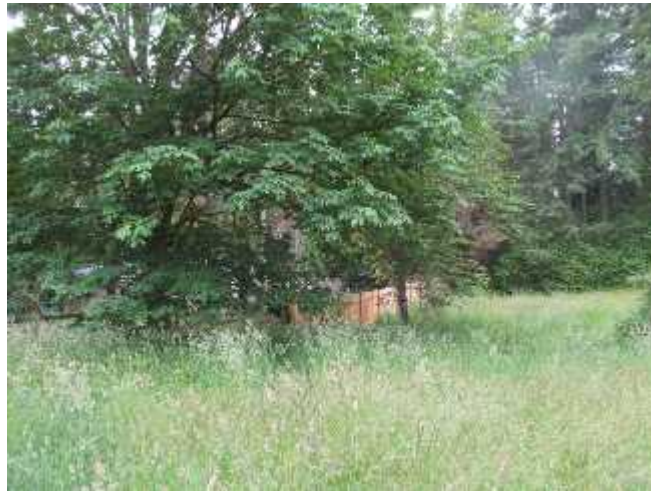
Photo 2 was taken from the same location as Photo 1. It looks southwesterly across the property toward the bigleaf maple growing just offsite to the south but overhangs the south edge of the property.

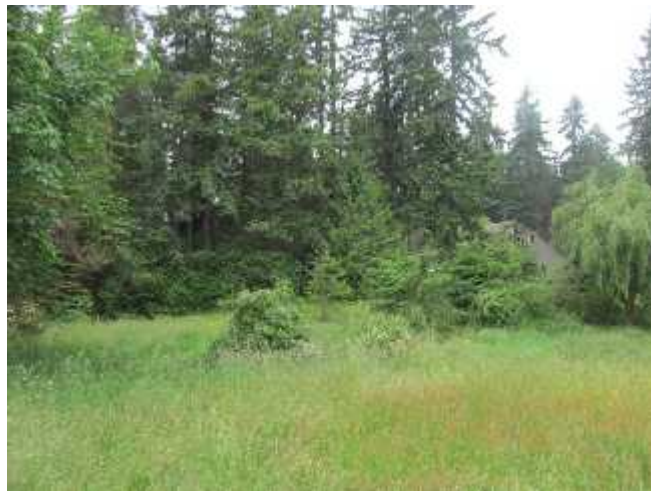
Photo 3 was taken from the same location as Photos 1 and 2. It looks westerly across the property. As this photo indicates, the grasses were unmowed at the time of the field visit.

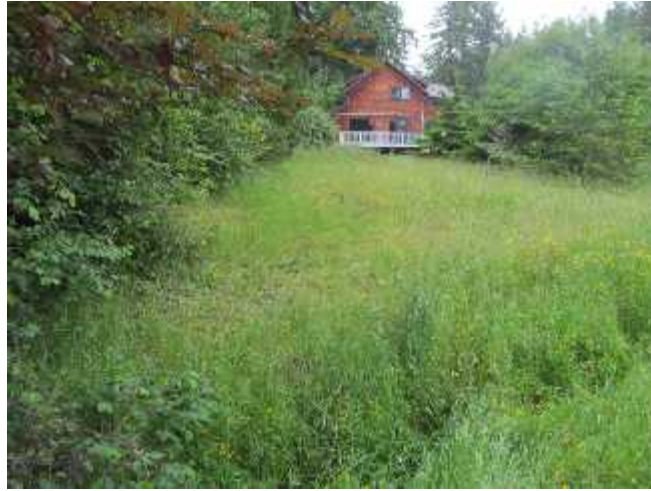
Photo 4 was taken from the southwest corner of the lot and looks north across the drainage toward the home on the property immediately north.

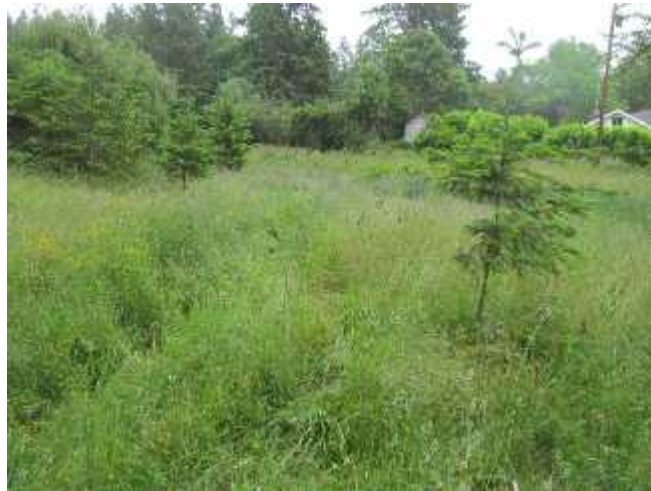
Photo 5 was taken from the same location as Photo 4. It looks northeasterly across the lot with the stream on the left side. The fir tree on the right was planted as part of a buffer mitigation prepared 10 to 12 years ago.

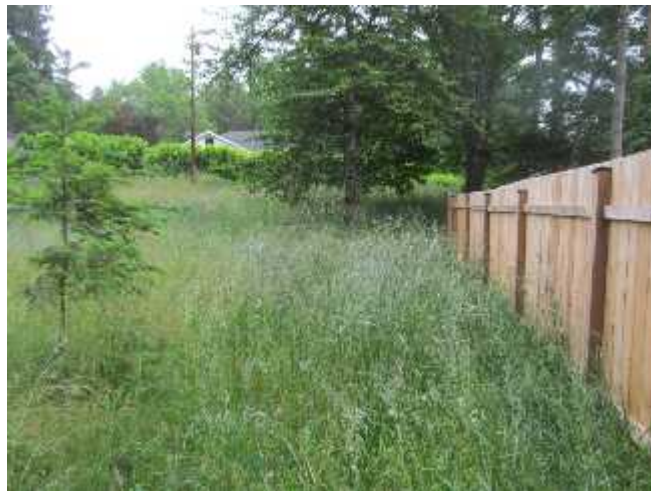
Photo 6 was taken from the same location as Photos 4 and 5. It looks easterly along the south property line, which is marked by the wood fence on the right.

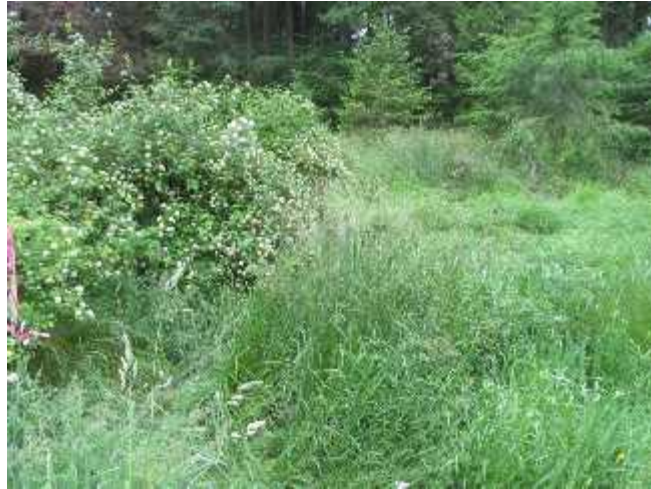
Photo 7 was taken from the upland east of the delineated wetland boundary, which runs just this side of the pacific ninebark bush on the left half of the photo.

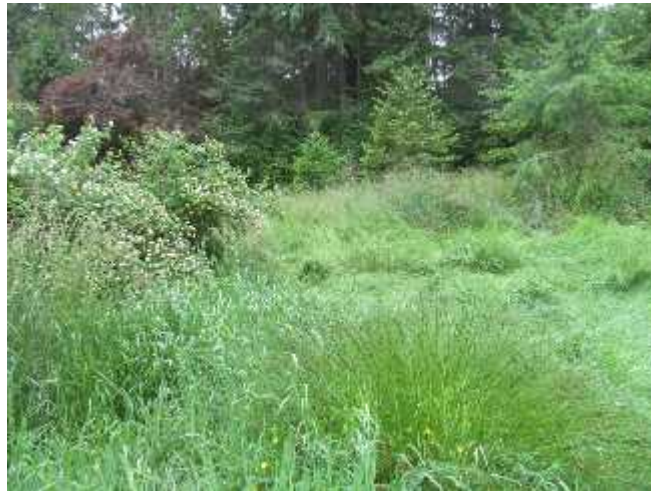
Photo 8 was taken from the same location as Photo 7 and looks westerly across the onsite portion of the wetland.

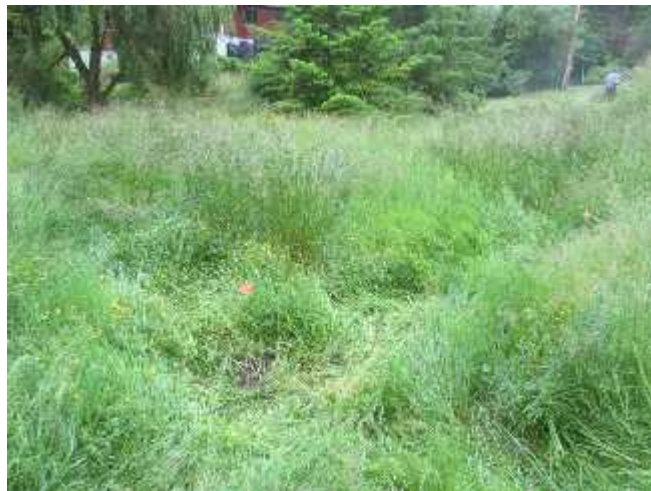
Photo 9 was taken from the same location as Photos 7 and 8. It looks northerly along the east side of the wetland with the pin flag marking the location of Test Plot 3, visible on the left and a wetland boundary flag near the right edge of the photo.

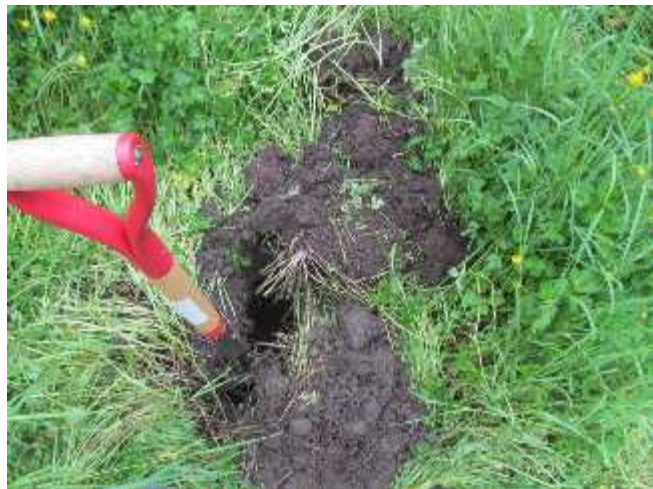
Photo 10 shows the soil conditions within the wetland test plots. This profile meets the criteria for hydric soil because of the low matrix chroma and presence of redoximorphic features.

The observed wetland soils at Test Plot 1 consisted of black (10YR 2/2) silty clay loam with five percent dark brown (10YR 3/6) redoximorphic features. This top layer extended down to 12 inches and was underlain by a second layer of black (10YR 2/2) gravelly sandy loam with no redoximorphic features. The soil profile met indicator F6: Redox dark surface. At wetland Test Plot 3, the entire 16 inches of the soil profile consisted of black (10YR 2/2) gravelly sandy loam with five percent dark brown (10YR 3/6) redoximorphic features and also met indicator F6.

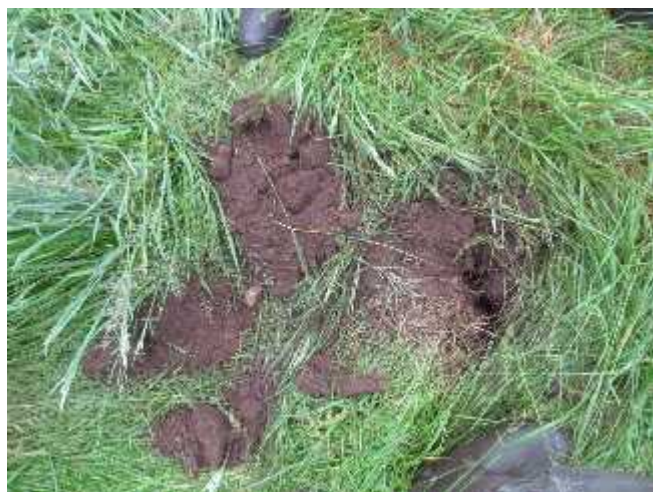
Photo 11 shows the soil condition of the upland test plots. The pictured soil is typical of the upland areas which have high matrix chroma soils with no redoximorphic features present.

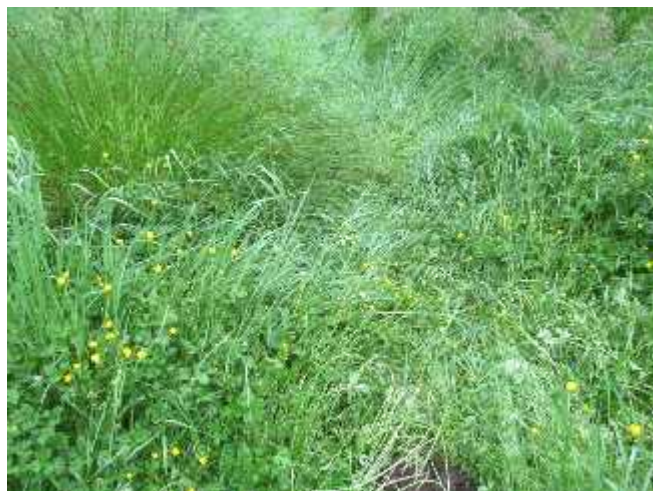
Photo 12 shows the dominant vegetation within the delineated wetland area. The species include common grasses, soft rush, and herbaceous plants. The area was un-mowed during the field delineation so was very dense that there were no bare areas within the wetland or upland.

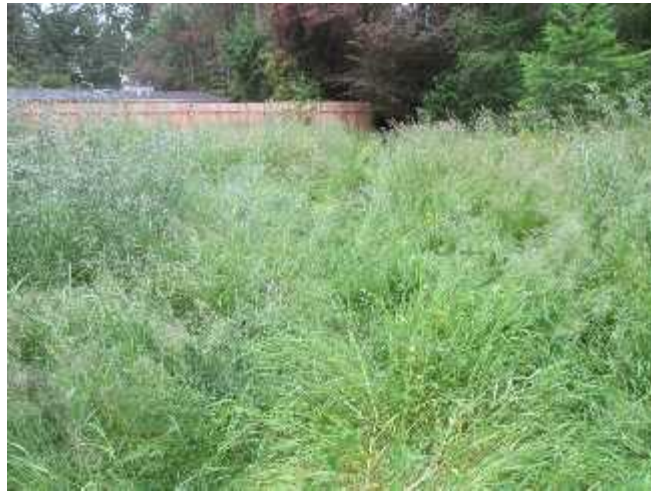
Photo 13 is taken along the stream after it exits the wetland. It looks southerly along the channel, which is not visible due to the density of the tall grass.

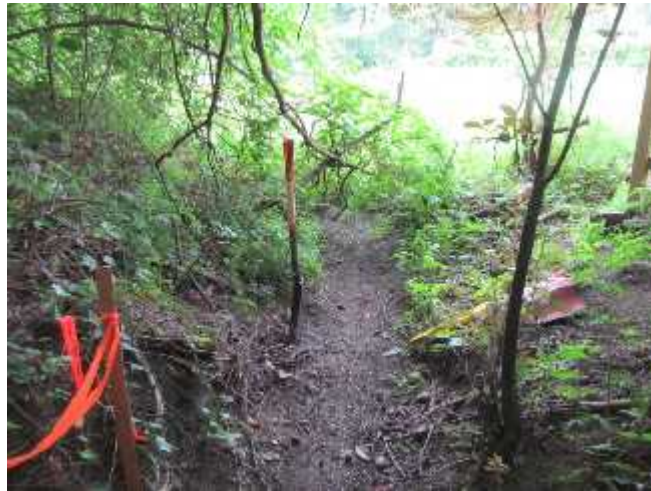
Photo 14 was taken from near the southwest property corner (lower left corner) and looks back up along the channel.

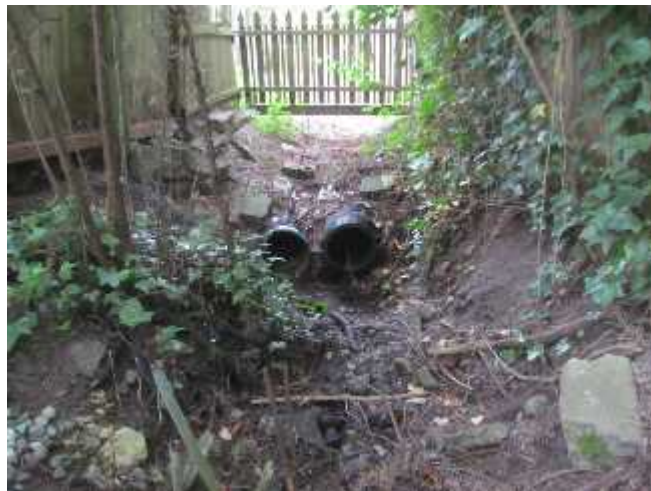
Photo 15 was taken from the same location as Photo 14. It looks south along the stream channel, which ends abruptly at the double pipes pictured.
