# Exhibit List Rehder / City File No. PLN50583A RUE

Staff Contact: Kelly Tayara, Senior Planner Public Hearing: January 14, 2021

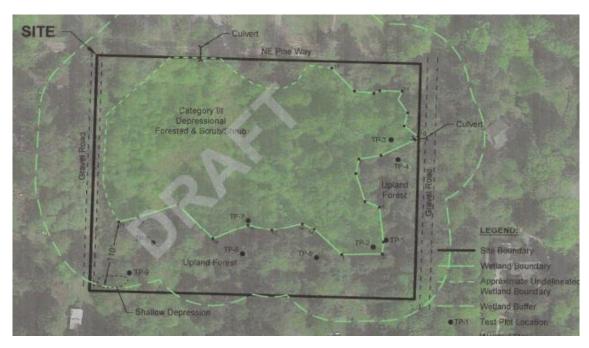
Figure 2: Wetland Delineation Report Ecological Land Services, Inc (October 2015)

The standard wetland buffer extends beyond the property lines, with the exception of a very small area in the southwest corner; in this area, the structure / hard surface setback extends beyond the property line. The property is completely encumbered by the wetland, buffer, and structure / hard surface setback (see Figure 2 from the wetland report below). The applicant proposes a buffer reduction as discussed in the section below; there is no provision for modification to a structure / hard surface setback.

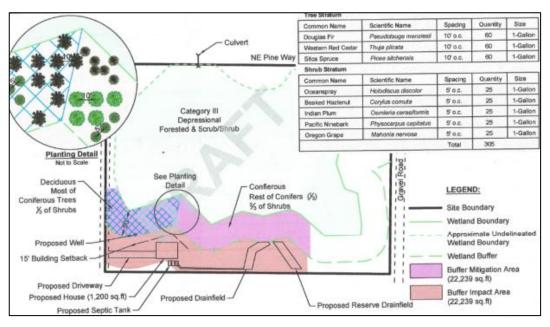
Figure 5: Wetland Delineation Report Ecological Land Services, Inc (October 2015)

To reduce and compensate for impacts, the applicant proposes enhancing a 50-foot width, one-half acre area which is between the homesite area and wetland (see Figure 5 from the wetland report below). The proposed homesite area is dominated by young conifer trees amongst dense salmonberry and holly. The mitigation planting proposal includes 180 trees and 305 shrubs to enhance existing vegetation.

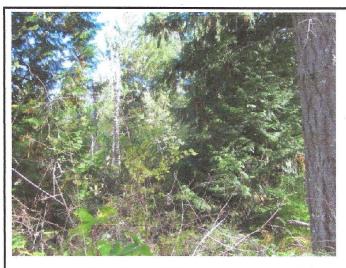
Photo 1 was taken from the west end of the property where the driveway will cross to the proposed single-family home. It is taken near where Test Plot 5 was conducted. This photo looks east toward the future homesite.

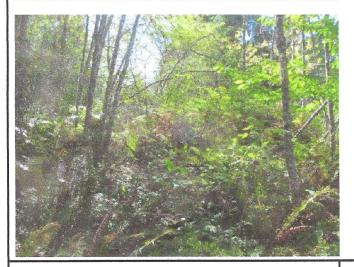
**Photo 3** was taken from the same location as Photos 1 and 2. It looks south across the upland area that occupies the southwest corner.
