RE: Updated Wetland Rating for Manitou Reasonable Use Exception & Variance (PLN51678)

# WETLAND DELINEATION REPORT AND BUFFER MITIGATION PLAN

May 13, 2020, Revised December 16, 2020

**Manitou Beach Drive Property**  
*Bainbridge Island, Washington*

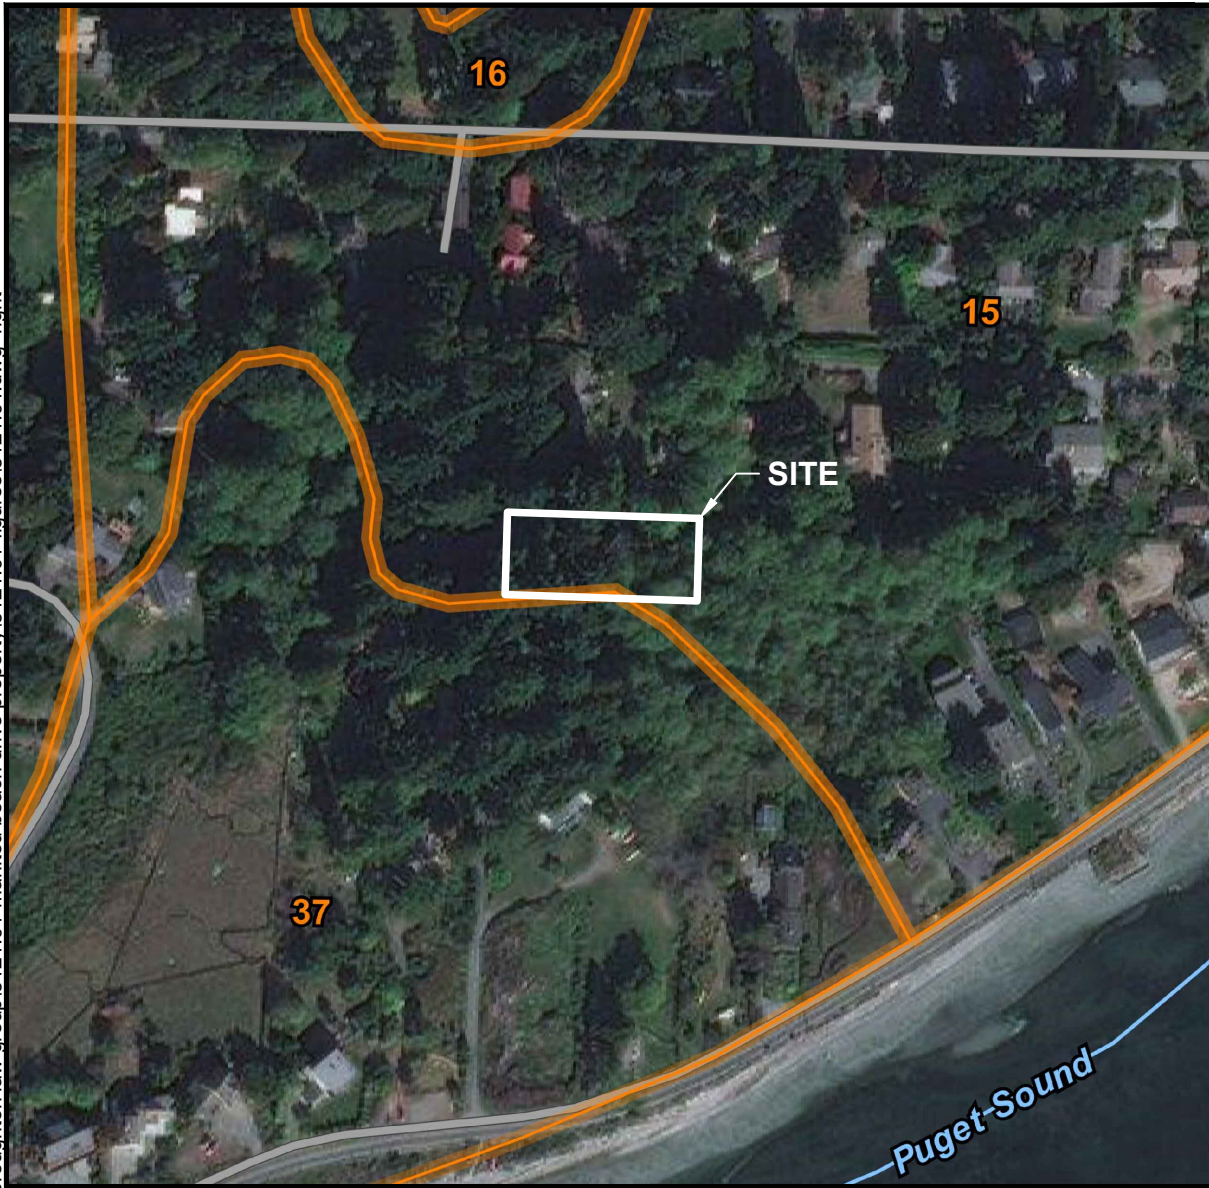
Figure 4  
SOIL SURVEY MAP  
Manitou Beach Drive Property  
Bill Broughton  
City of Bainbridge Island, Kitsap County, WA  
Section 14, Township 25N, Range 2E, W.M.

- 15** Harstine gravelly ashy sandy loam, 6 to 15 percent slopes. Not hydric.

As referenced on the U.S.D.A. Natural Resources Conservation Service (NRCS 2019) website, Harstine gravelly ashy sandy loam, 16 to 15 percent slopes (15) is the primary soil unit mapped on the lot (Figure 3). Harstine soils are moderately well drained, formed from sandy glacial till, and is usually found in uplands. Areas mapped as hydric or non-hydric do not necessarily mean an area is or is not wetland—hydrology, hydrophytic vegetation, and hydric soils must all be present to classify an area as a wetland.

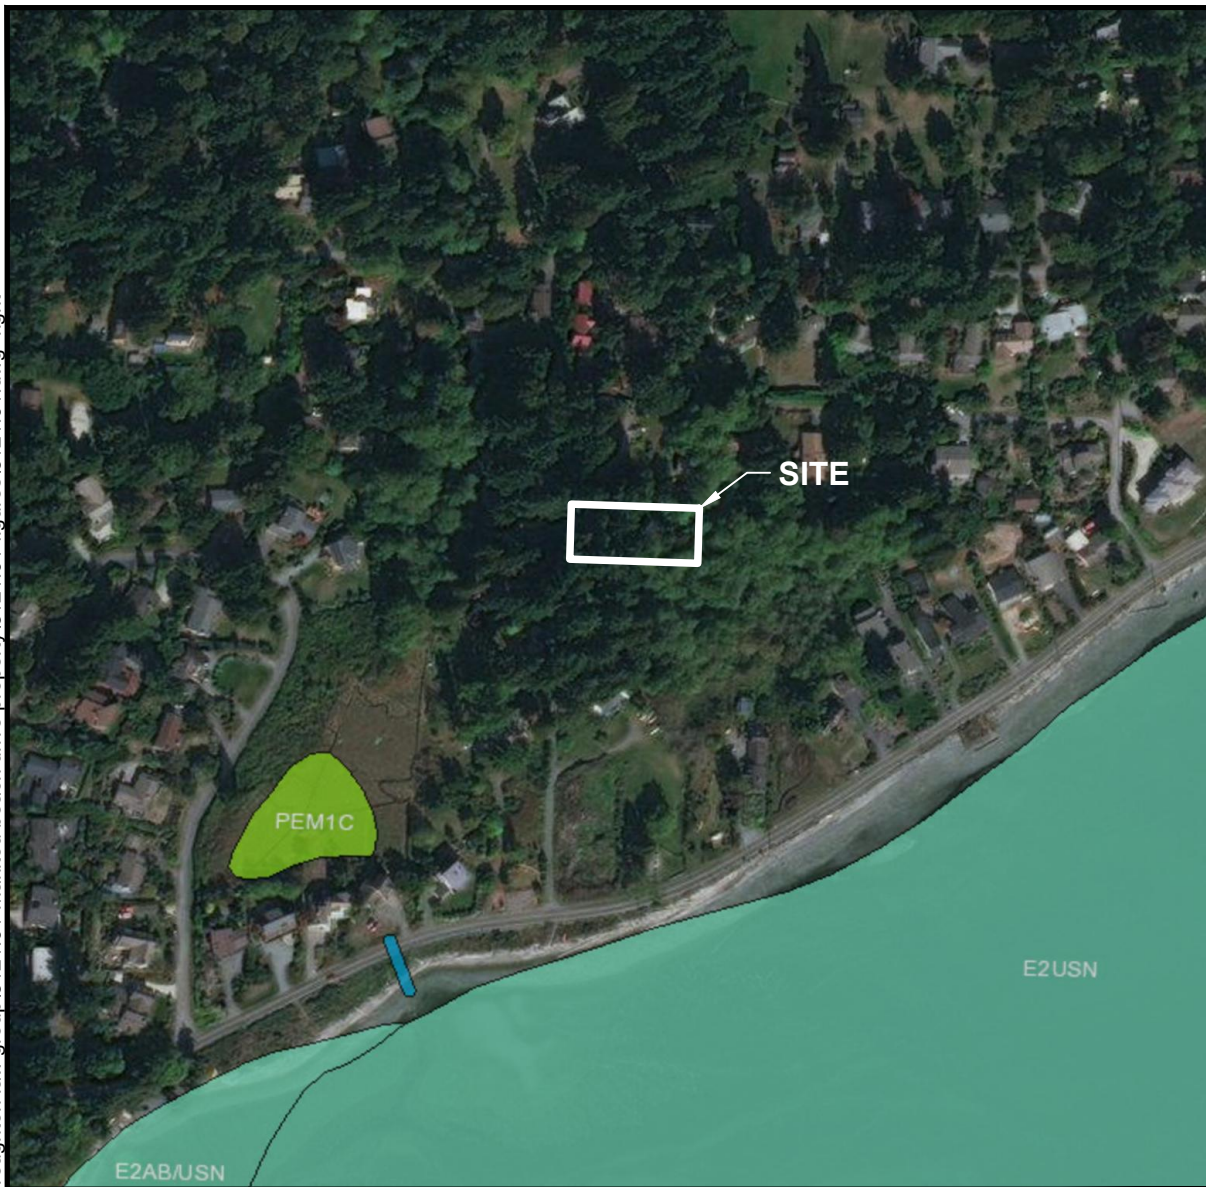
**NATIONAL WETLANDS INVENTORY MAP**  
Manitou Beach Drive Property  
Bill Broughton  
City of Bainbridge Island, Kitsap County, WA  
Section 14, Township 25N, Range 2E, W.M.

No mapped wetlands indicated onsite by US Fish & Wildlife Service.

The National Wetlands Inventory (NWI) does not map any wetlands on or within the vicinity of the lot (USFWS 2019). The closest wetland areas mapped by the NWI is a freshwater emergent wetland over 400 feet southwest of the lot and estuarine and marine wetlands in Murden Cove. The NWI maps should be used with discretion because they are used to gather general wetland information about a regional area and therefore are limited in accuracy for smaller areas because of their large scale.

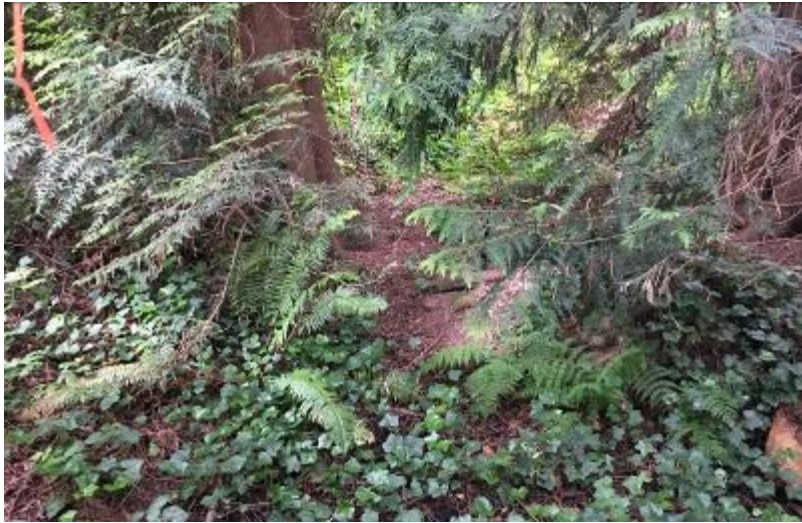
**Photo 1** was taken from Wetland A looking north toward the wetland boundary. The flags for test plot 1 (in the foreground) and test plot 2 (in the background) can be seen in this photo.

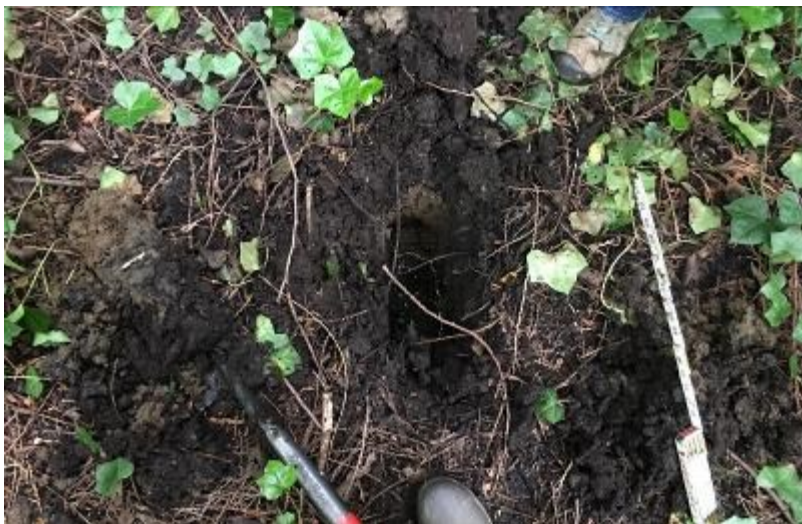
**Photo 2** was taken at Test Plot 1 and shows the soils. The soil profile met indicator A2: Histic Epipedon, because there was a top layer of organic soils underlain by mineral soils with a chroma less than one.

The evaluated wetland soil at Test Plot 1 was composed of a top layer of 8 inches of black (10YR 2/1) muck underlain by two inches of dark brown (10YR 3/1) silt loam and a third layer of medium brown (10YR 4/3) sandy silt loam. This soil profile met hydric soil indicator A2: Histic Epipedon, because of the presence of a muck layer above the mineral soil layers.

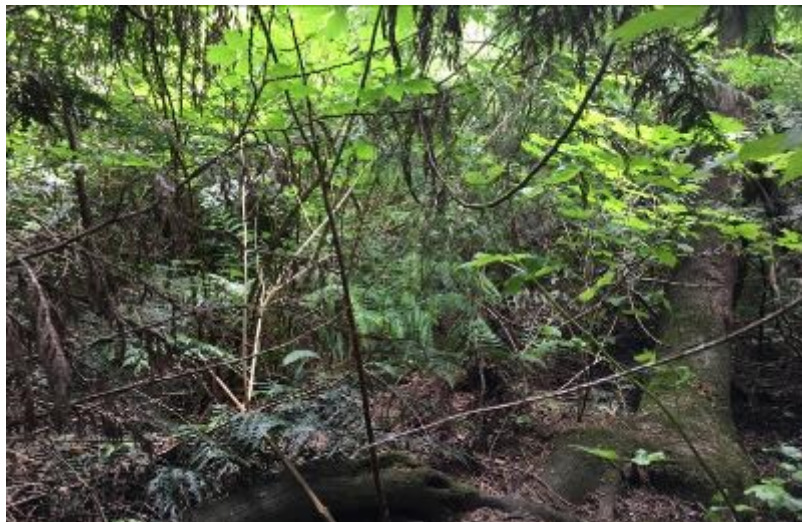
**Photo 3** was taken from the same location as Photo 1 looking south into the wetland. This portion of Wetland A was dominated by Western red cedar and salmonberry.

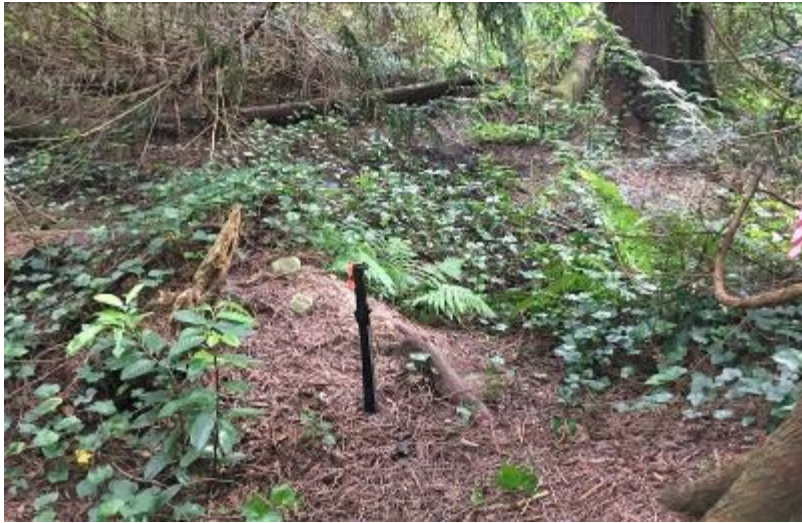
**Photo 4** was taken at Test Plot 2 and looks south toward the wetland from the upland.

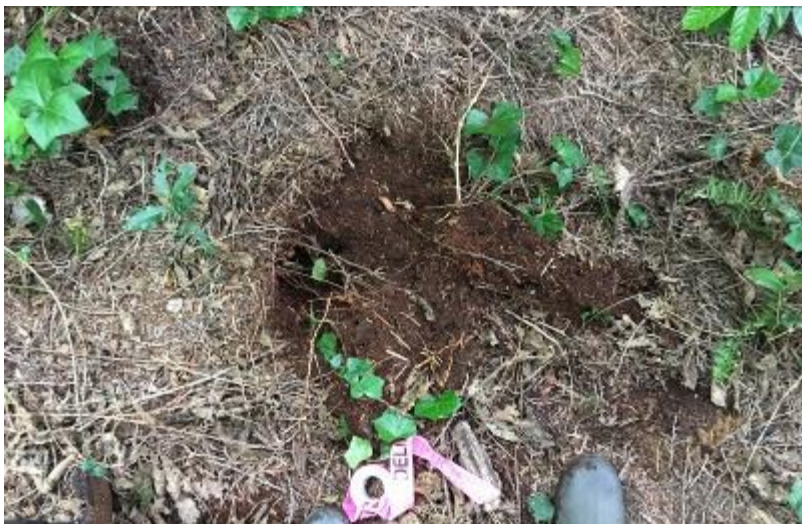
**Photo 5** shows the soils at Test Plot 2. These soils were medium brown and did not meet any hydric soil indicators.

The evaluated upland soil at Test Plot 2 consisted of a thick layer (12 inches) of duff underlain by a mixed layer (50 percent 10YR 3/2 and 50 percent 10YR 3/6) of gravelly sandy loam. The soil profile at Test Plot 3 consisted of a top layer of dark brown (10YR 2/2) sandy silt loam underlain by ten inches of mixed (50 percent 10YR 4/4 and 50 percent 10YR 4/6) gravelly sandy loam. The mixed soils did not meet any hydric soil indicators because their matrix chromas were too high, they lacked redoximorphic features, and organic soils were not present.

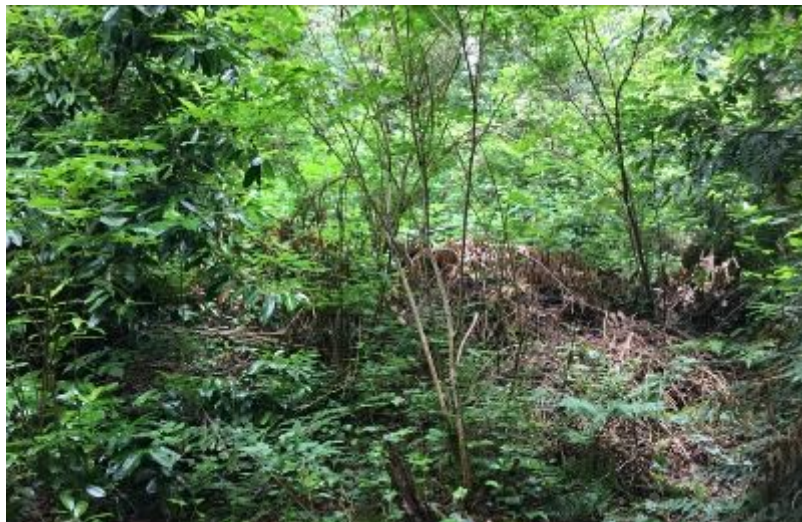
**Photo 6** shows vegetation in the upland consisting of English laurel, salmon-berry, and bracken fern. Douglas fir, western red cedar, sword fern, and red elderberry were also present throughout the upland.

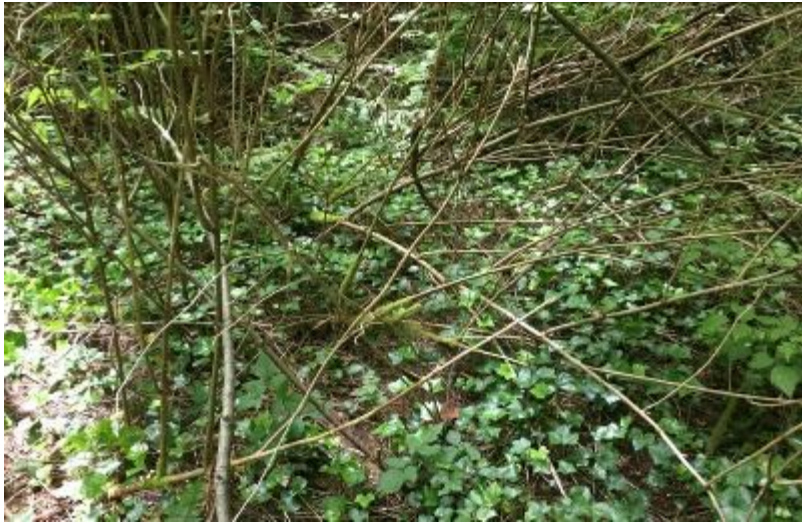
**Photo 7** shows the dominance by English ivy throughout the property. There is potential for enhancement within the buffer by removing this invasive species.

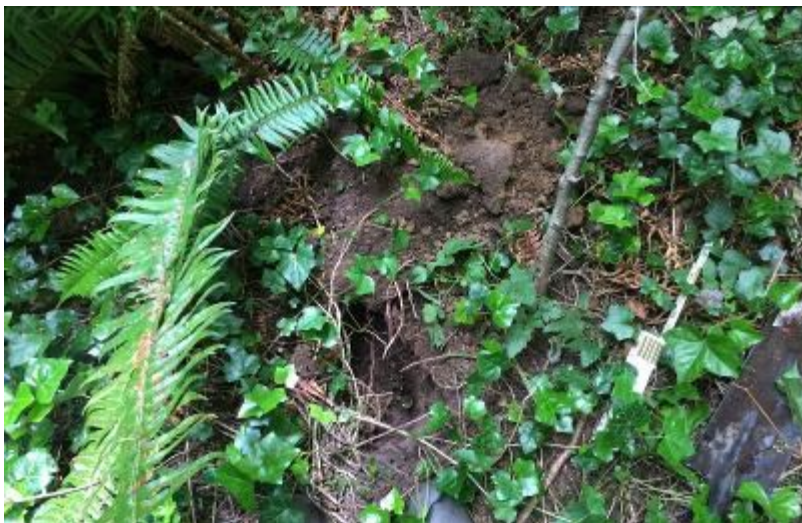
**Photo 8** shows the soils at Test Plot 3. The soils in this area had a dark top layer underlain by medium brown mixed soils and was not hydric.
