Exhibit 1

General Information
Pre-Application Conference Date: June 20, 2017
Project Name and Number: Inhabit LLC Pre-App – PLN 50850 PRE
Project Description: Construct two SFRs on Lots 5 and 6 (Block 4) of Fort Ward Estates, on Soundview Drive NE. Lot 5 contains a mapped wetland on its eastern edge, and both lots are encumbered by associated wetland buffers.
Project Address: 2171 Soundview Dr. NE (Lot 5) and TBD (Lot 6)
Tax Parcel Number(s): 4146-004-005-0004 (Lot 5) and 4146-004-006-0003 (Lot 6)
Tax Parcel Size: 0.2 acres (Lot 5) and 0.16 acres (Lot 6)
Zoning/Comp Plan Designation: R-2
Planning Contact: Annie Hillier
Development Engineer: Janelle Hitch

Figure 3
BUFFER IMPACT MAP
 Fort Ward Lots 5 & 6 RUE
 Julian Prosser
 City of Bainbridge Island, Kitsap County, WA
 Section 11, Township 24N, Range 2E, W.M.

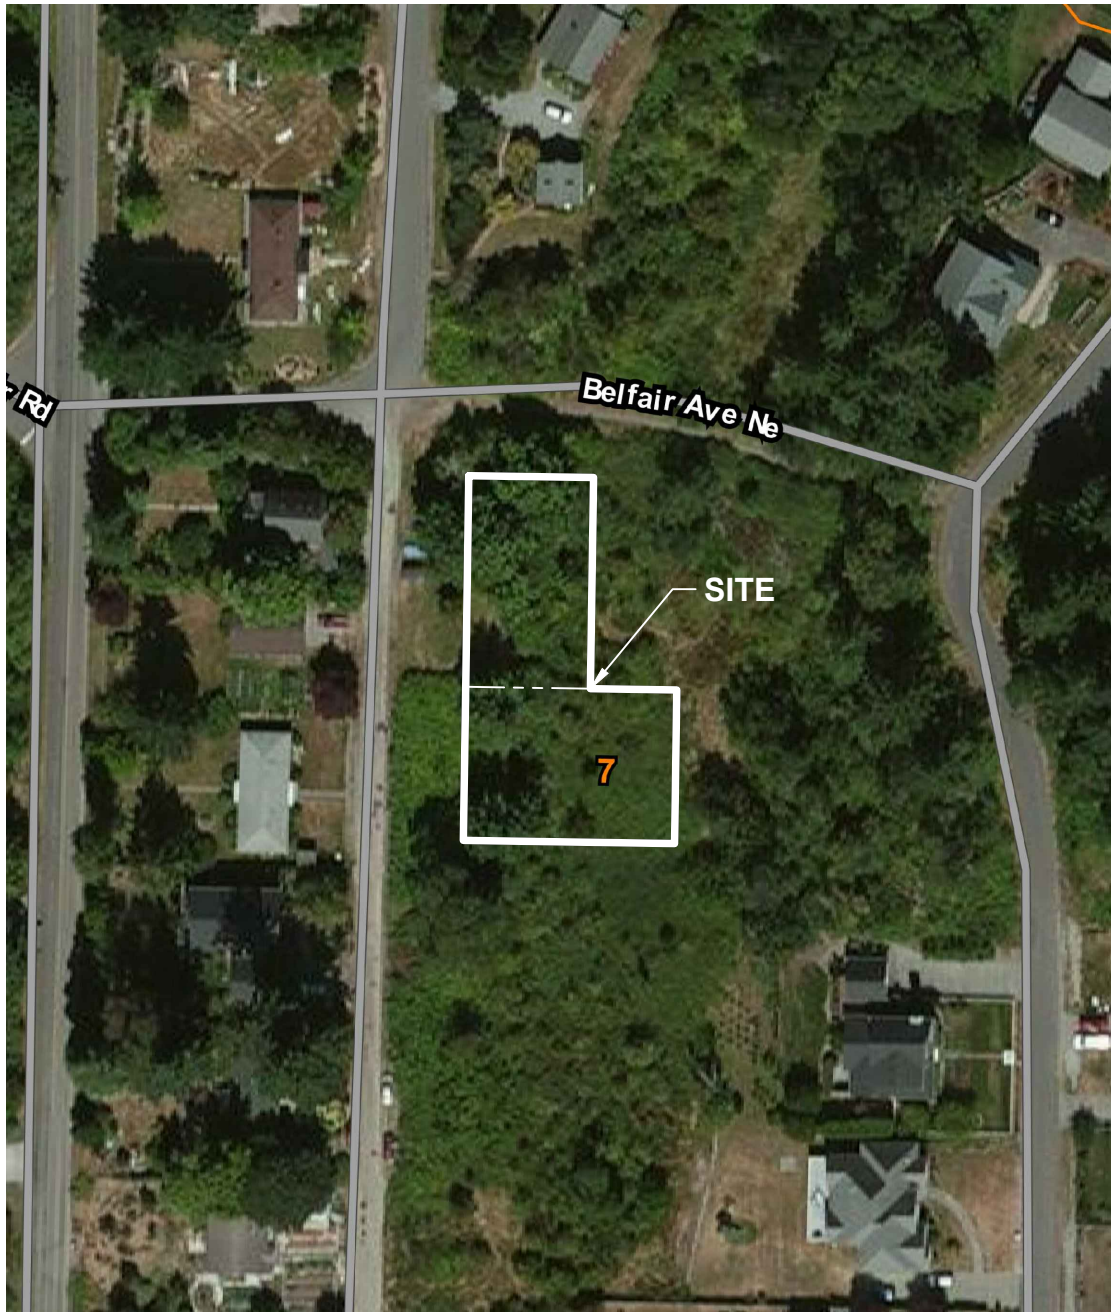
Figure 4
SOIL SURVEY MAP
Fort Ward Lots 5 & 6 RUE
Julian Prosser
City of Bainbridge Island, Kitsap County, WA
Section 11, Township 24N, Range 2E, W.M.

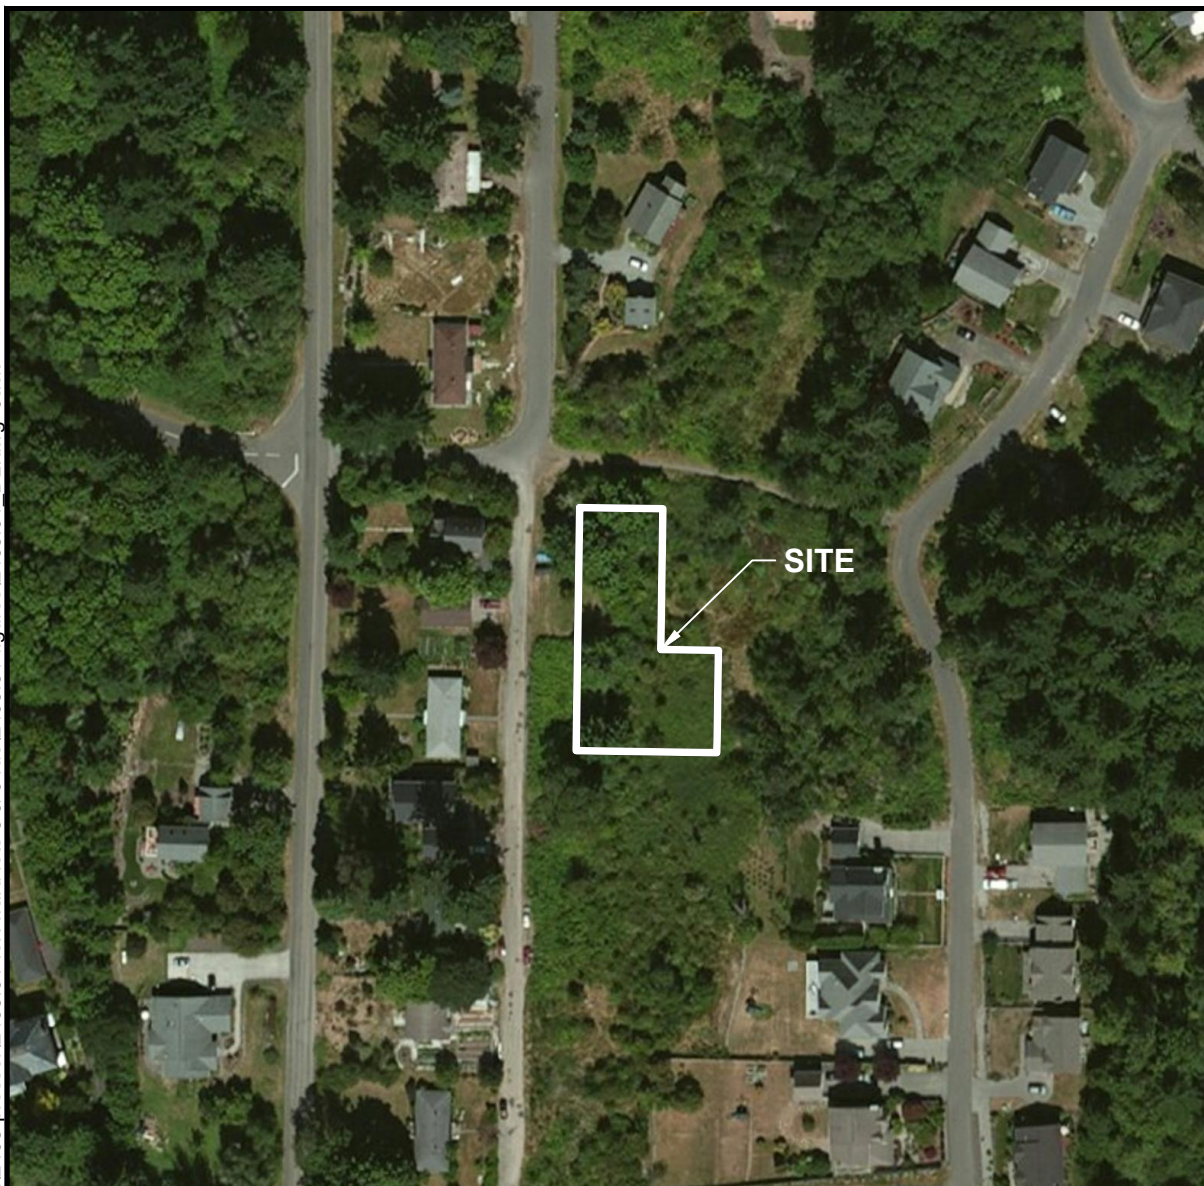
No mapped wetlands indicated onsite by US Fish & Wildlife Service.

Figure 5
NATIONAL WETLANDS INVENTORY MAP
Fort Ward Lots 5 & 6 RUE
Julian Prosser
City of Bainbridge Island, Kitsap County, WA
Section 11, Township 24N, Range 2E, W.M.

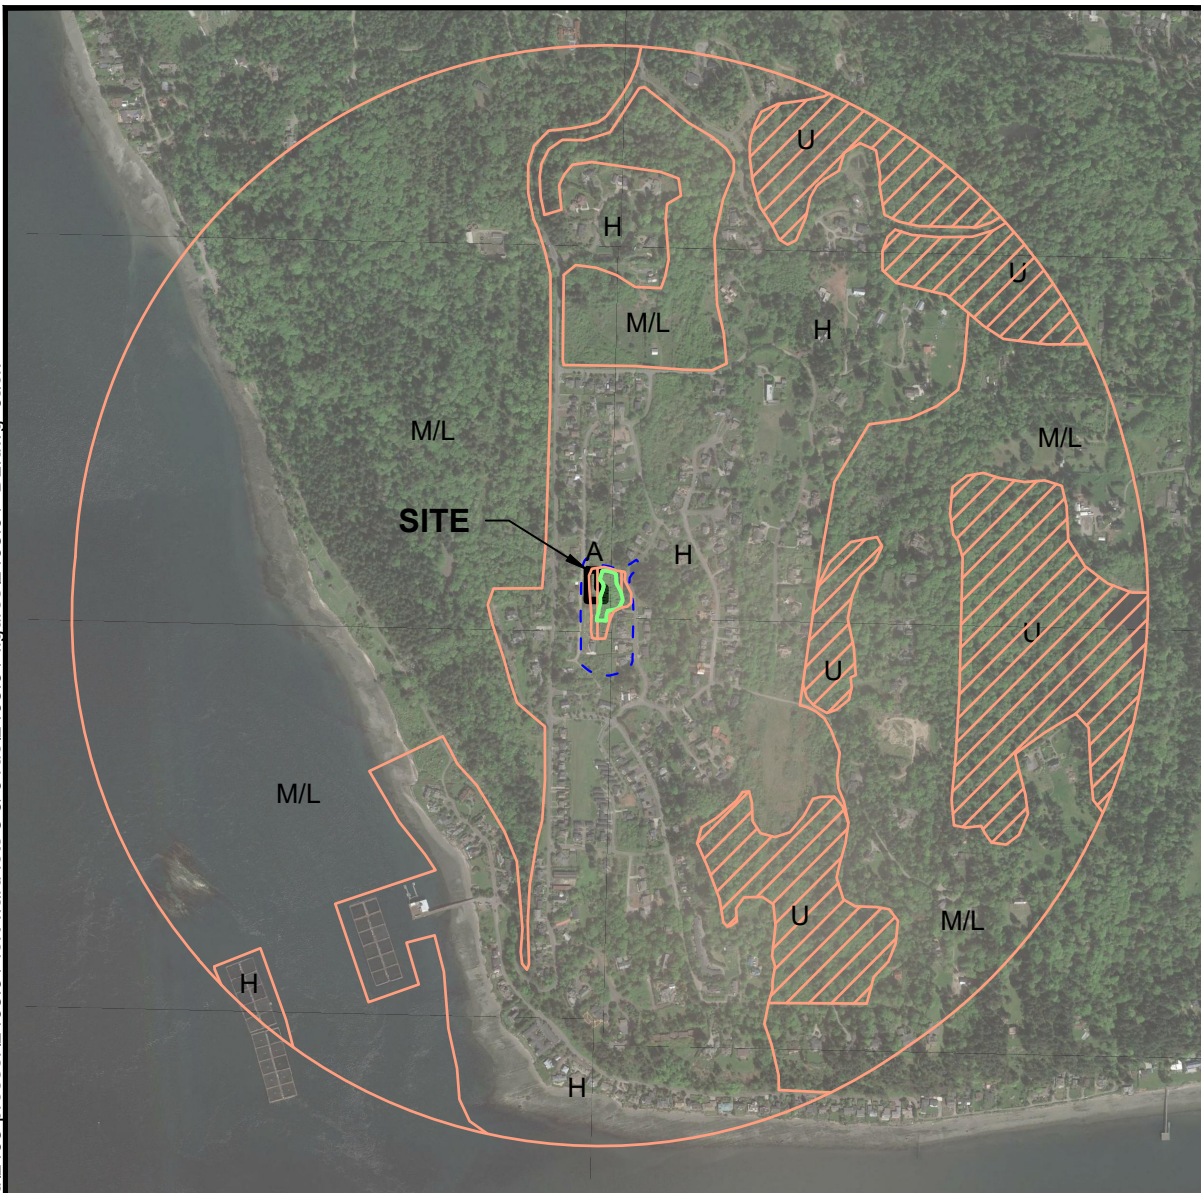
Figure 8

- Wetland Unit Boundary
- Contributing Basin
- A Accessible Habitat (0.1%)
- U Undisturbed Habitat (12.0% *Includes Accessible Habitat)
- H High Intensity Land Use (33.9%)
- M/L Moderate/Low Intensity Land Use (54.1%)

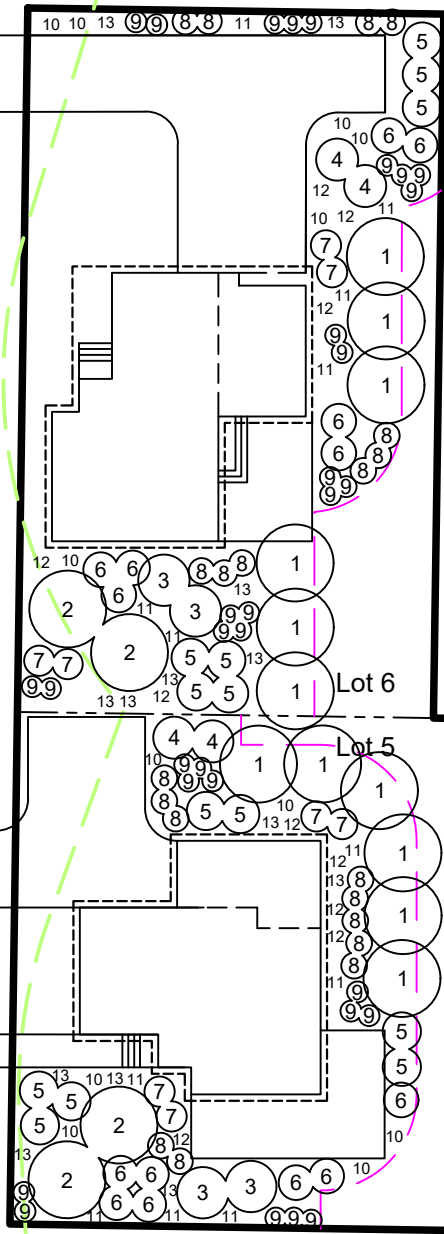
Species Name	Spacing (feet from center)	Minimum Size	Quantity
1 Shore pine (<i>Pinus contorta contorta</i>)	10	2-gallon, potted	12
2 Vine maple (<i>Acer circinatum</i>)	10-15	Bareroot	4
3 Mock orange (<i>Philadelphus lewisii</i>)	8	Bareroot	4
4 Pacific rhododendron (<i>Rhododendron macrophyllum</i>)	6	1-gallon, potted	4
5 Tall Oregon grape (<i>Mahonia aquifolium</i>)	8	Bareroot	14
6 Salal (<i>Gaultheria shallon</i>)	5	Bareroot	14
7 Evergreen huckleberry (<i>Vaccinium ovatum</i>)	6	Bareroot	8
8 Sword fern (<i>Polystichum munitum</i>)	3	Bareroot	20
9 Low Oregon grape (<i>Mahonia nervosa</i>)	3	Bareroot	24
10 False Solomon's seal (<i>Smilacina racemosa</i>)	3	Bareroot	12
11 American dog violet (<i>Viola labridorica</i>)	1	4" pot	12
12 Beach strawberry (<i>Fragaria chiloensis</i>)	1	4" pot	10
13 Wood sorrel (<i>Oxalis oregana</i>)	1	4" pot	14
Total Plantings			152

1. Plant the specified trees in the winter 201-2018 (or subsequent winter) or after construction activities are completed, as listed in Table 1. Planting after construction is completed is recommended to avoid impacting the plants during construction. Space the trees roughly 10 feet apart along the edge of the buffer and just inside the split-rail fence. Plant the trees with a tree shovel or comparable tool.

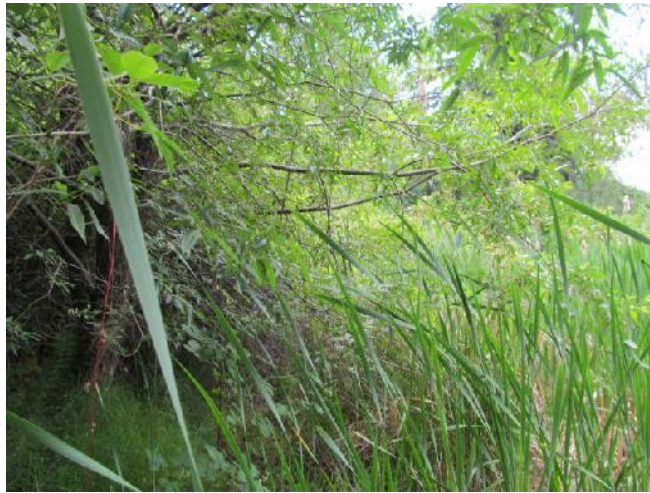
Photo 7 was taken from the northern extent of Wetland A facing southeast. It demonstrates the vegetation that was growing in this area of wetland.

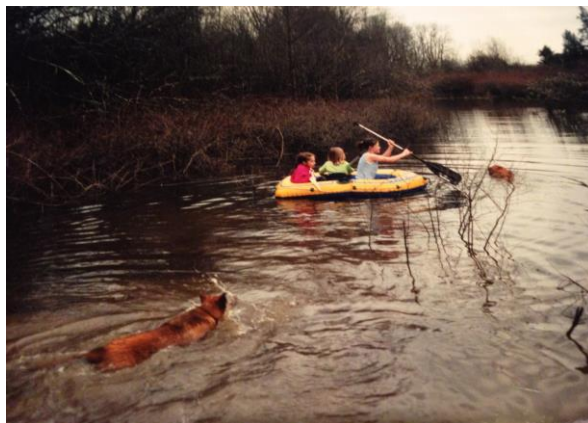
In their SEPA checklist, the current applicant implies that the boundaries of the wetland are due to the culvert being misplaced. Certainly, human activity has impacted the wetland! The roadbed through the wetland (Belfair trail) was put in by the military without regard to the wetland. Before that, the wetland ran continuously from approximately Parkview, north to Port Blakely. Before the current culvert was put in, the wetland was even larger. Here's what the wetland was like before the current culvert:

Replacing the current culvert will not "restore" the wetland, but reduce it's impact on the lots in question.

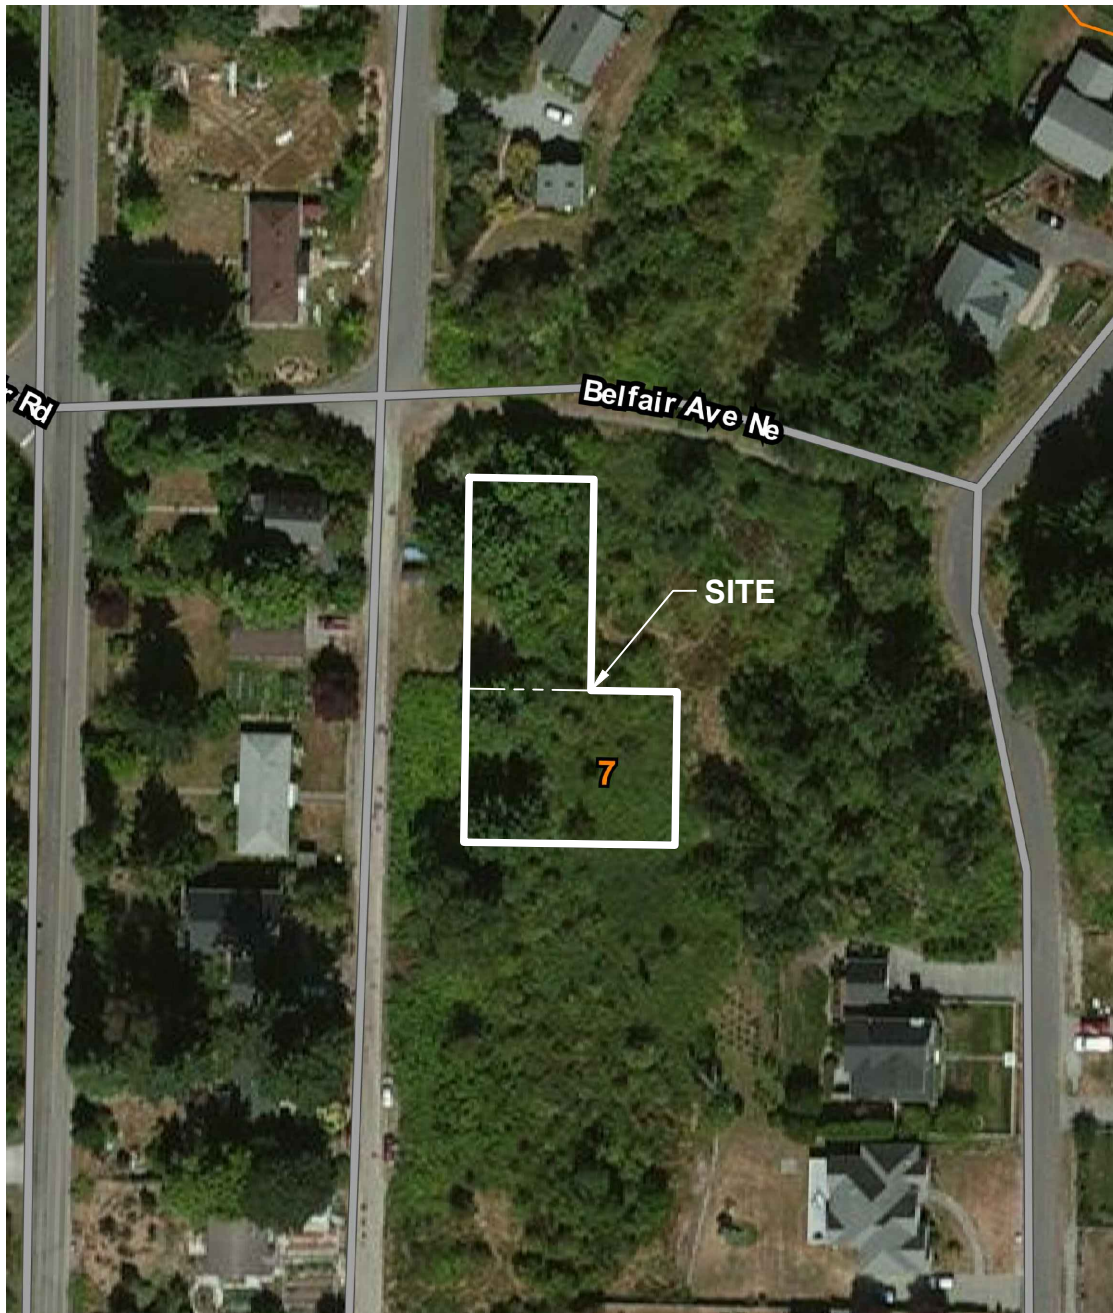
- 7 Cathcart silt loam, 2 to 8 percent slopes. Not hydric.

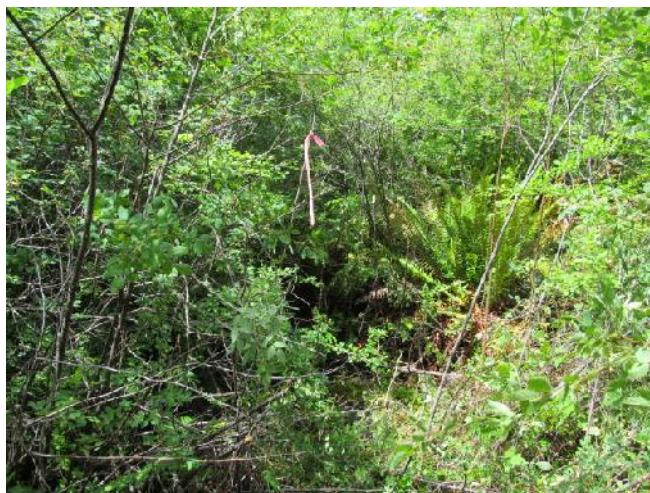
Photo 12 was taken of the area where Test Plot 2 was conducted. It was located upslope of Test Plot 1 in the forested upland.

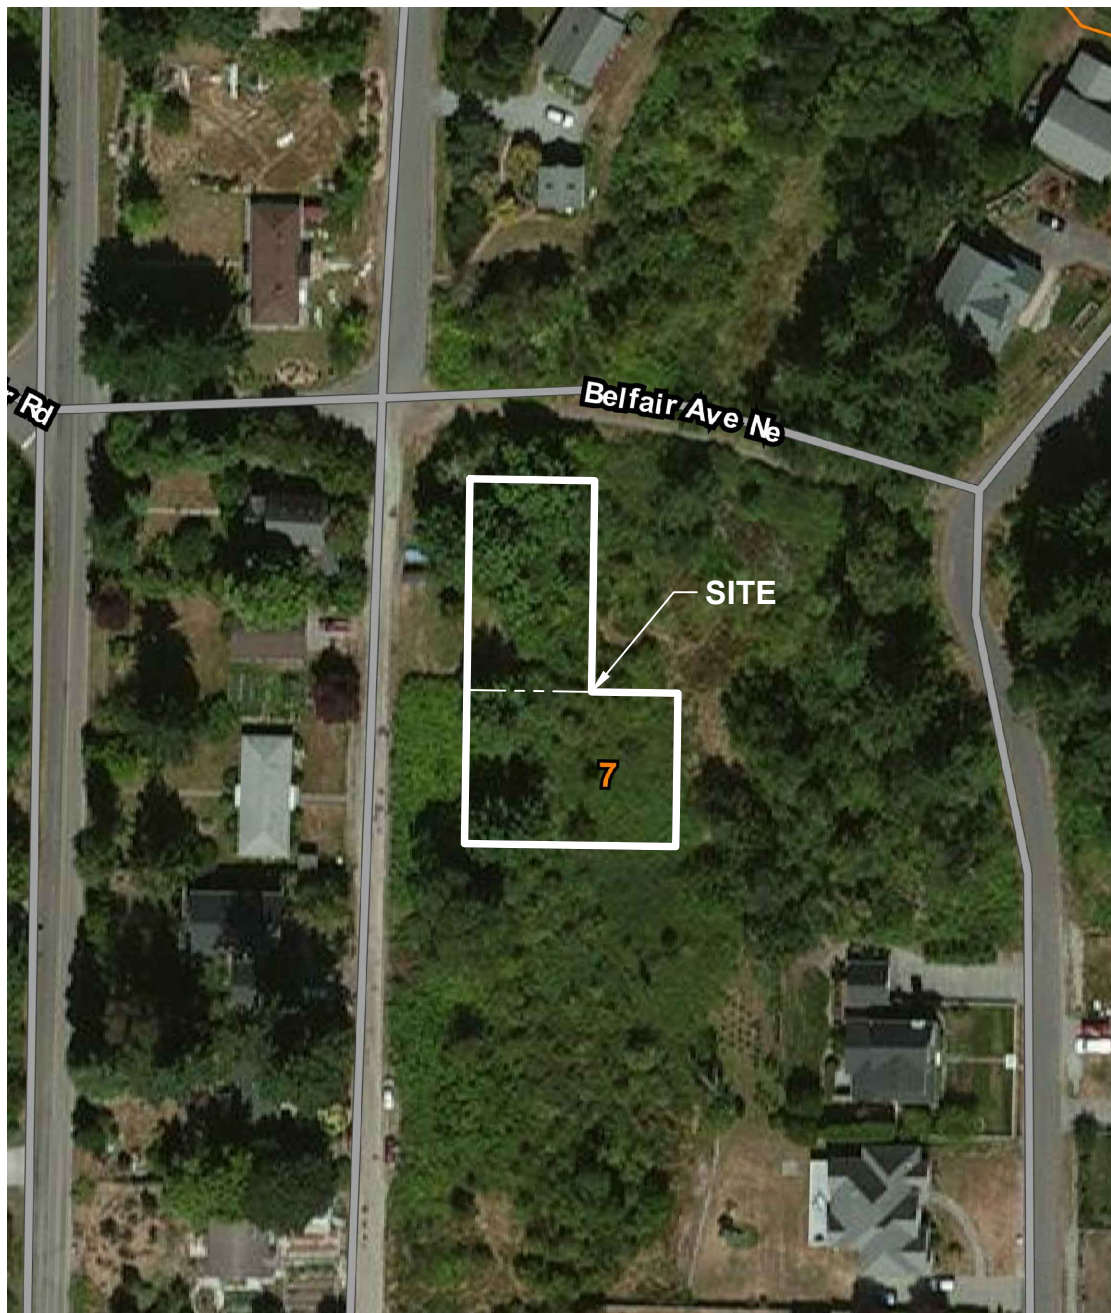
- 7 Cathcart silt loam, 2 to 8 percent slopes. Not hydric.

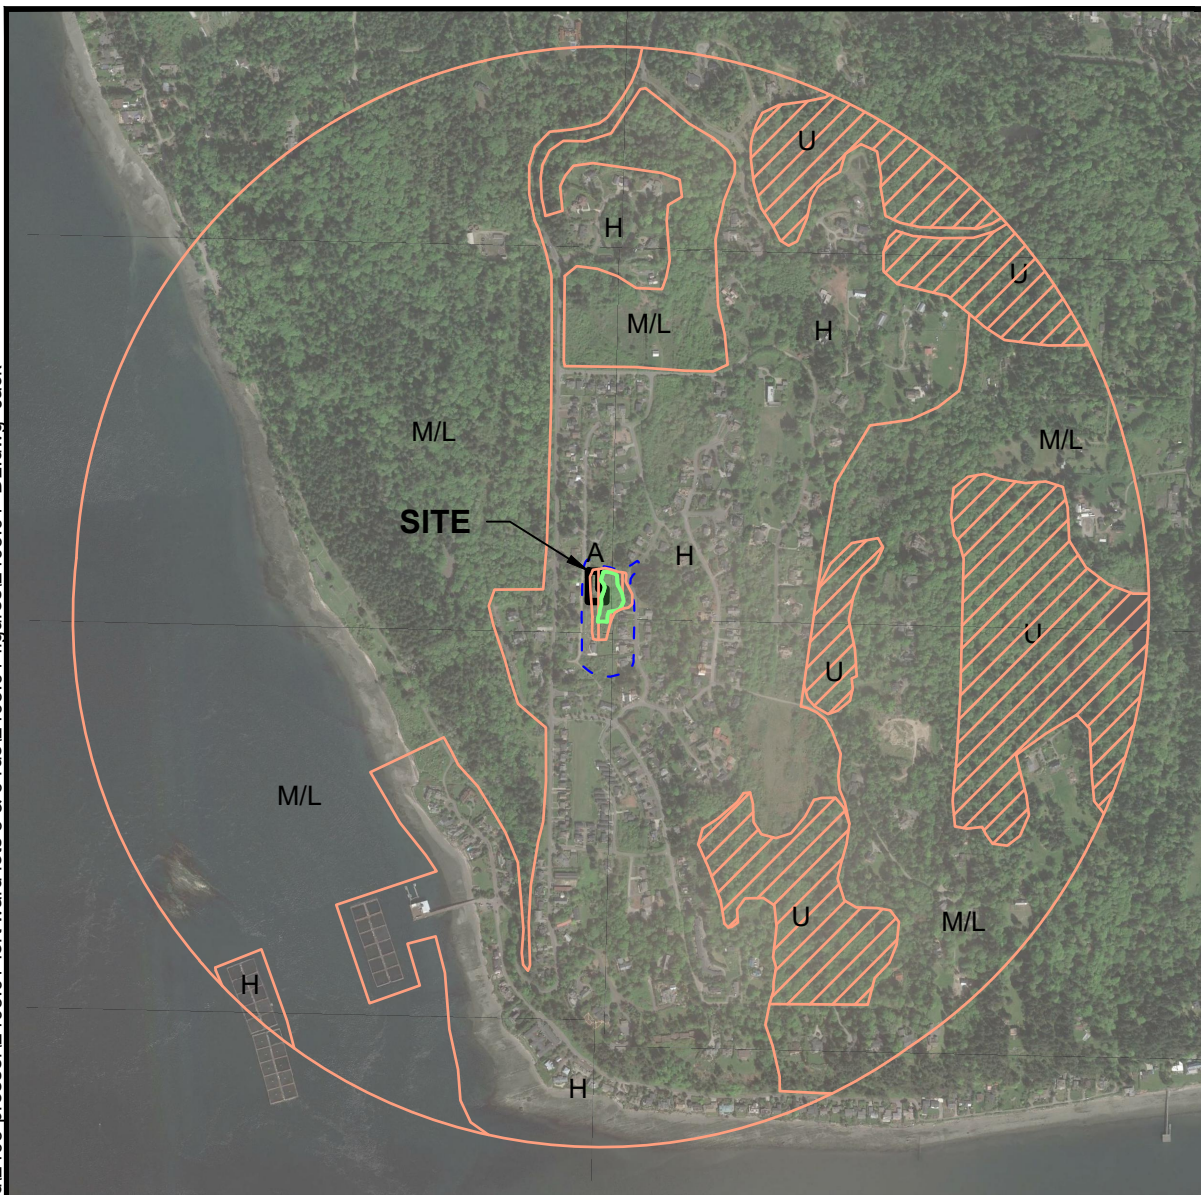
Figure 8
WETLAND RATING FORM-1 KM OFFSET
Fort Ward Lots 5 & 6 RUE
Julian Prosser
City of Bainbridge Island, Kitsap County, WA
Section 11, Township 24N, Range 2E, W.M.

- Wetland Unit Boundary
- Contributing Basin
- A Accessible Habitat (0.1%)
- U Undisturbed Habitat (12.0% *Includes Accessible Habitat)
- H High Intensity Land Use (33.9%)
- M/L Moderate/Low Intensity Land Use (54.1%)
