# **CRITICAL AREAS AND HABITAT MANAGEMENT REPORT**

**Blakely Elementary School  
City of Bainbridge Island, Washington**

**July 19, 2017**

Project Number: 2017-014

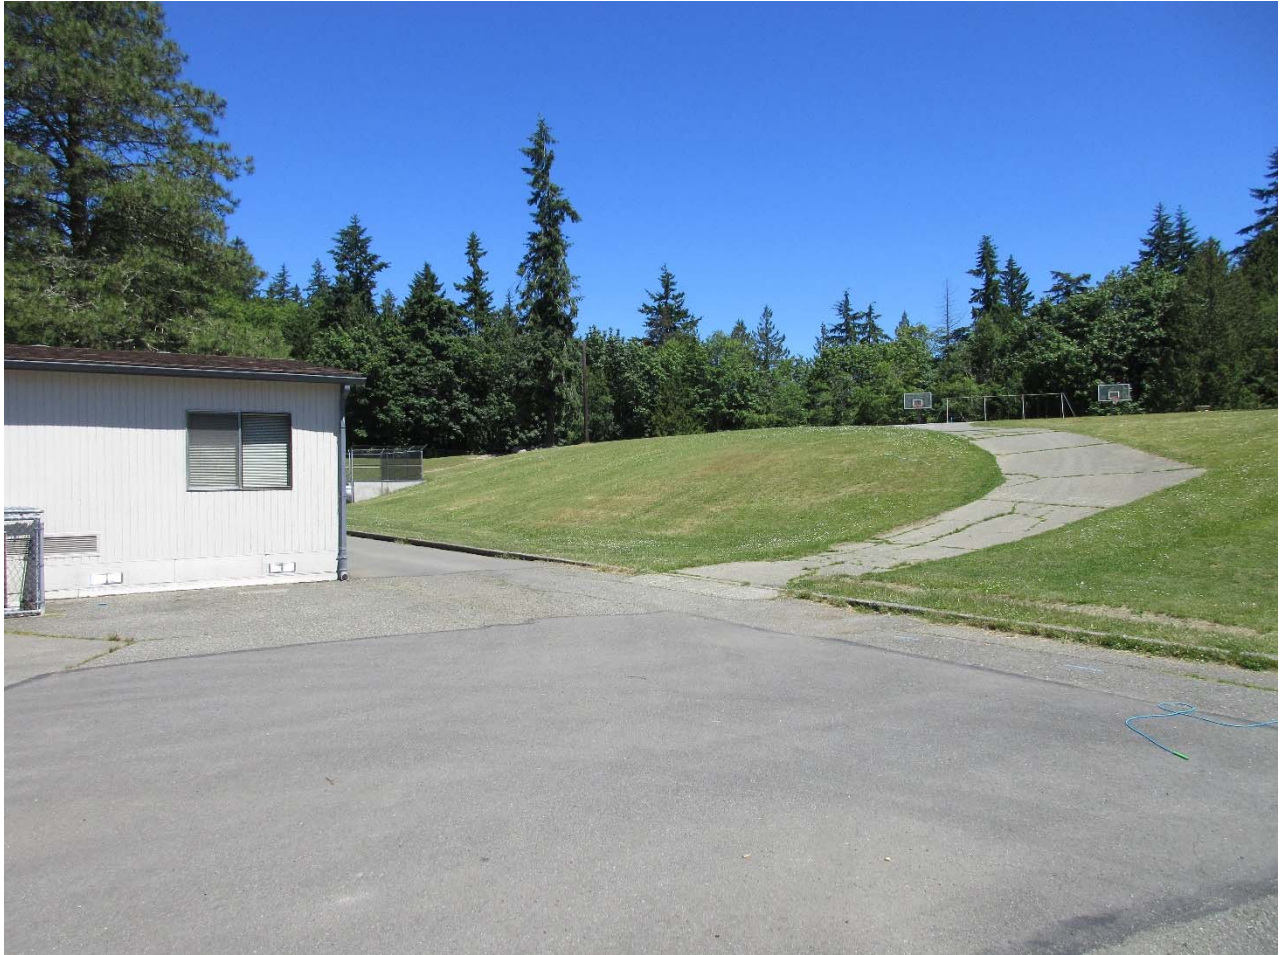
PHOTO 1: Outer edge of prescriptive buffer draining away from wetland unit and toward existing school

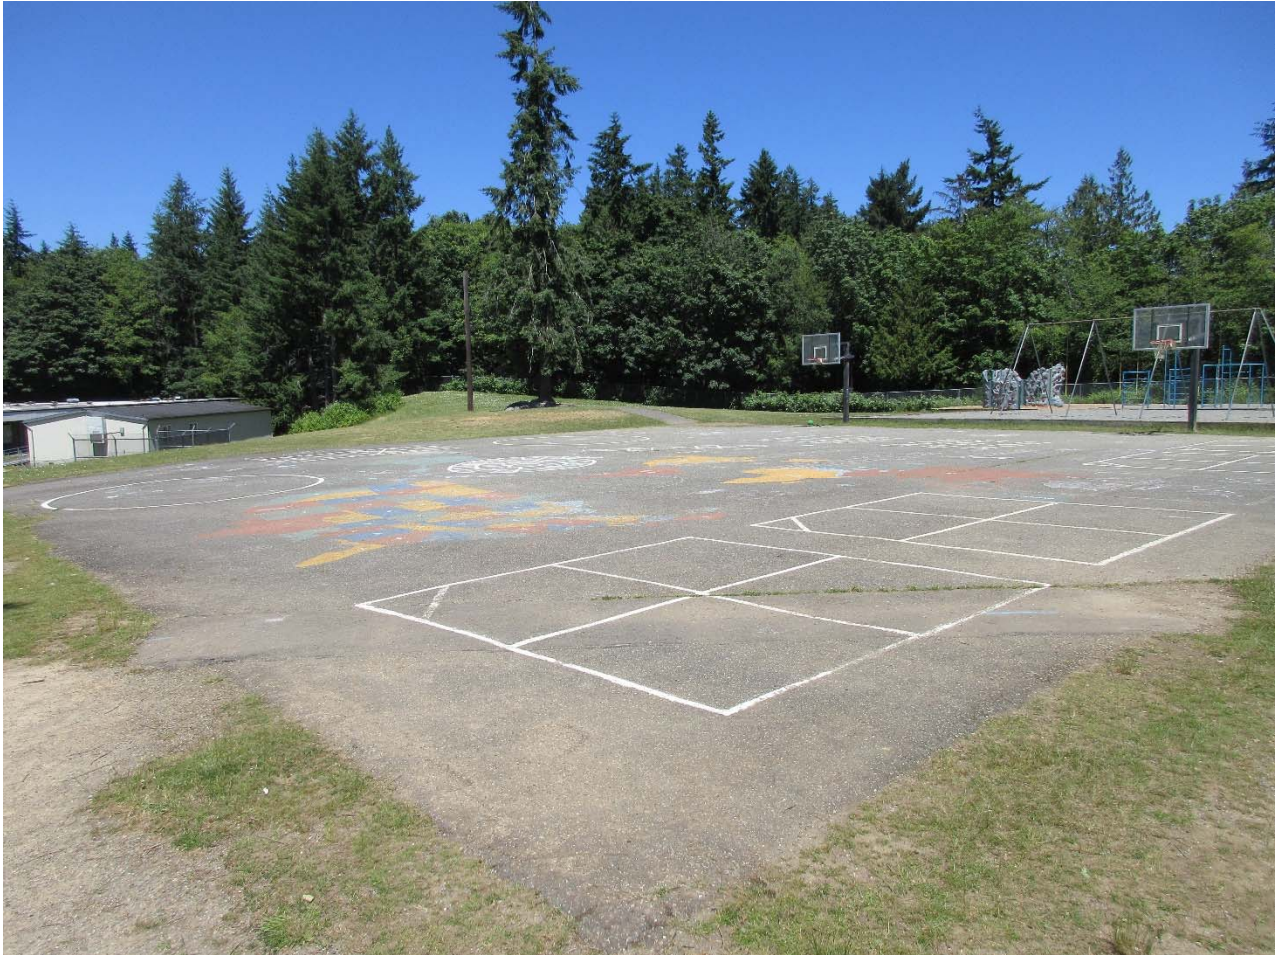
PHOTO 2: Existing paved play areas within prescriptive 300-foot wetland buffer and within the wetland drainage basin

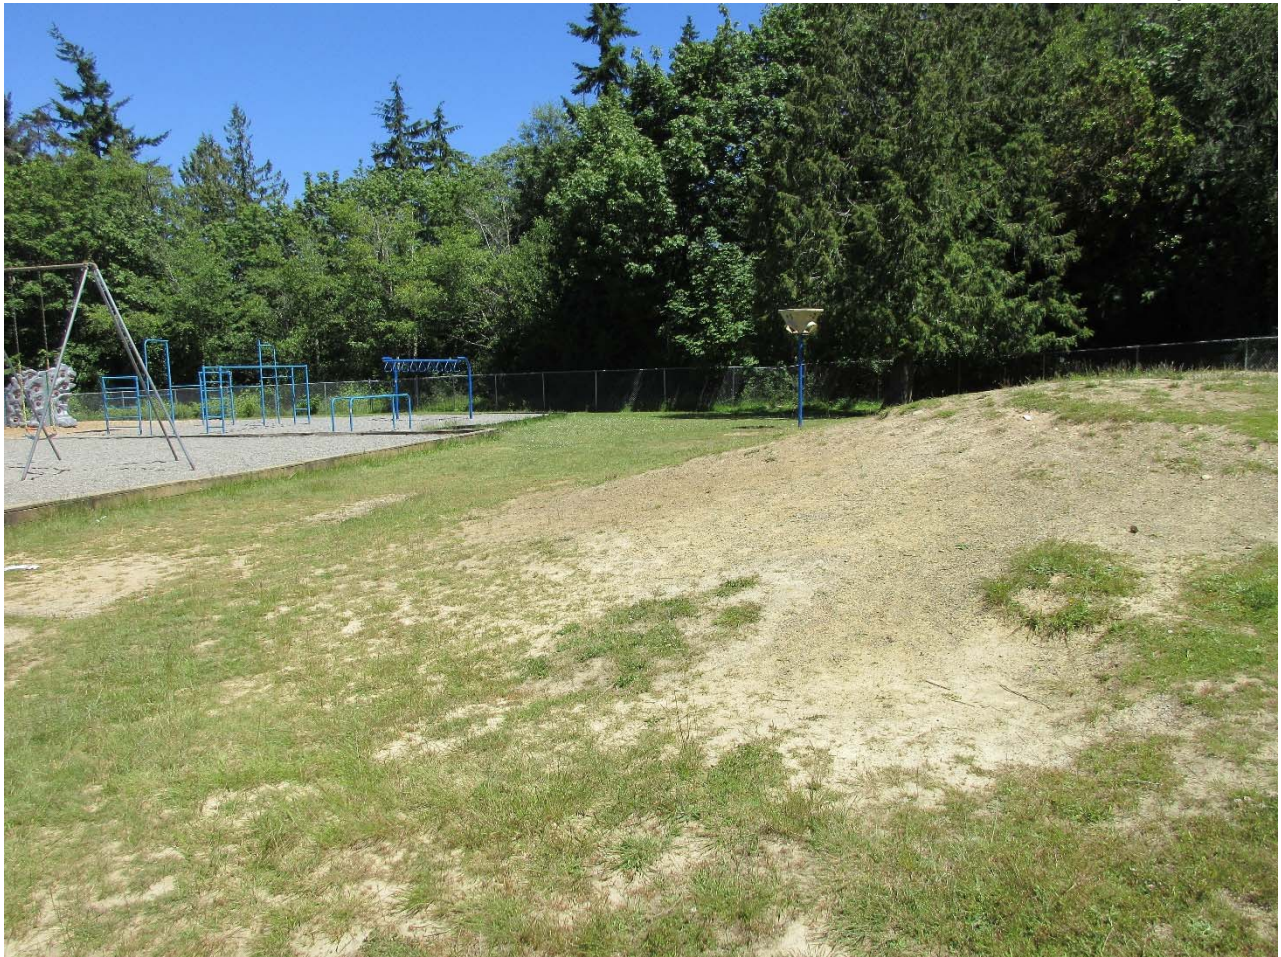
PHOTO 3: Existing buffer conditions within the wetland drainage basin

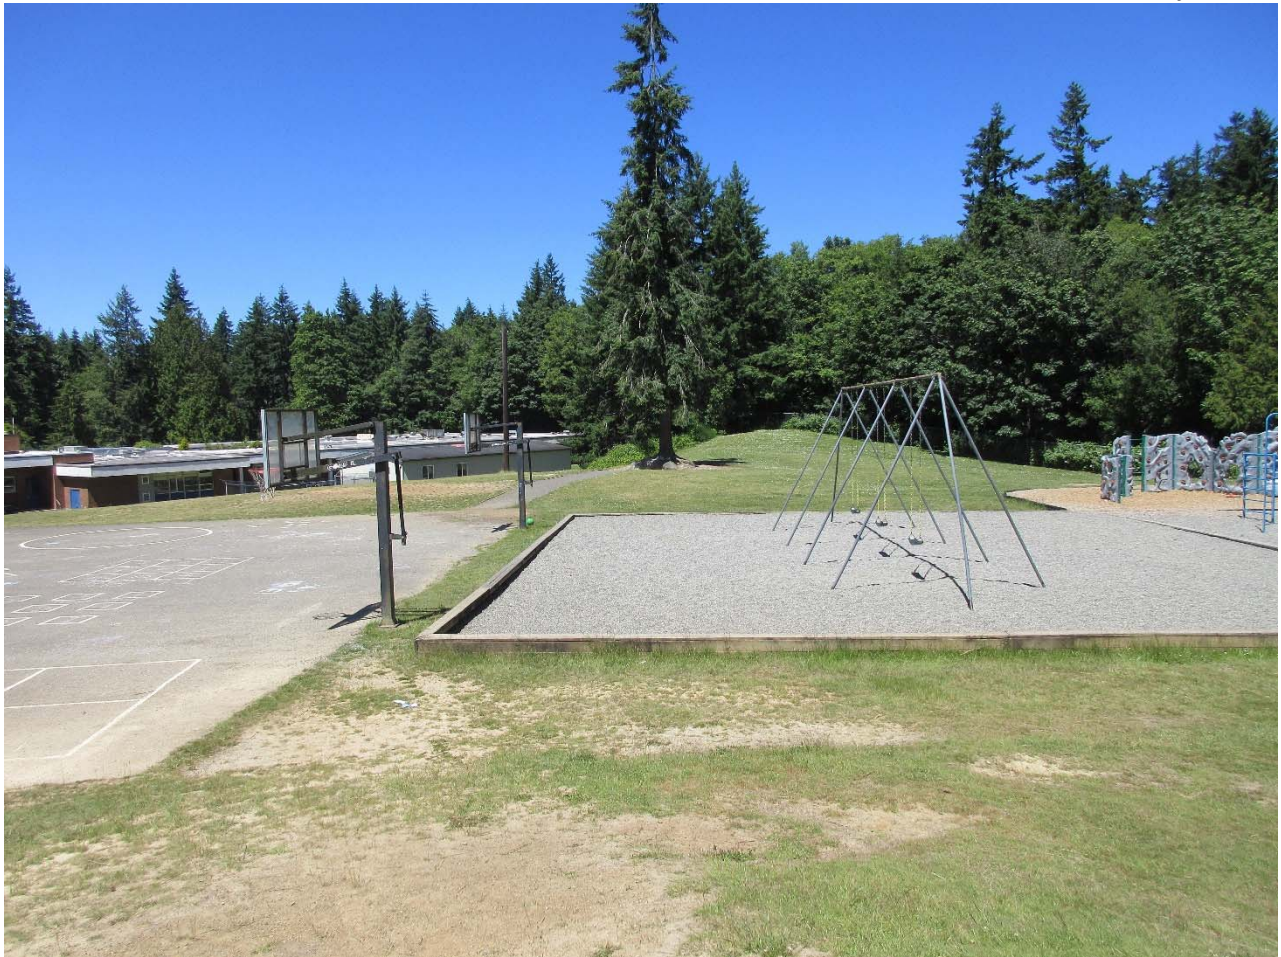
PHOTO 4: Existing buffer conditions within the wetland drainage basin

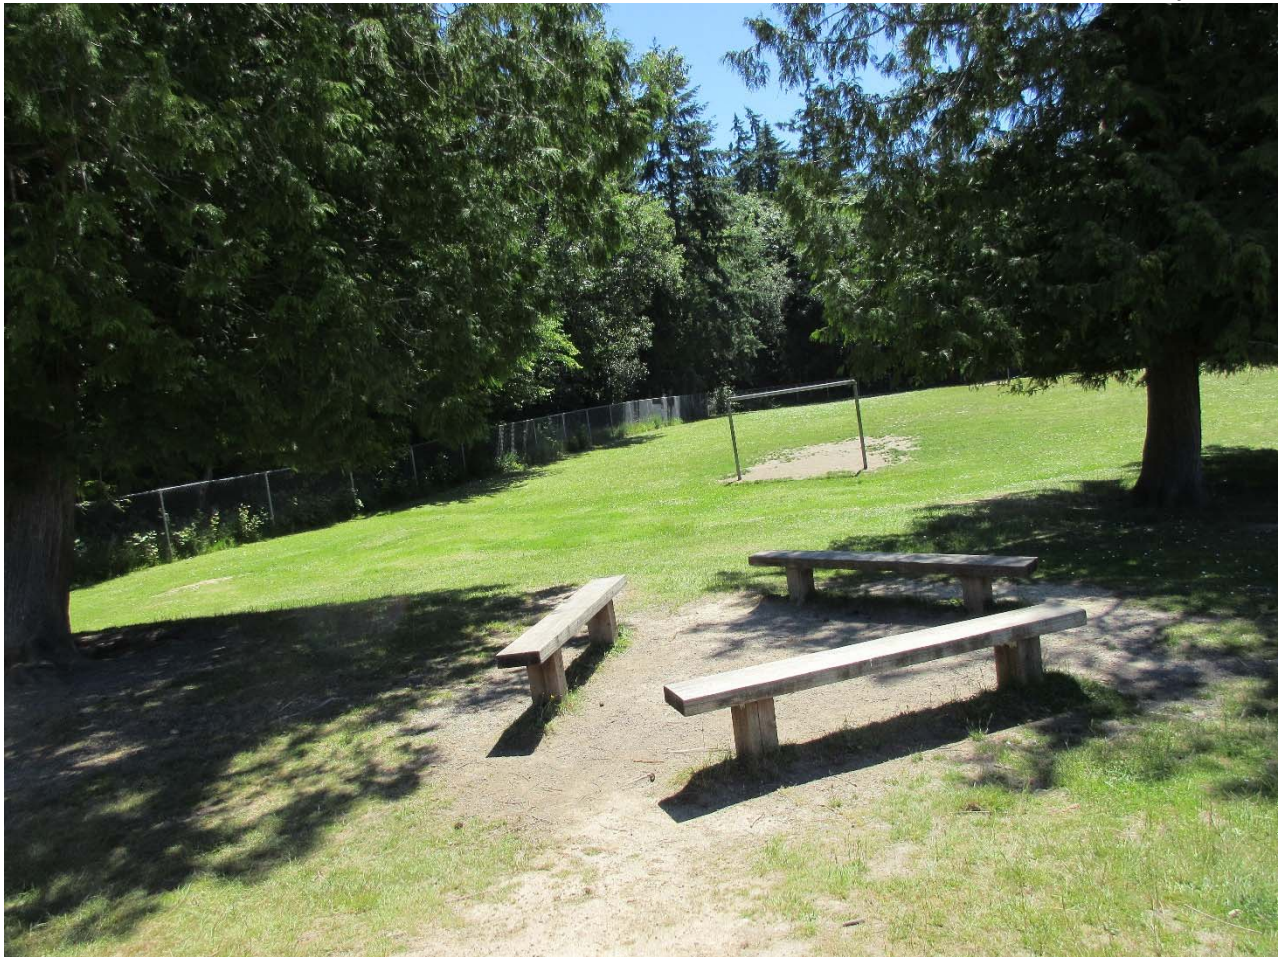
PHOTO 5: Existing buffer conditions within the 300-foot prescriptive buffer
