CRITICAL AREAS AND HABITAT MANAGEMENT REPORT

**Blakely Elementary School
City of Bainbridge Island, Washington**

July 19, 2017

Critical Areas & Habitat Management Report,
Blakely Elementary School,
City of Bainbridge Island, Washington

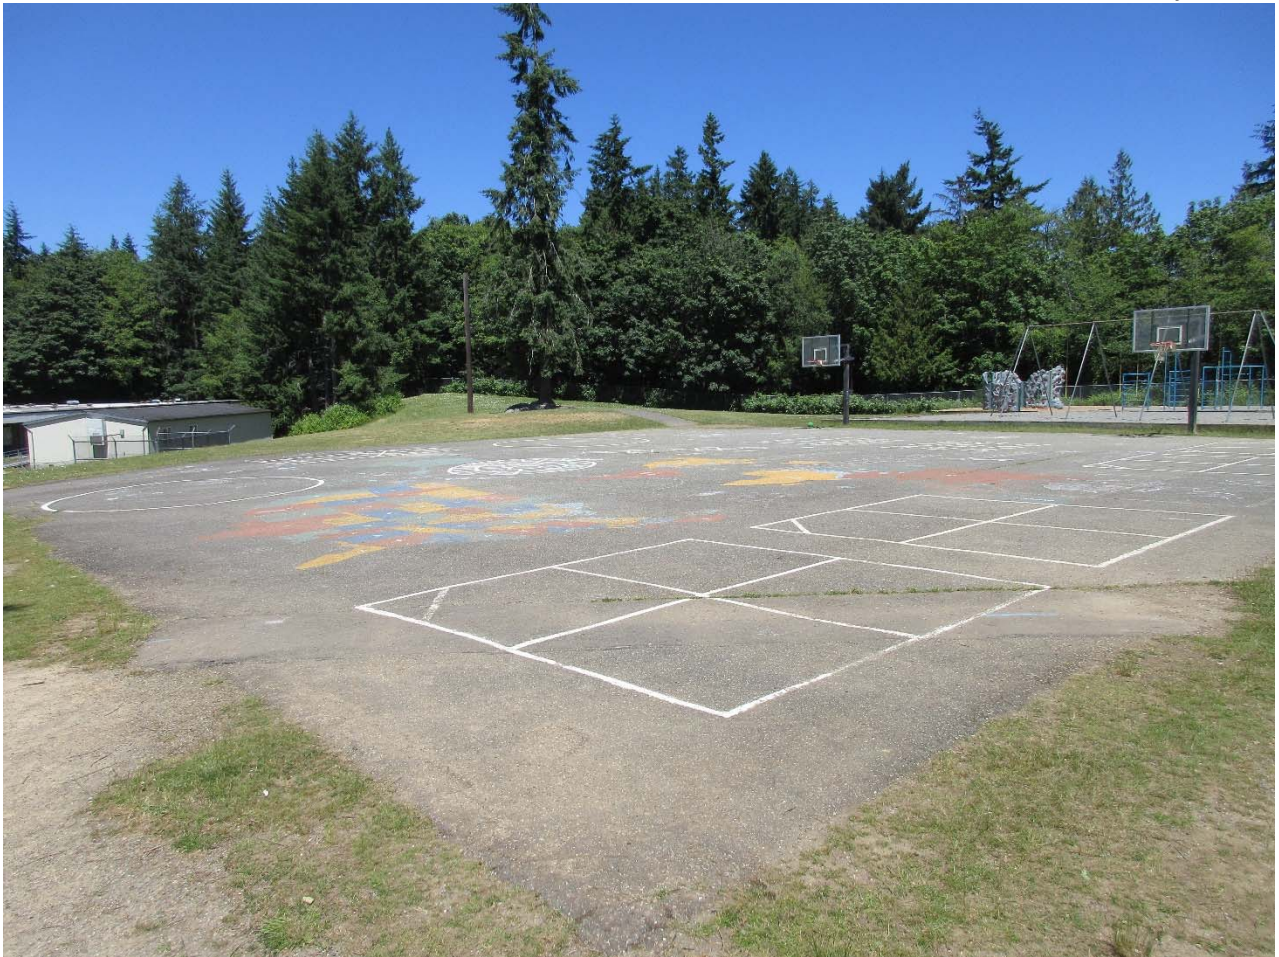
PHOTO 2: Existing paved play areas within prescriptive 300-foot wetland buffer and within the wetland drainage basin

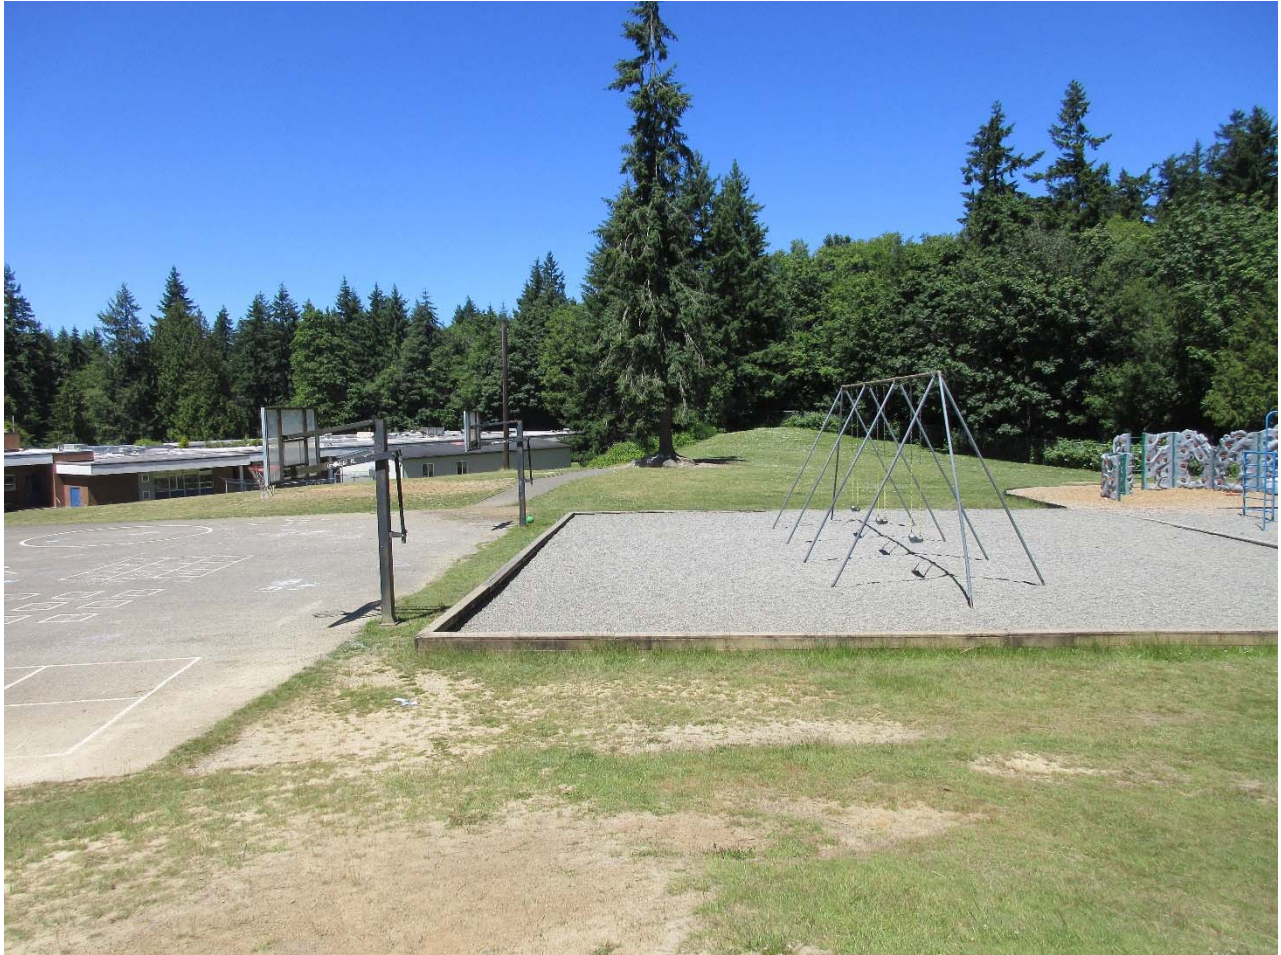
PHOTO 4: Existing buffer conditions within the wetland drainage basin
