Re: Fisher Residence - Final Letter for Geotechnical Special Inspections 12400 Sunrise Dr. NE, Bainbridge Island, Washington – Permit No. BLD22704 Aspect Consulting Project No. 160350

11	E: 11/16/2017 (THU) Report #001	PROJECT NO.: 160350	PROJECT NAME: Fisher Residence Slope Protection
WEA ⁻	WEATHER: Partly cloudy, 50's °F		PROJECT LOCATION:
		MUNICIPALITY: City of Bainbridge Island	12400 Sunrise Dr. NE Bainbridge Island, Washington 98110
то:	TO: Mark Fisher 12400 Sunrise Dr. NE, Bainbridge Island, WA 98110		ENGINEER: Aspect Consulting, LLC CONSTRUCTION MANGEMENT:
			GENERAL CONTRACTOR: GSI
			LANDSCAPER: Reyes Lawn Service
EQUI	PMENT USED:

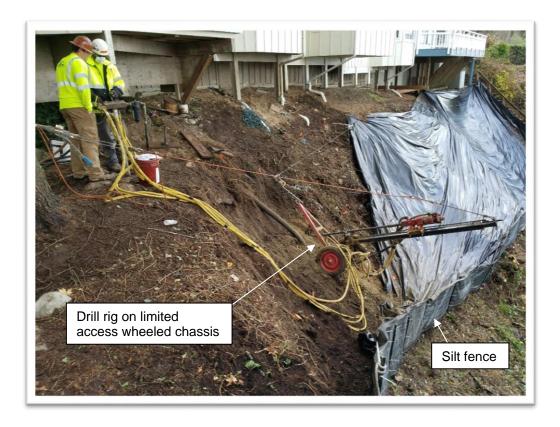
All earthwork is interior to the site. All temporary erosion control measures are functioning appropriately. A silt fence is in place along the downslope edge and sides of the project area. No sediment was observed passing over or under the silt fence. The entrance/exit to the site and the nearby street are clear of tracking. We observed the contractor consistently using Duradeck traction plates and plywood to reduce soil disturbance and tracking by equipment. The only vehicles entering or leaving the site today were driving exclusively on clean pavement. In our opinion, the work area is appropriately stabilized for erosion control; the TESC elements are generally performing as intended, and if properly maintained, will minimize the chance for erosion and off-site sediment transport.

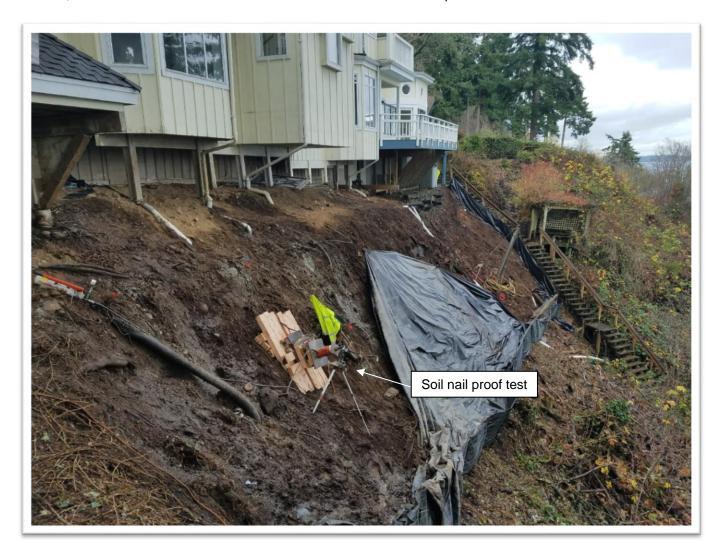
A proof test was performed today on a production soil nail (B2 in the Southern Stabilization Area) following the FHWA Soil Nail Walls Manual, 2015, NHI-14-007 (see photos). The location of the proof tested soil nail is shown on the attached installation schematic. Aspect observed and recorded the total displacement and creep displacement as the nail was loaded to a test load of 42 kips, which was then held for 10 minutes. The observed total displacement and creep displacement were within project specifications.
