Date: January 14, 2020
To: Ellen Fairleigh, Planner
City of Bainbridge Island, Planning Division
From: Peter Leon, Principal Scientist
Subject: Manlowe Bulkhead Replacement
10750 NE Broomgerrie Rd
Request for Emergency Authorization under BIMC 2.16.165.E.2.a

**Subject: Geotechnical Evaluation
 Failing Bulkhead
 10750 Northeast Broomgerrie Road
 Bainbridge Island, Washington**

Subject: Manlowe Bulkhead – Emergency Permit

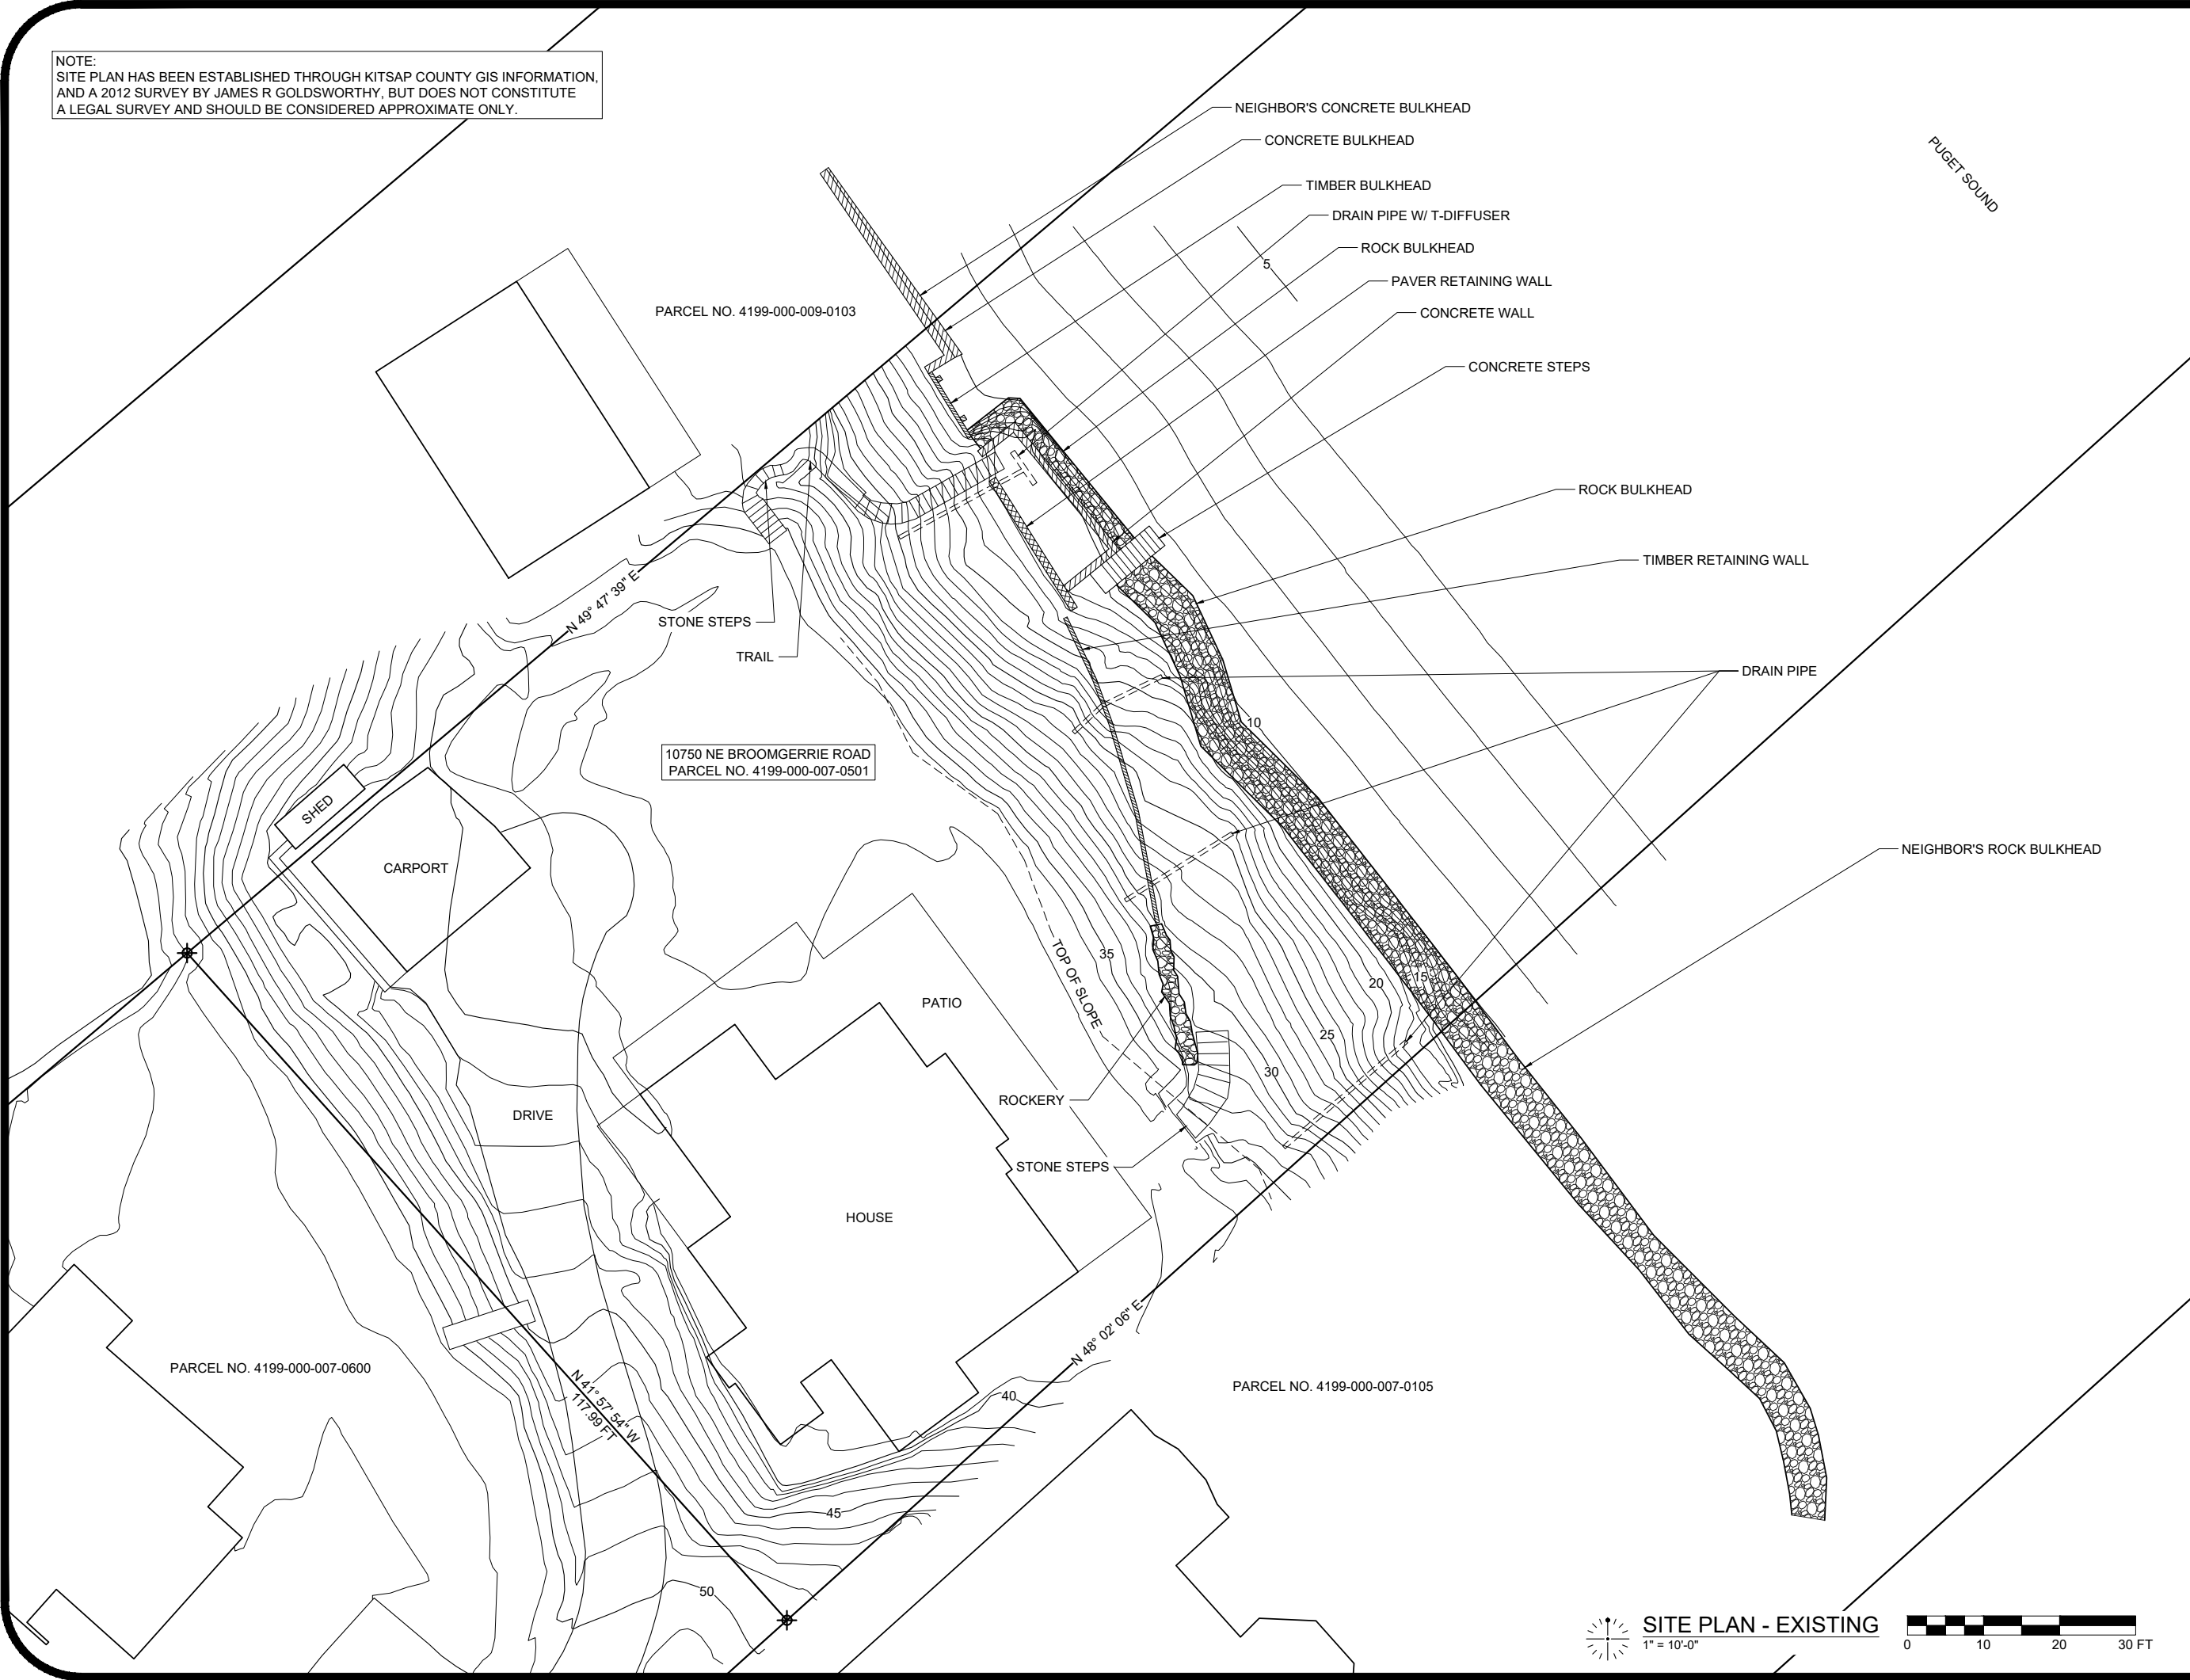
SITE PLAN - EXISTING
1" = 10'-0"

- The bulkhead has experienced a partial collapse at the northern end. We believe that a primary cause was the loss of beach sands covering the base rock, allowing the rocks to move and topple.

- We noted additional undermining and rock movement at the existing concrete stairs.

It is our opinion that the Manlowe rock bulkhead is in a state of progressive failure and should be replaced immediately through an emergency permit.
