October 17, 2018

JN 18485

Subject: **Critical Area Report and Update of Previous Geotechnical Engineering Study**
Proposed New Multi-Family Building
230 Madison Avenue South
Bainbridge Island, Washington

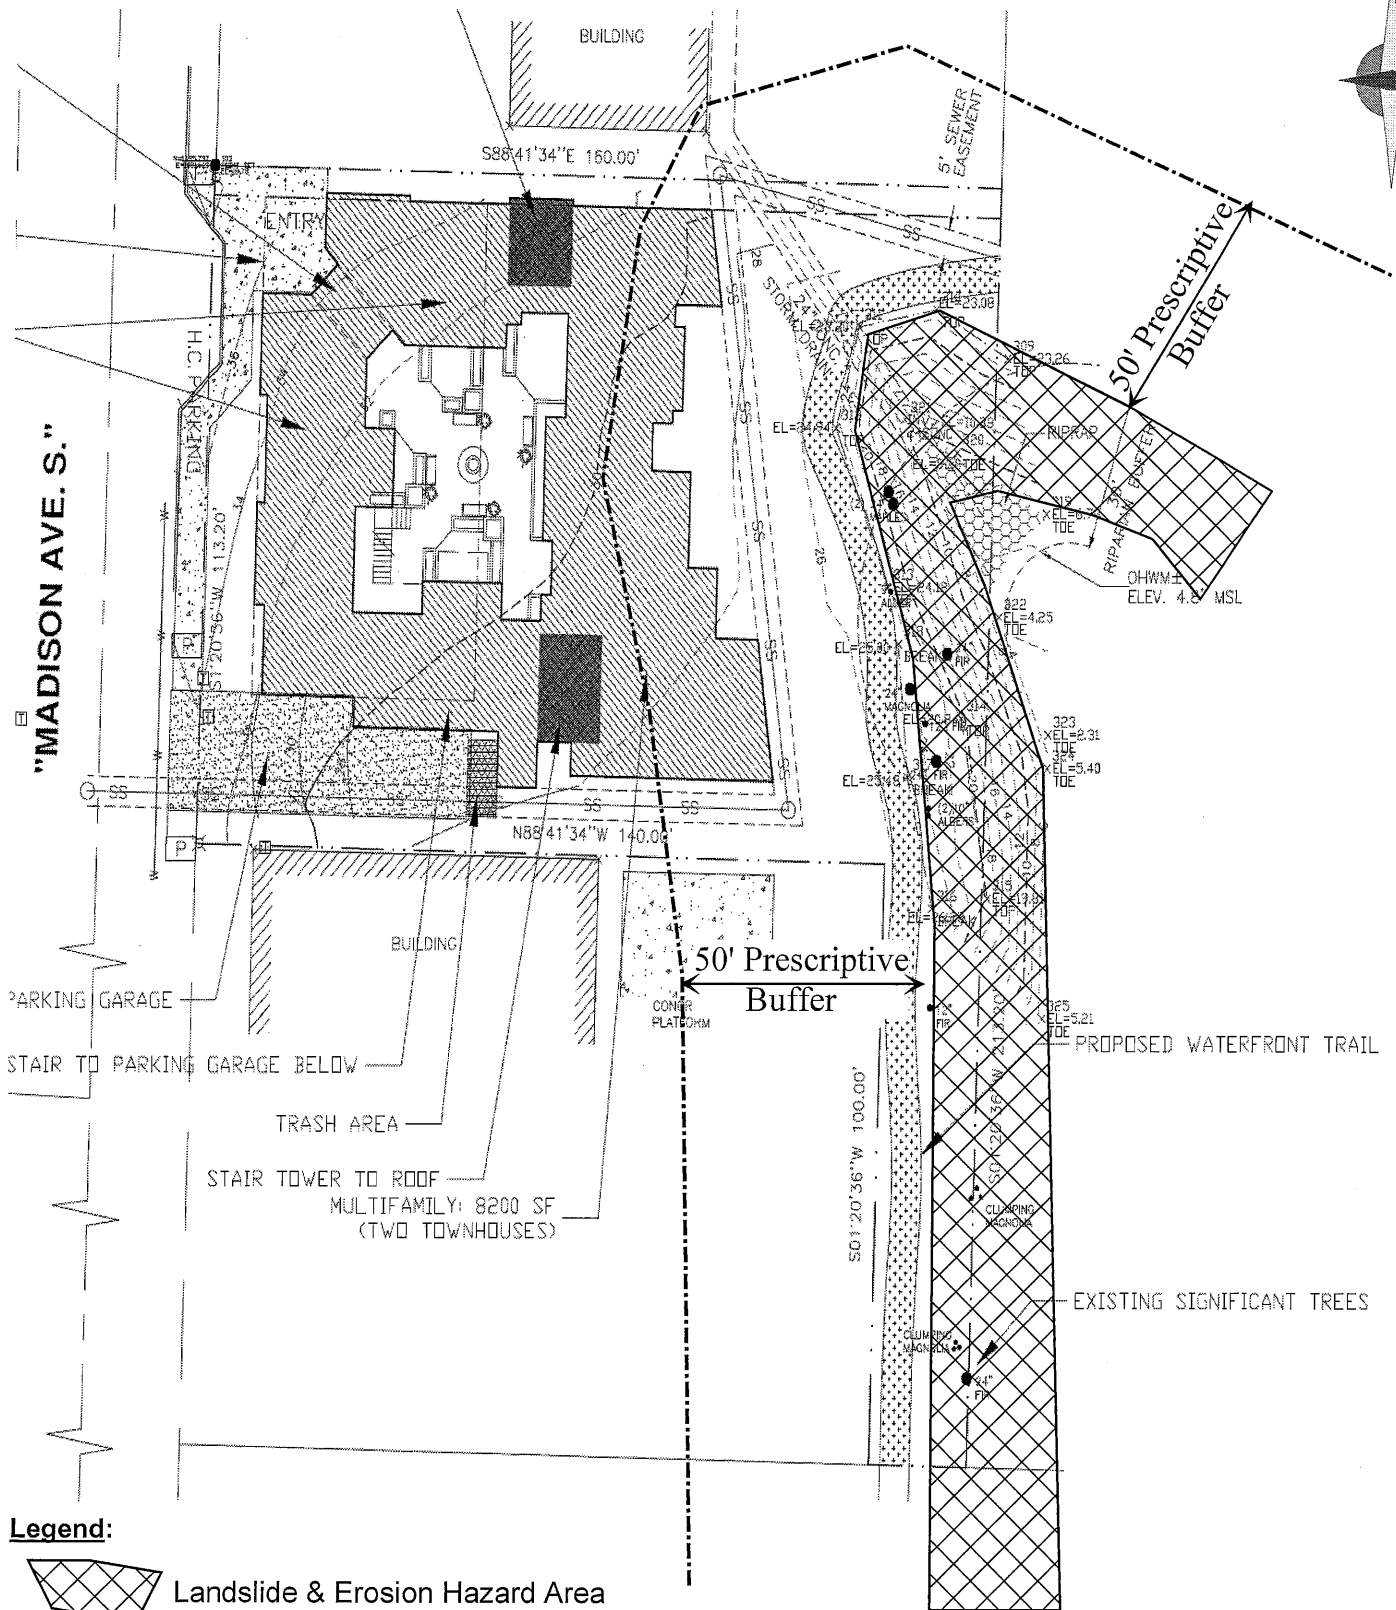
Plate: 3

Under BIMC 16.12.060, the steep slope on the eastern edge of the property meets the criteria for a landslide hazard area and an erosion hazard area. This is primarily due to the steep inclination of the waterfront slope, which extends down to a small tidal inlet. On the Critical Areas Plan, Plate 3, we have indicated the geologically hazardous areas (landslide hazard and erosion hazard areas as defined by BIMC 16.12.060). Based on our interpretation of the BIMC, the prescriptive buffer from a landslide hazard area is 50 feet or the height of the slope, whichever is greater. This 50-foot buffer zone is also indicated on the Critical Areas Plan.

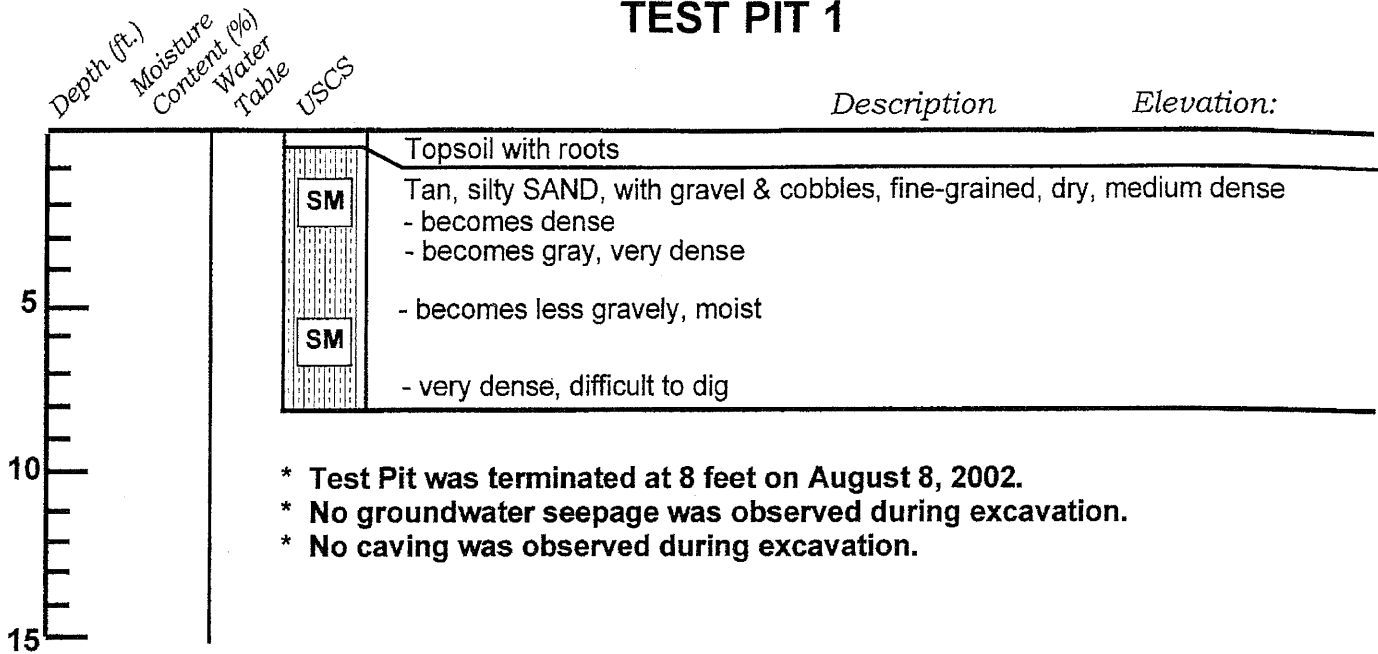
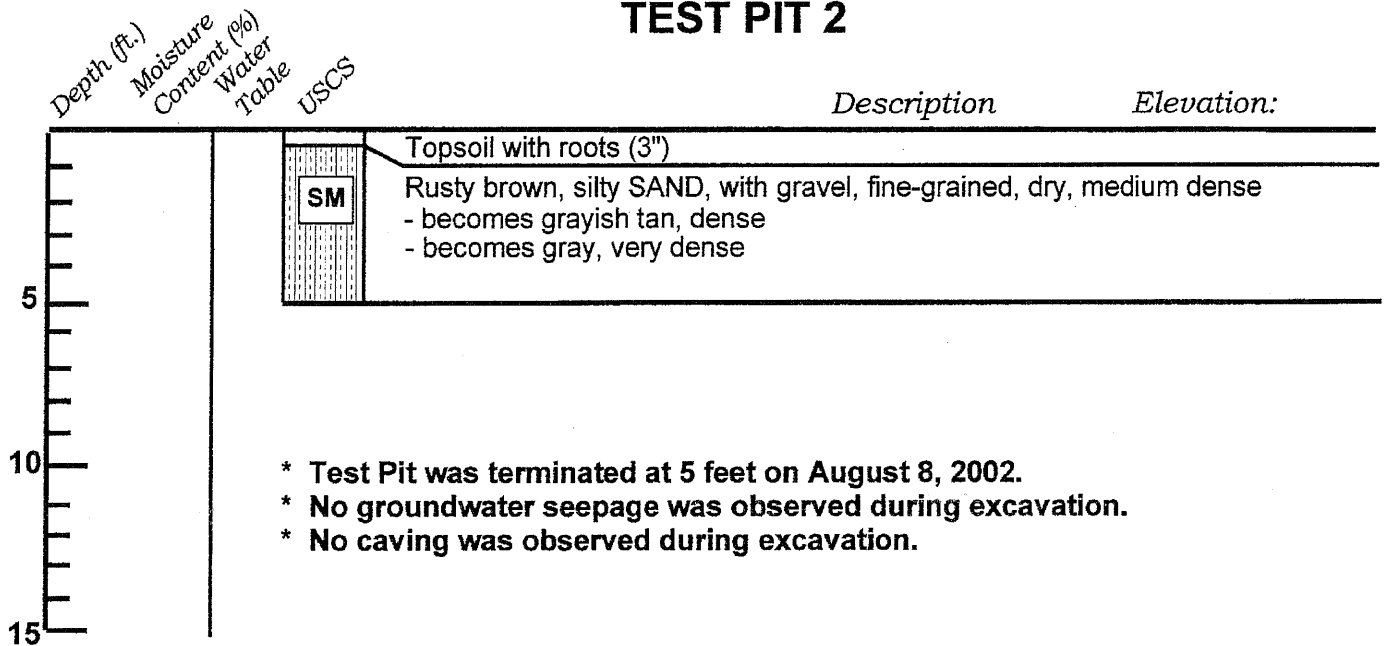
Job No: 02302	Date: November 2002	Logged By: T.A.J.	Plate: 3
------------------	------------------------	----------------------	-------------

With the exception of approximately 5.5 feet of fill in Test Pit 3, the test pits excavated across the site generally encountered similar conditions. We typically observed a very thin layer of topsoil and highly organic material, overlying medium-dense silty sand with gravel that became dense between 2 and 4 feet in depth and very dense within 5 feet. The fill encountered in Test Pit 3 was medium-dense with roots. A dark brown, one-inch-thick organic layer separated the fill from underlying native silty sand.

No groundwater seepage was observed in any of the five test pits excavated. The test pits were excavated in the summer and were left open for only a short time period. Therefore, the absence of seepage levels on the logs does not preclude the presence of groundwater in future excavations. It should be noted that groundwater levels can vary seasonally with rainfall and other factors. We anticipate that perched groundwater could be found above and within the glacial till soils in the winter and spring months, especially in excavations near the wetlands.
