# MESSENGER HOUSE PHASE II

## Geotechnical Engineering Report

Prepared for: Cascadia Senior Living & Fieldstone  
Communities

Project No. 200104 • June 22, 2020 • FINAL

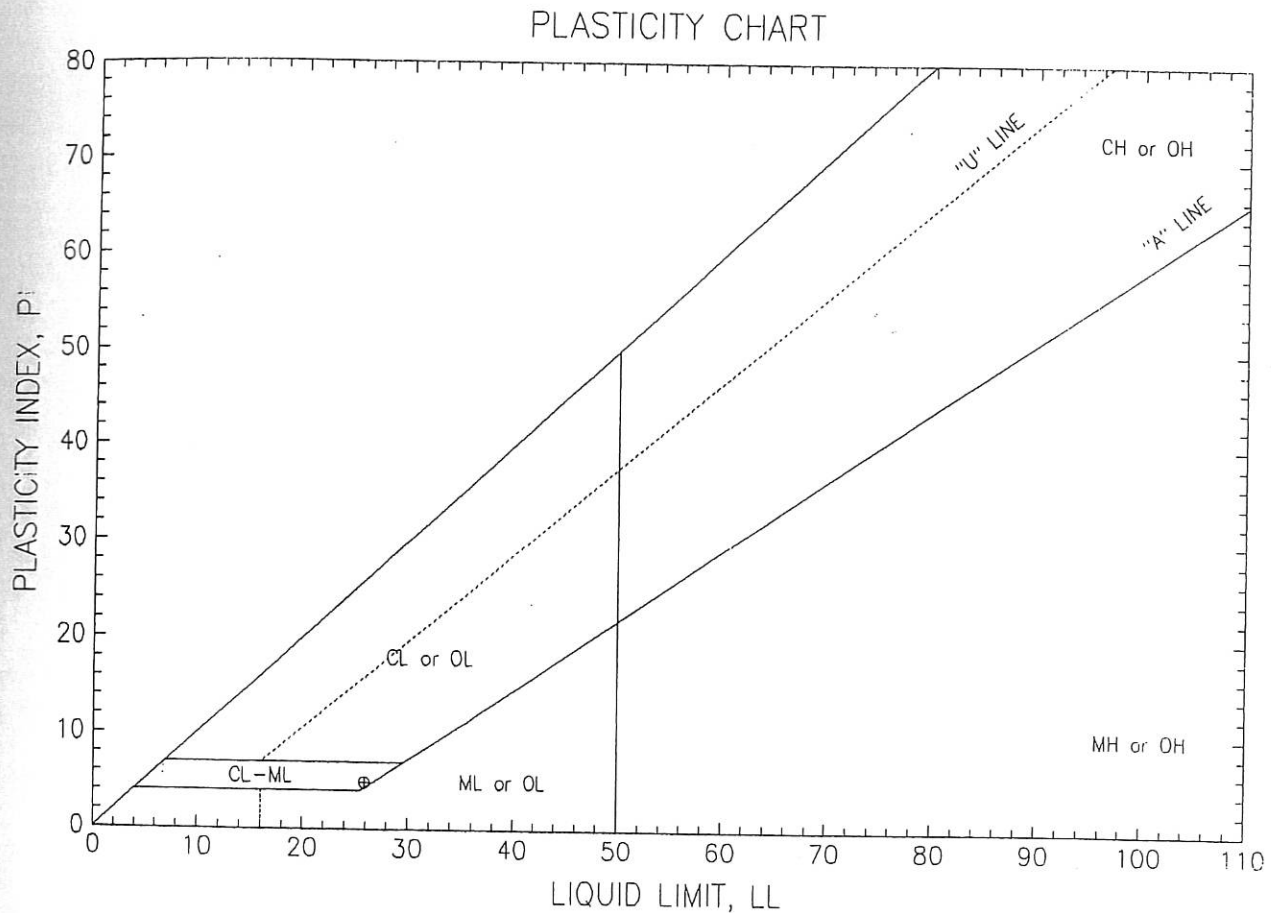
Project : MYERS BIODYNAMICS-MESSENGER HOUSE PR.# 94478-5  
 Project No. : J-649B  
 Location : MESSENGER HOUSE  
 Date : Tue Nov 08 1994

Symbol	Sample Number	Water Content	Liquid Limit	Plastic Limit	Plasticity Index	Soil Classification
O	TP-7 S-2	27	26	21	5	(CL-ML) Sandy silty clay

\* Based on visual observation and plasticity
