Re: Response to Comments
6134 Old Mill Road NE
Bainbridge Island, WA 98110
Project No. 170422

Attachment: Slope Stability Analyses (revised)

Slope Stability Analysis

Muzzi ADU and Garage
6134 Old Mill Road NE, Bainbridge Island, WA 98110

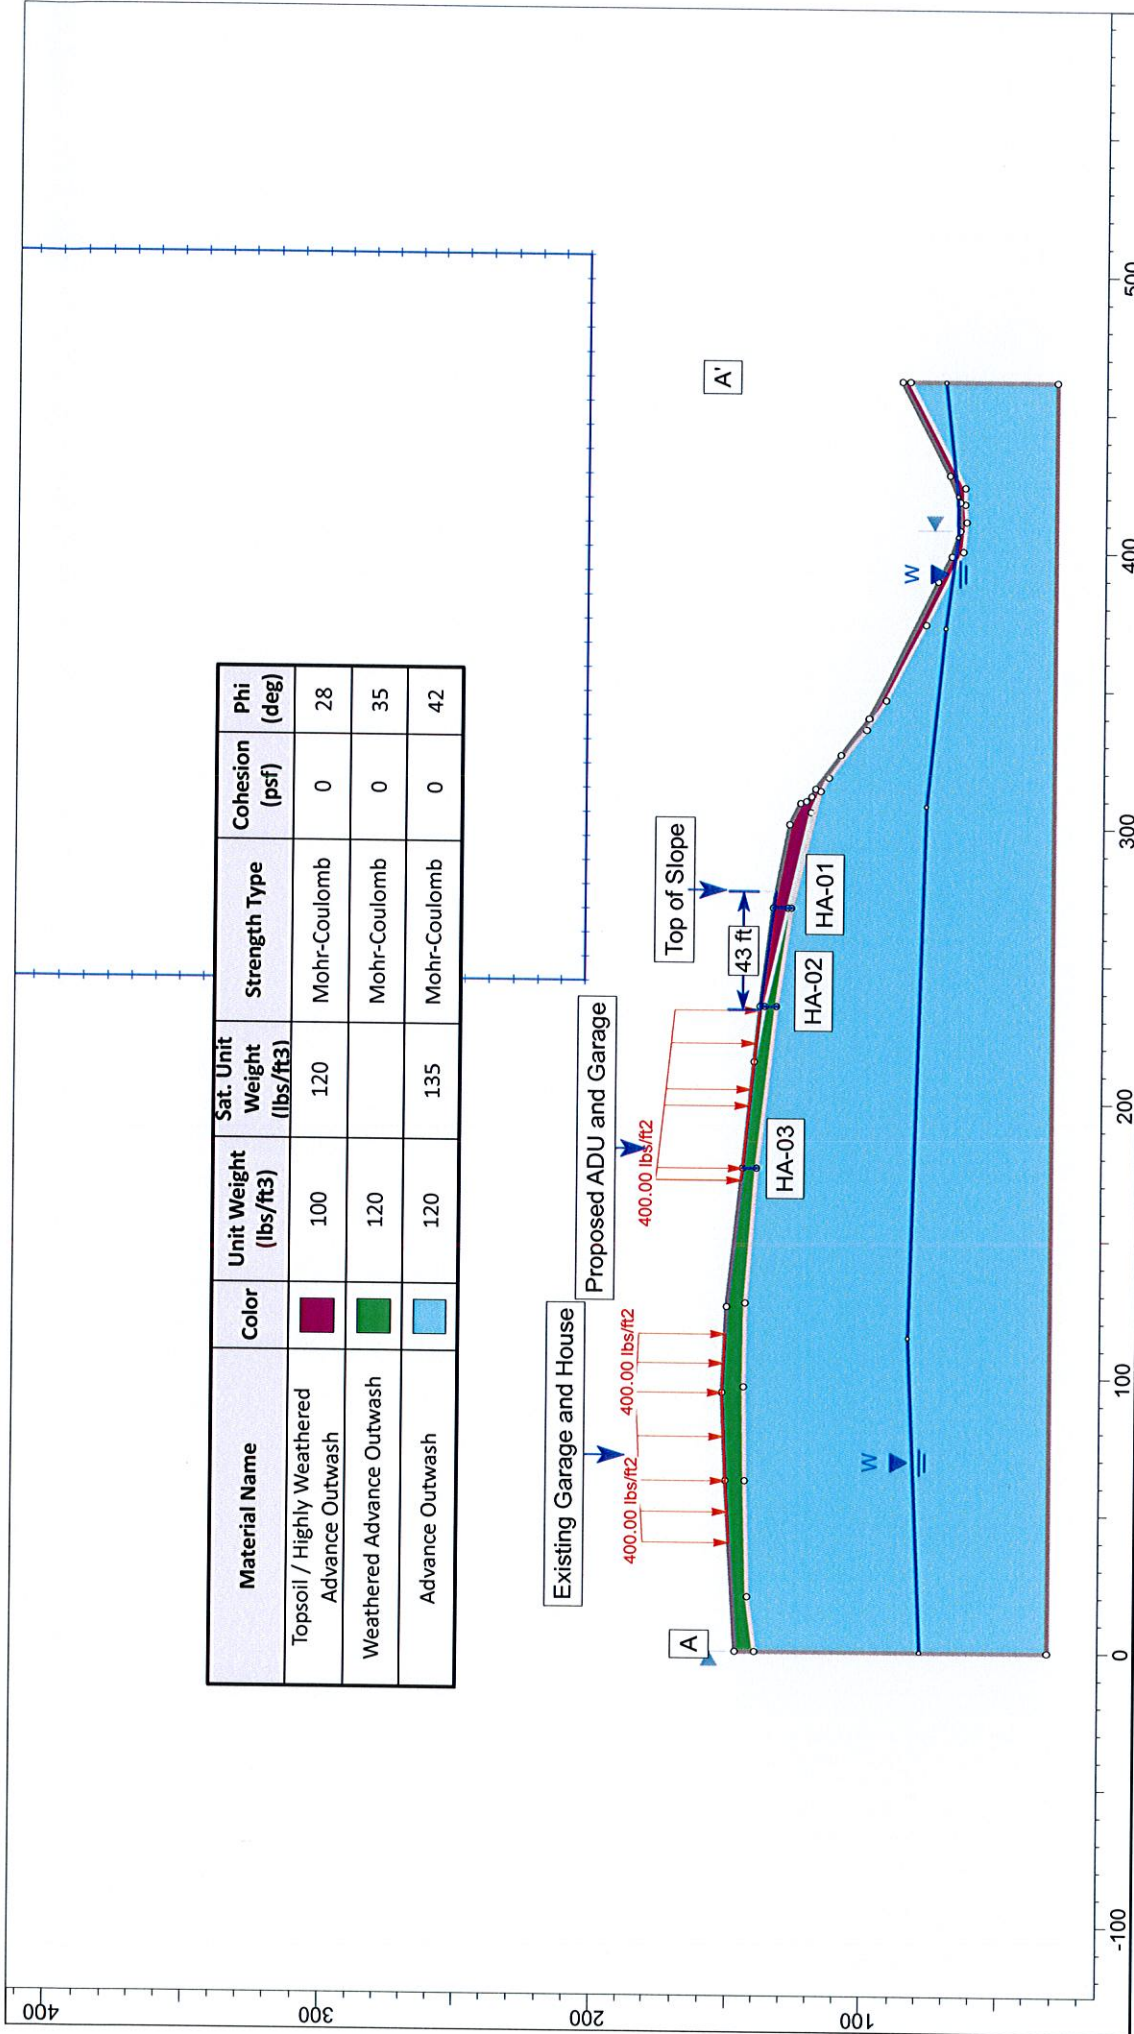
APPENDIX: **B-1**

Section A-A' Model Setup

(a) Table 2 on Page 7 of the report states that the static factor of safety is greater than 1.5 and that the seismic factor of safety is greater than 1.1 at a distance of 43 feet from the top of the steep slope. The slope stability results in Appendix B on Figures B-2 and B-3 present the minimum static and seismic factors of safety achieved for a shallow failure surface of 0.902 and 0.506, respectively, which is not consistent with the results presented in Table 2. While we infer that Aspect are trying to show that the lowest factors of safety occur within the colluvium, we recommend that Aspect present the factor of safety for a failure surface that terminates at the edge of the recommended buffer and setback. In addition, Aspect state in the paragraph below Table 2 that a seismic factor of safety greater than 1.0 was achieved, which is also inconsistent with the “greater than 1.1” shown in the table. We also recommend that Aspect provide further discussion and clarification of the stability results.

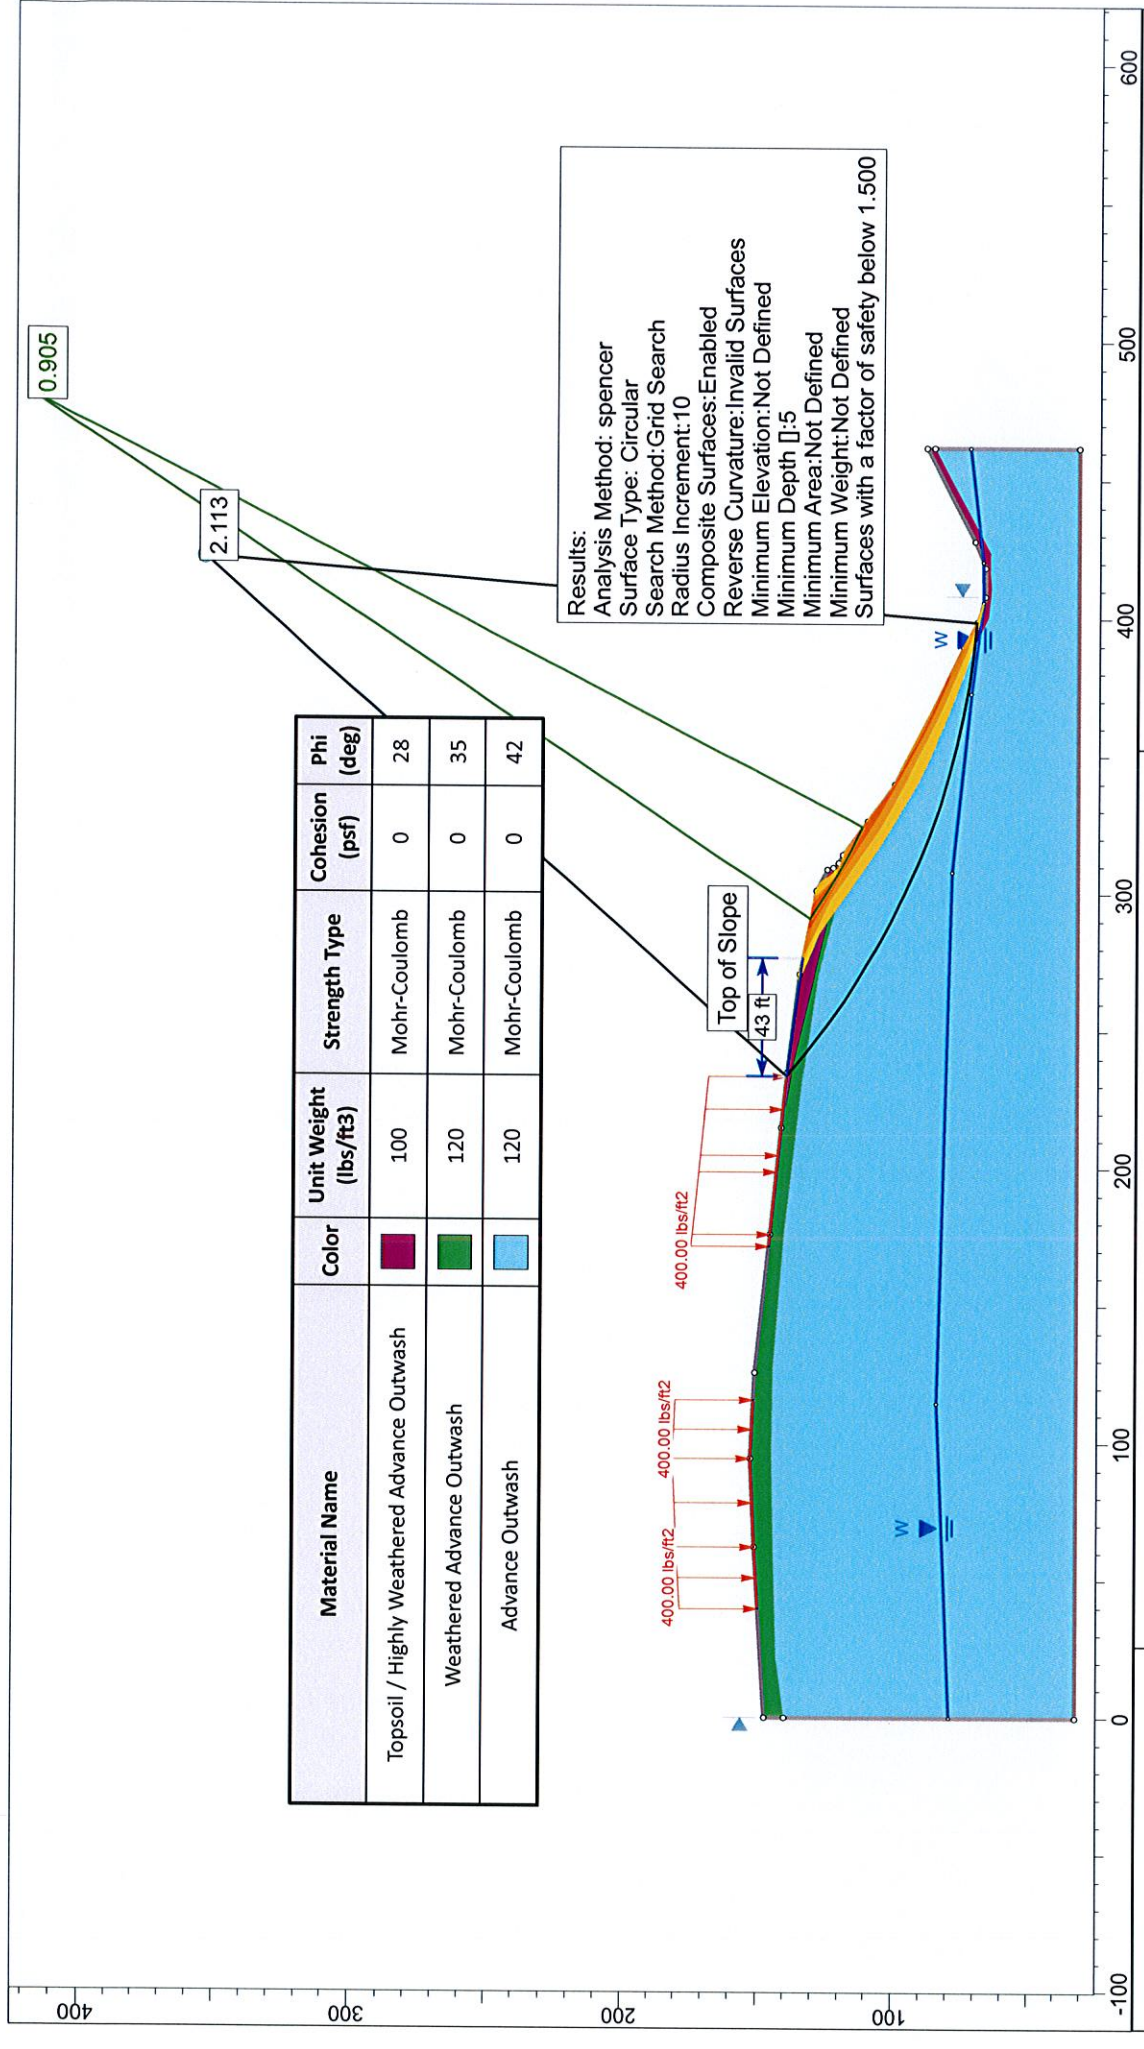
Section A-A' Static Conditions
