# GEOTECHNICAL REPORT

Ericksen Ave Development

568 Ericksen Avenue NE  
Bainbridge Island, Washington

Project No. 170194 • June 21, 2018

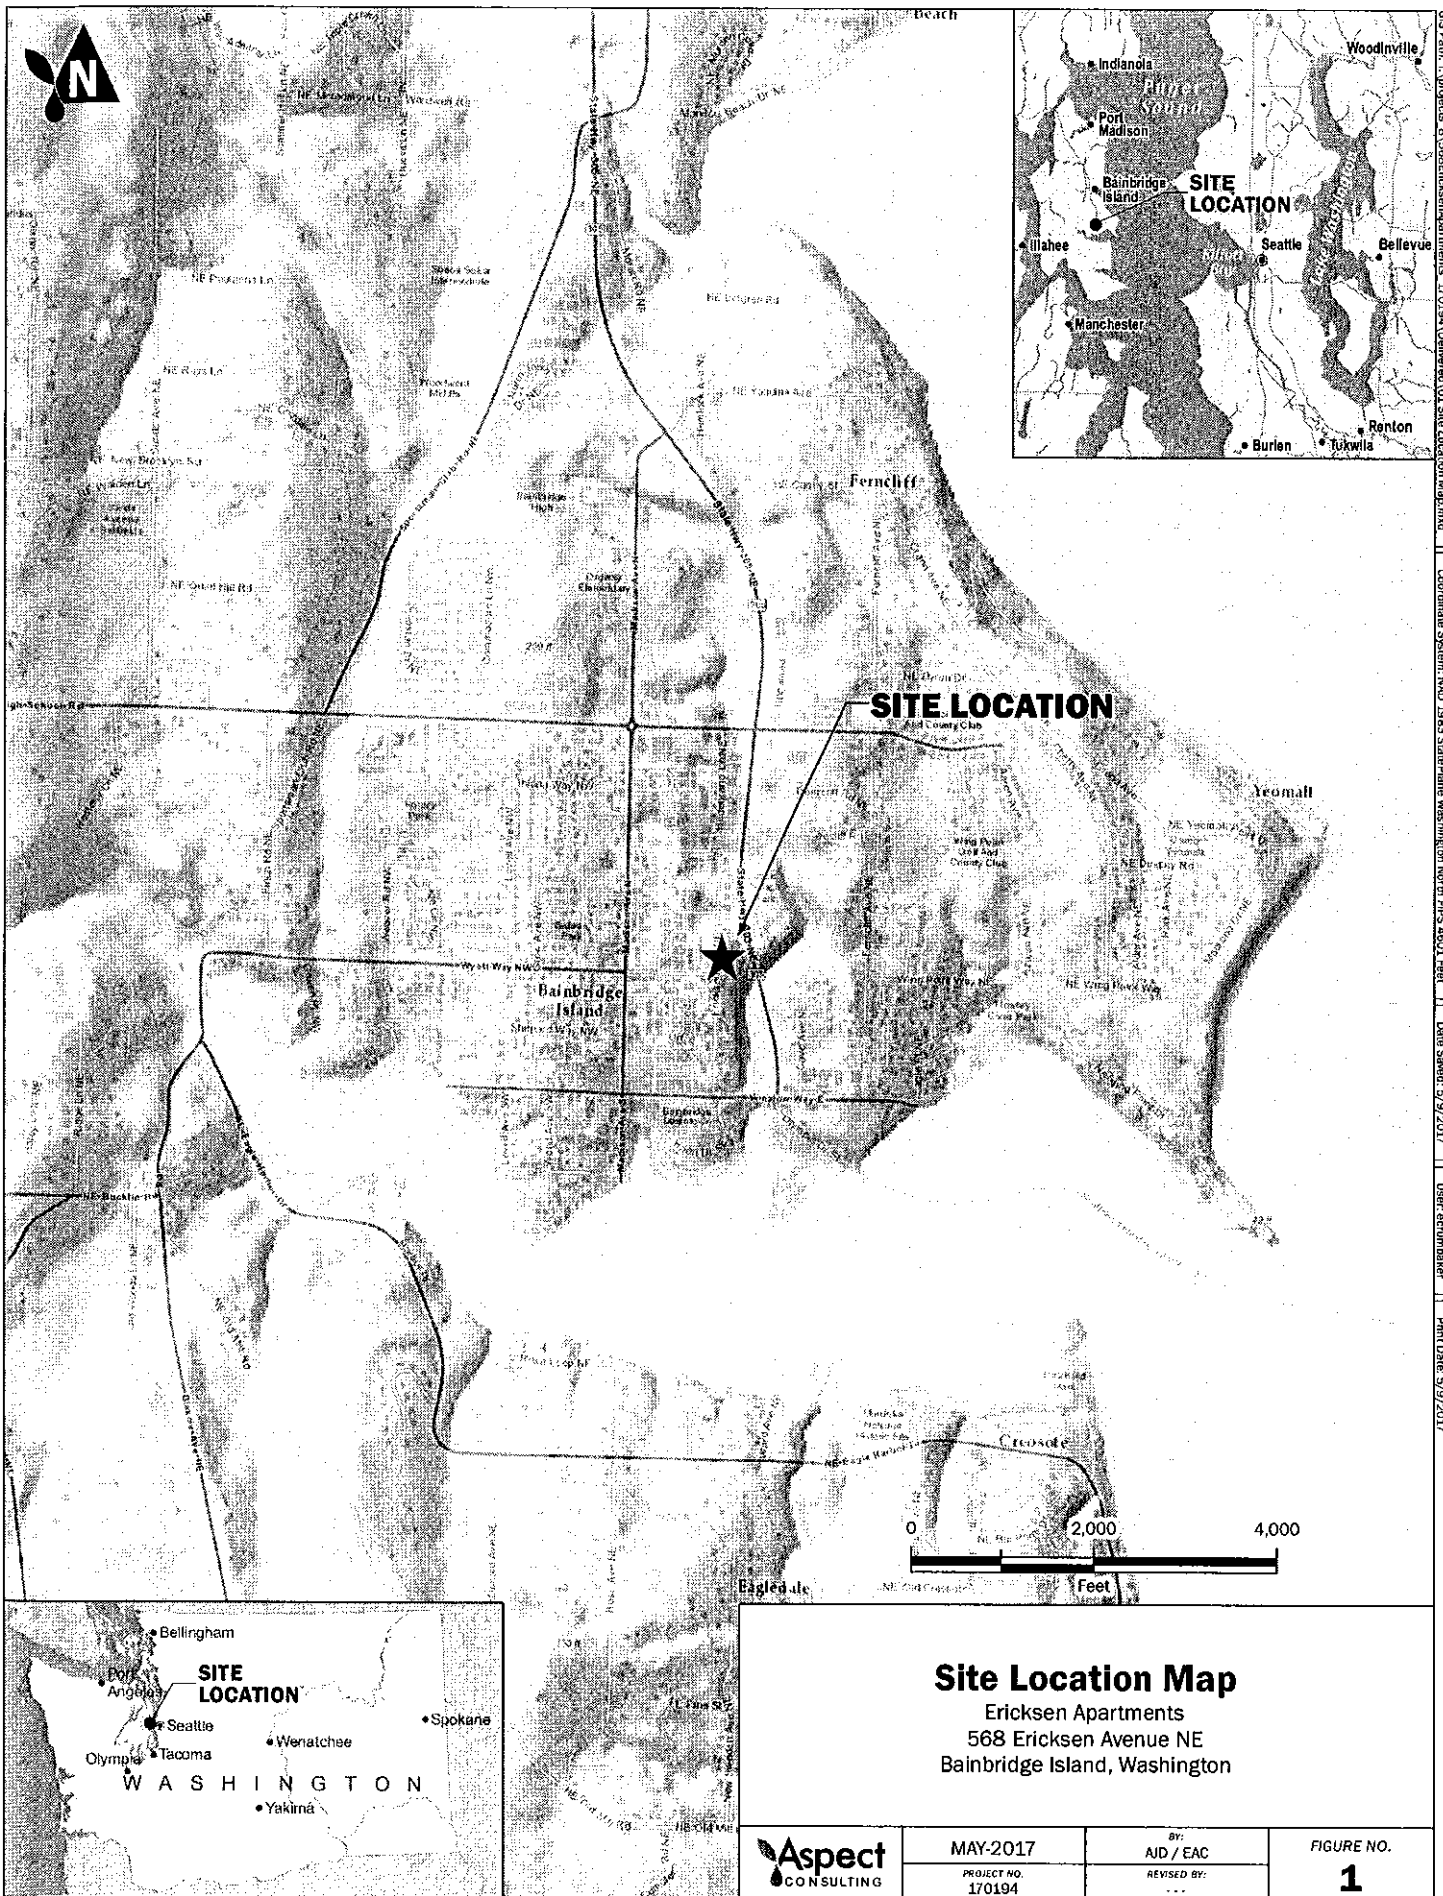
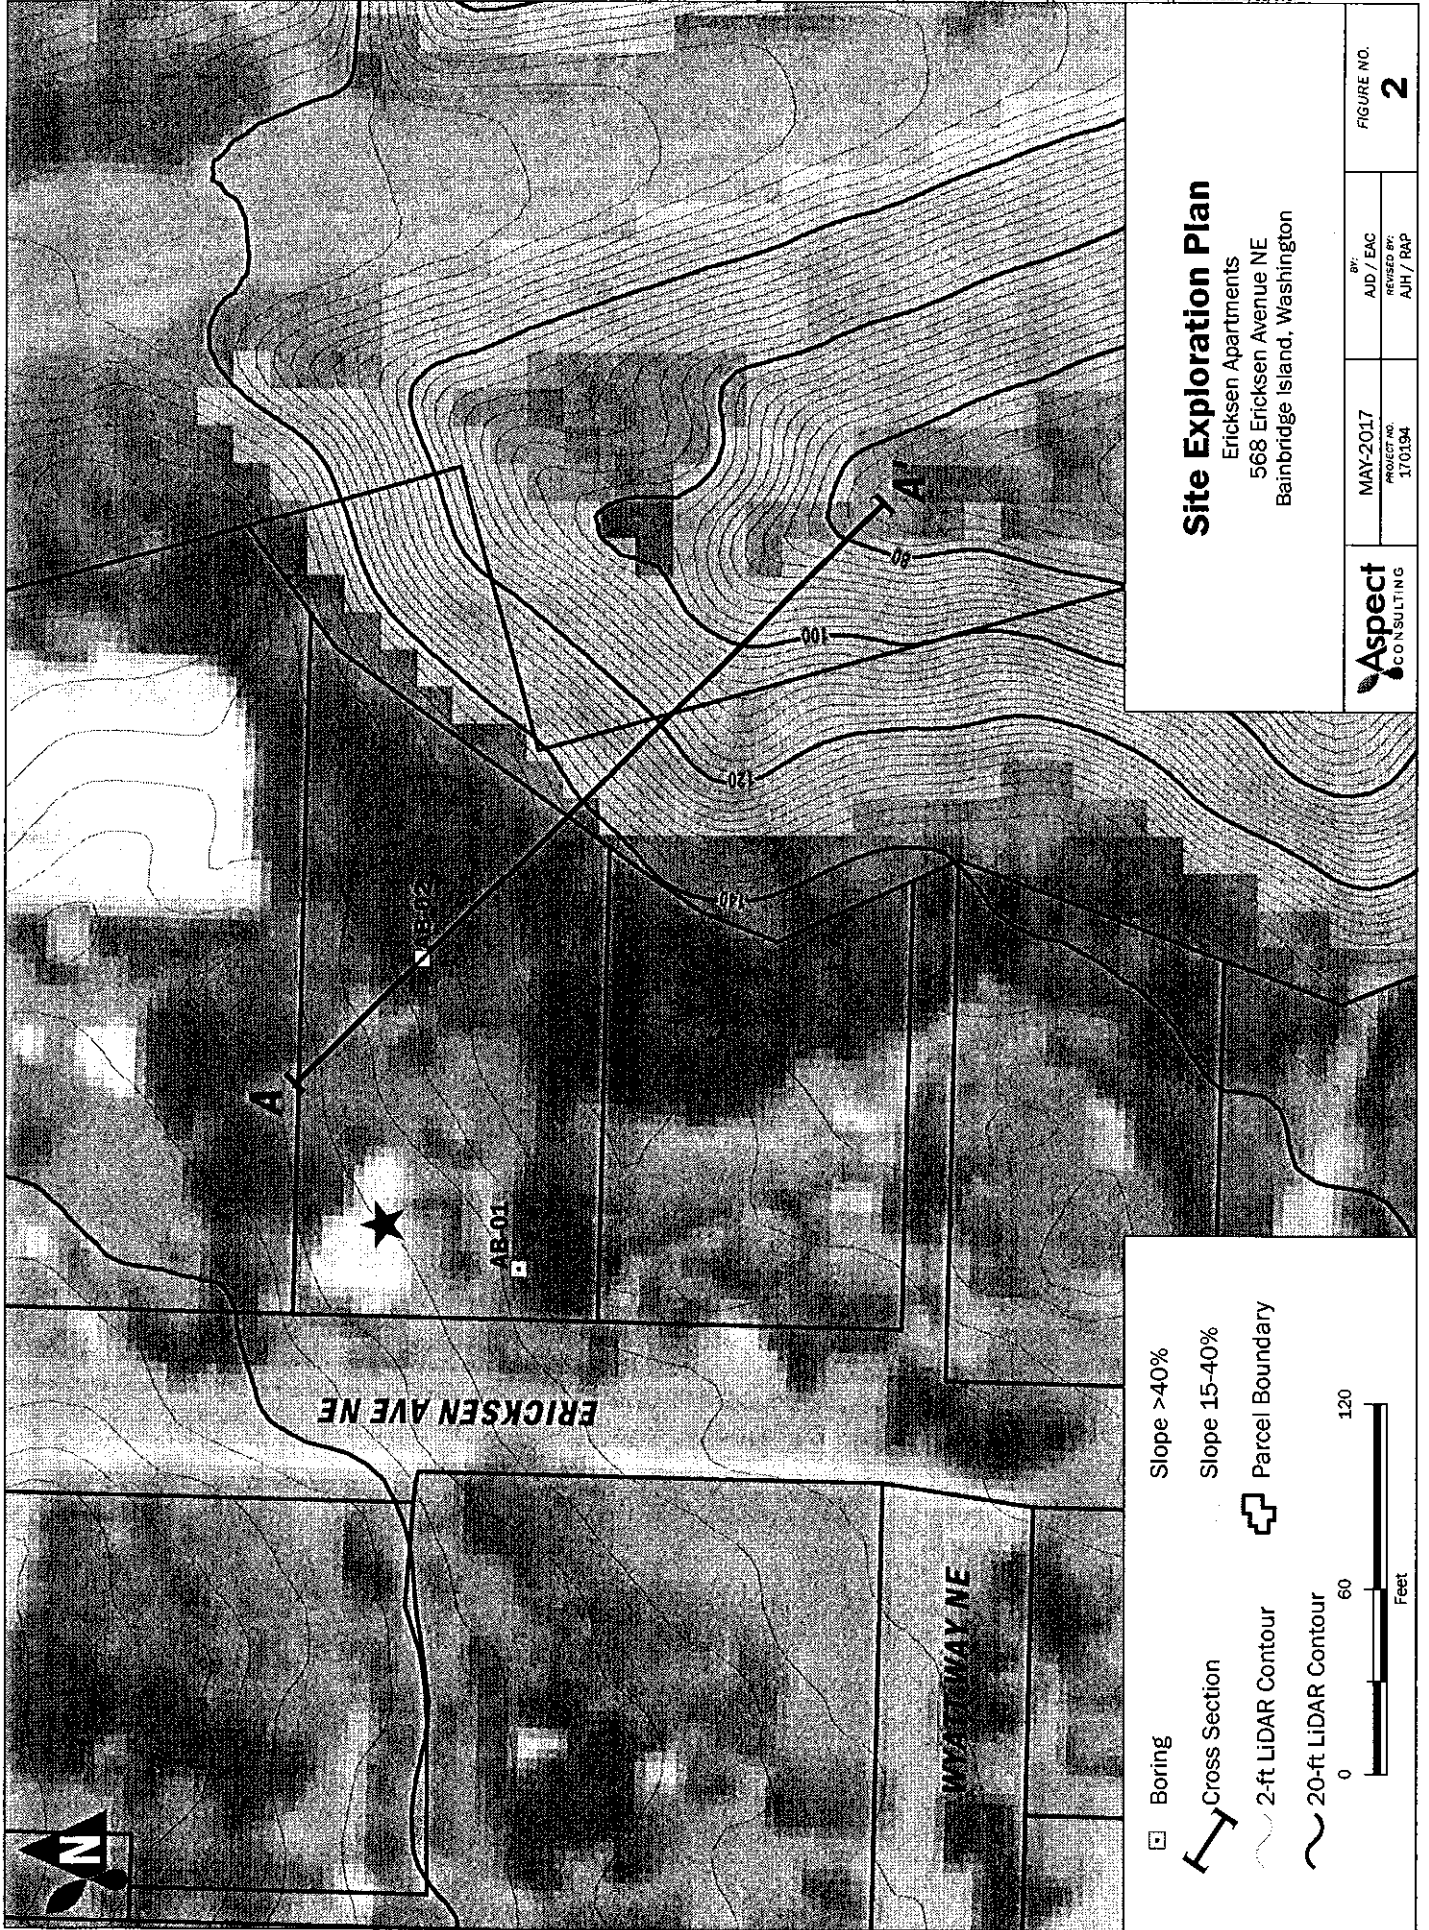
# **Site Exploration Plan** Ericksen Apartments 568 Ericksen Avenue NE Bainbridge Island, Washington

The east-facing slope on the east side of the Site is approximately 64 feet tall with a greater than 40 percent steep slope, as shown on Figure 2. The slope is considered by City of Bainbridge Island (COBI) as a geologically hazardous area. This geotechnical

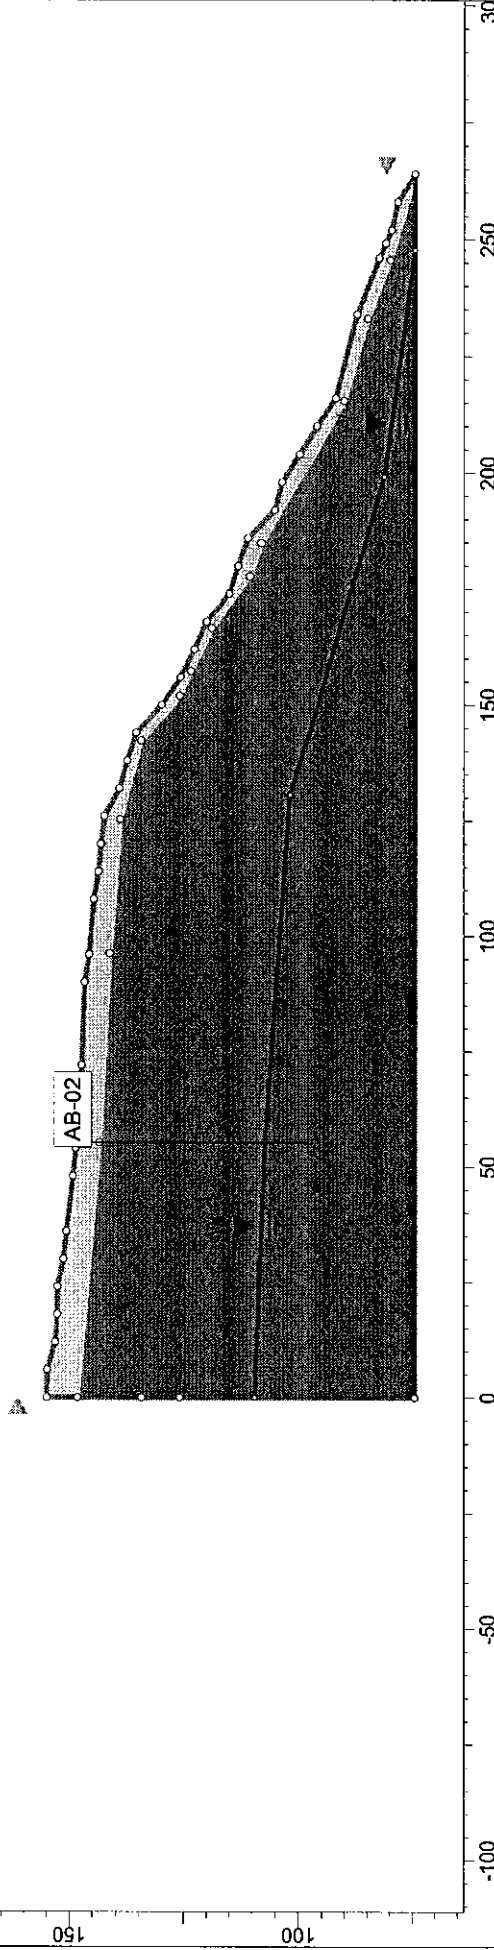
APPENDIX:  
**B-1**

## Existing Conditions Model Setup

## Slope Stability Analysis Ericksen Apartments 568 Ericksen Apartments

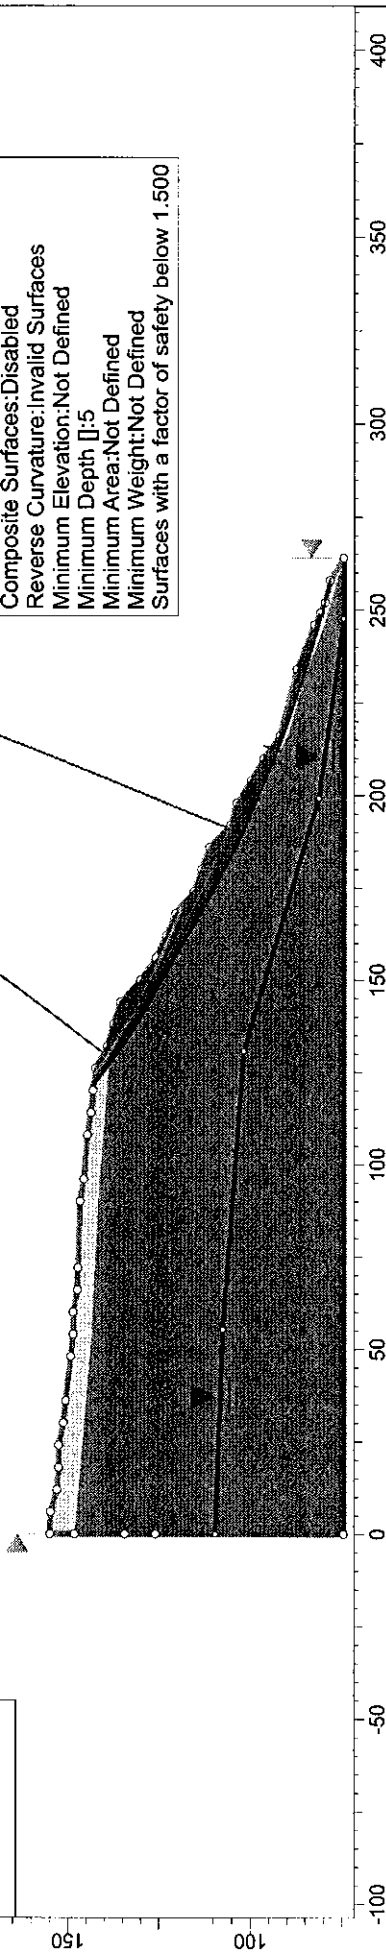
APPENDIX:  
**B-2**

## Existing Conditions Static

## Slope Stability Analysis

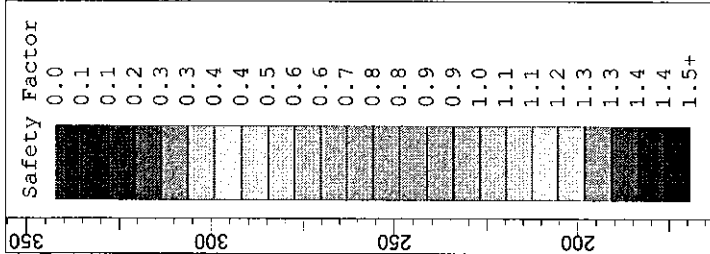
Material Name	Color	Unit Weight (lbs/ft <sup>3</sup> )	Strength Type	Cohesion (psf)	Phi (deg)
Colluvium		120	Mohr-Coulomb	0	30
Vashon Till		130	Mohr-Coulomb	0	40

Results:  
 Analysis Method: spencer  
 Surface Type: Circular  
 Search Method: Grid Search  
 Radius Increment: 10  
 Composite Surfaces: Disabled  
 Reverse Curvature: Invalid Surfaces  
 Minimum Elevation: Not Defined  
 Minimum Depth [J]: 5  
 Minimum Area: Not Defined  
 Minimum Weight: Not Defined  
 Surfaces with a factor of safety below 1.000

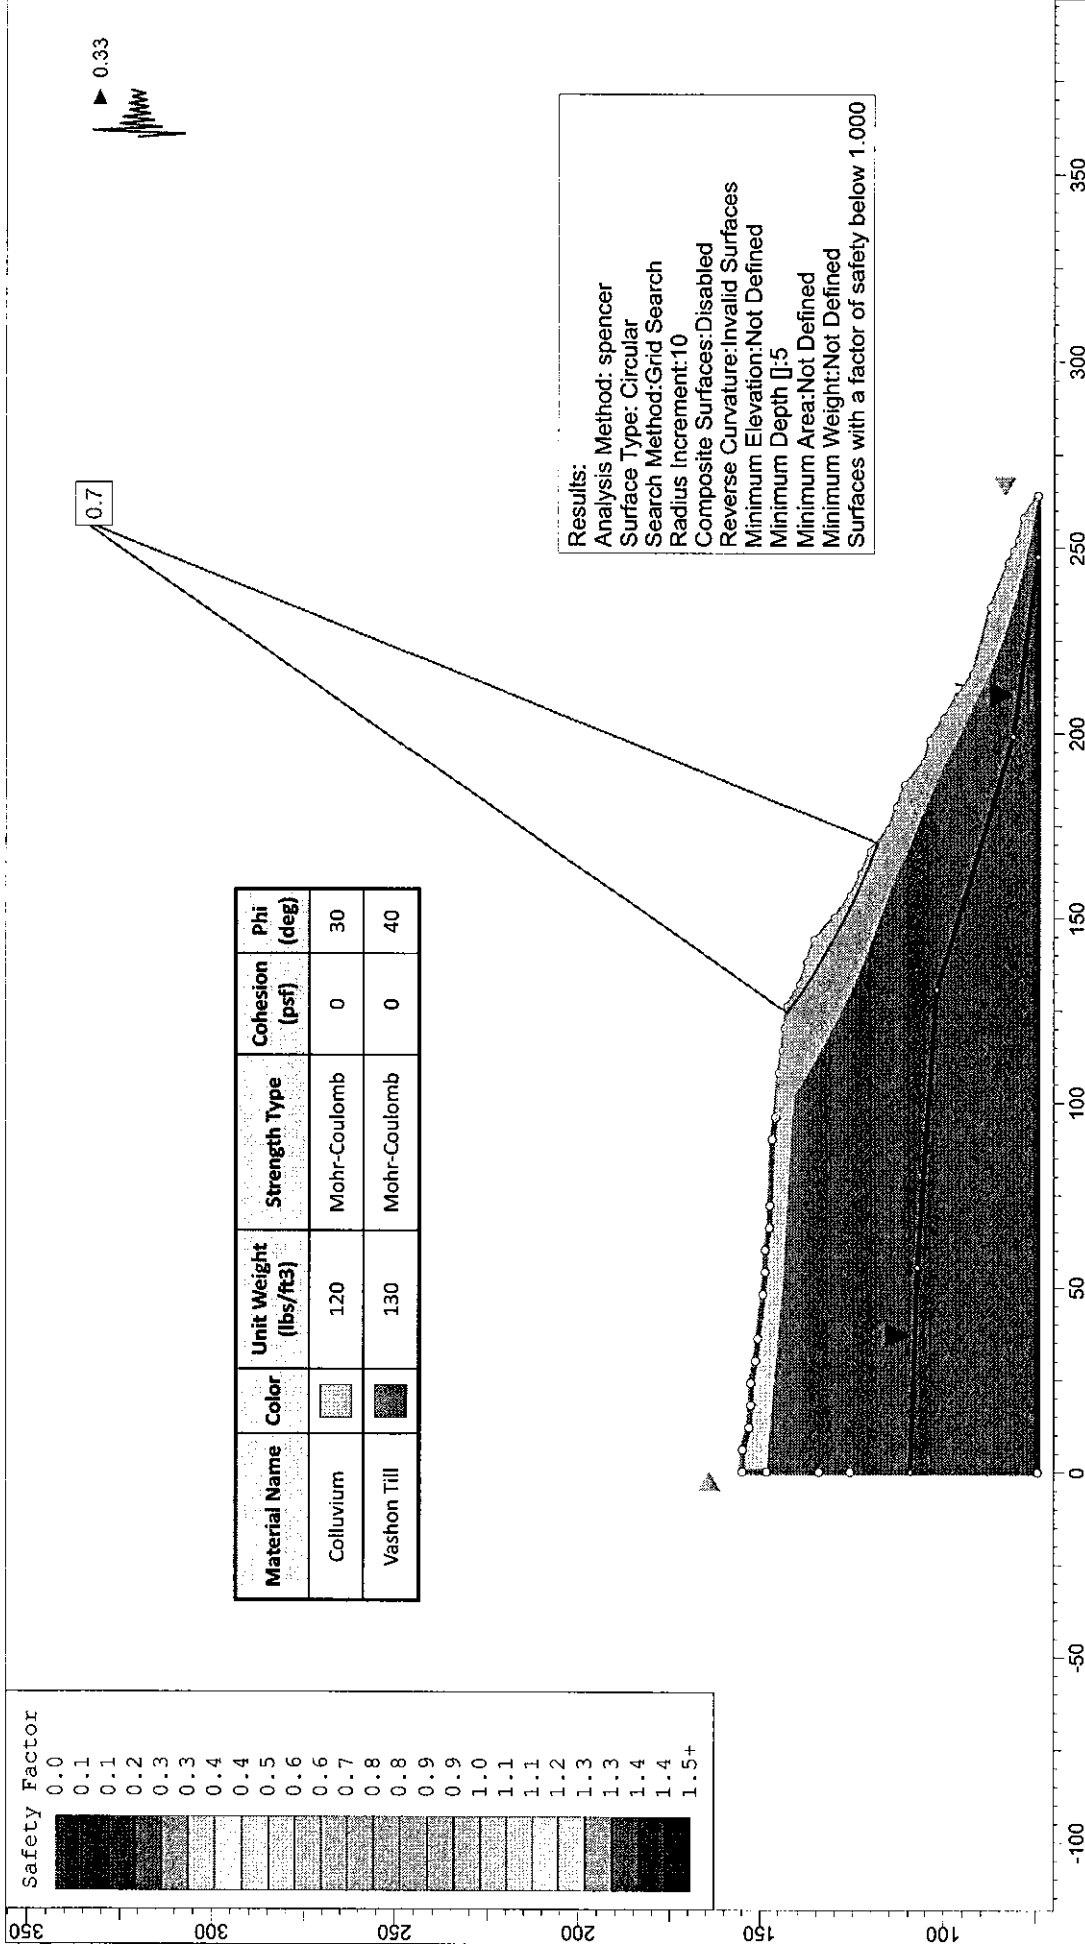
## Existing Conditions Seismic

## Slope Stability Analysis

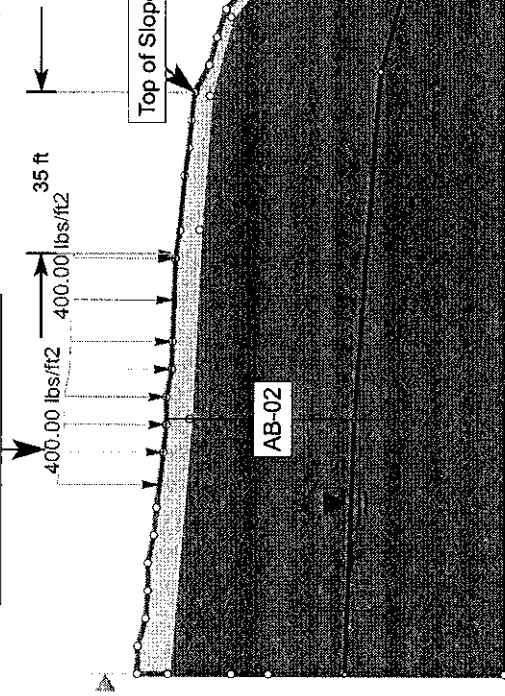
APPENDIX:  
**B-4**

Proposed Building Surcharge

## Proposed Conditions Model Setup

## Slope Stability Analysis Ericksen Apartments 568 Ericksen Apartments

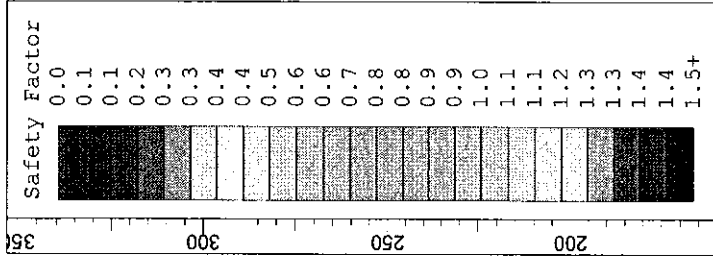
Material Name	Color	Unit Weight (lbs/ft <sup>3</sup> )	Strength Type	Cohesion (psf)	Phi (deg)
Colluvium		120	Mohr-Coulomb	0	30
Vashon Till		130	Mohr-Coulomb	0	40

Results:  
 Analysis Method: Spencer  
 Surface Type: Circular  
 Search Method: Grid Search  
 Radius Increment: 10  
 Composite Surfaces: Disabled  
 Reverse Curvature: Invalid Surfaces  
 Minimum Elevation: Not Defined  
 Minimum Depth [J]: 5  
 Minimum Area: Not Defined  
 Minimum Weight: Not Defined  
 Surfaces with a factor of safety below 1.500

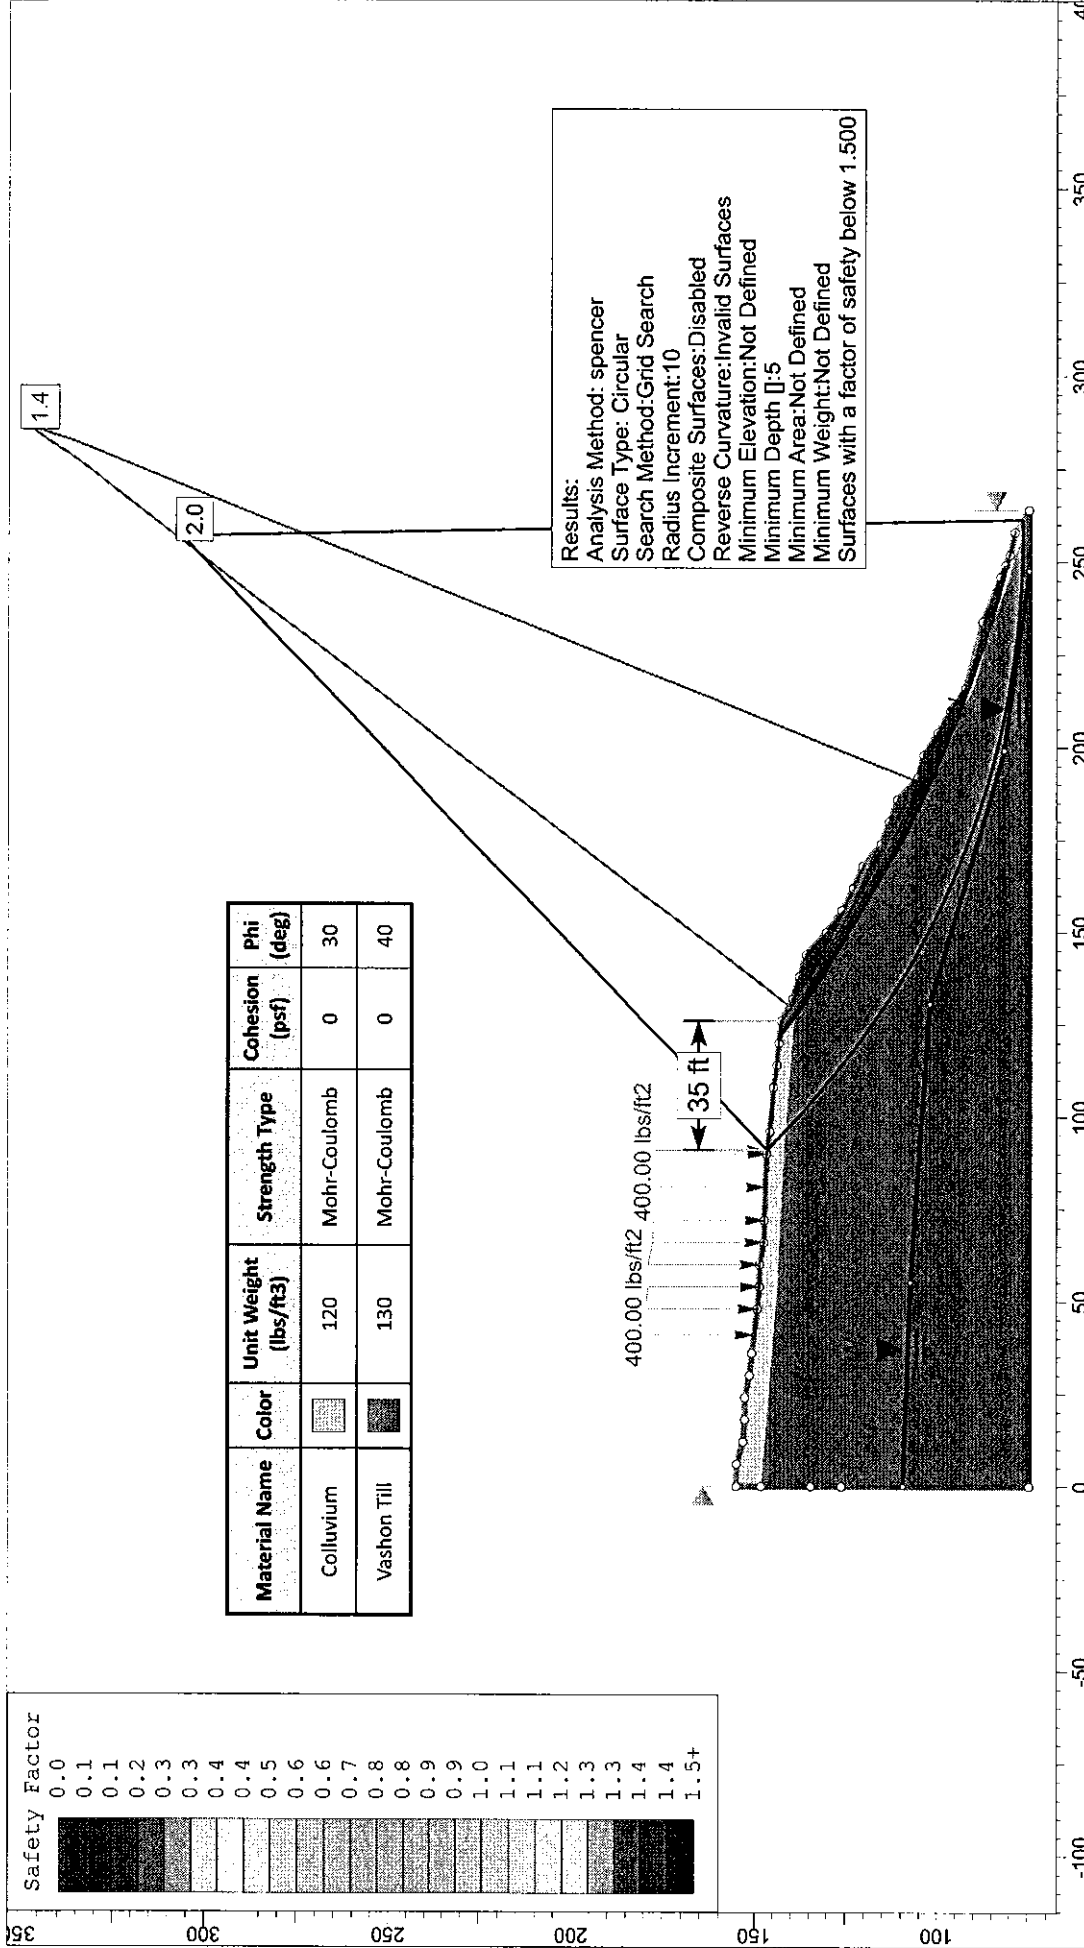
## Proposed Conditions Static Conditions

## Slope Stability Analysis

SLIDEINTERPRET 7.024	Aspect CONSULTING		6/20/2018	BY: NHC REVISED BY: AJH	APPENDIX: <b>B-5</b>
	SCALE: 1" = 50'		PROJECT NO: 170194

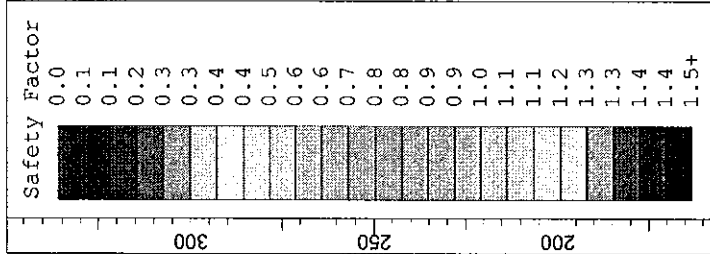
Material Name	Color	Unit Weight (lbs/ft <sup>3</sup> )	Strength Type	Cohesion (psf)	Phi (deg)
Colluvium		120	Mohr-Coulomb	0	30
Vashon Till		130	Mohr-Coulomb	0	40

Results:  
 Analysis Method: spencer  
 Surface Type: Circular  
 Search Method: Grid Search  
 Radius Increment: 10  
 Composite Surfaces: Disabled  
 Reverse Curvature: Invalid Surfaces  
 Minimum Elevation: Not Defined  
 Minimum Depth: 5  
 Minimum Area: Not Defined  
 Minimum Weight: Not Defined  
 Surfaces with a factor of safety below 1.000

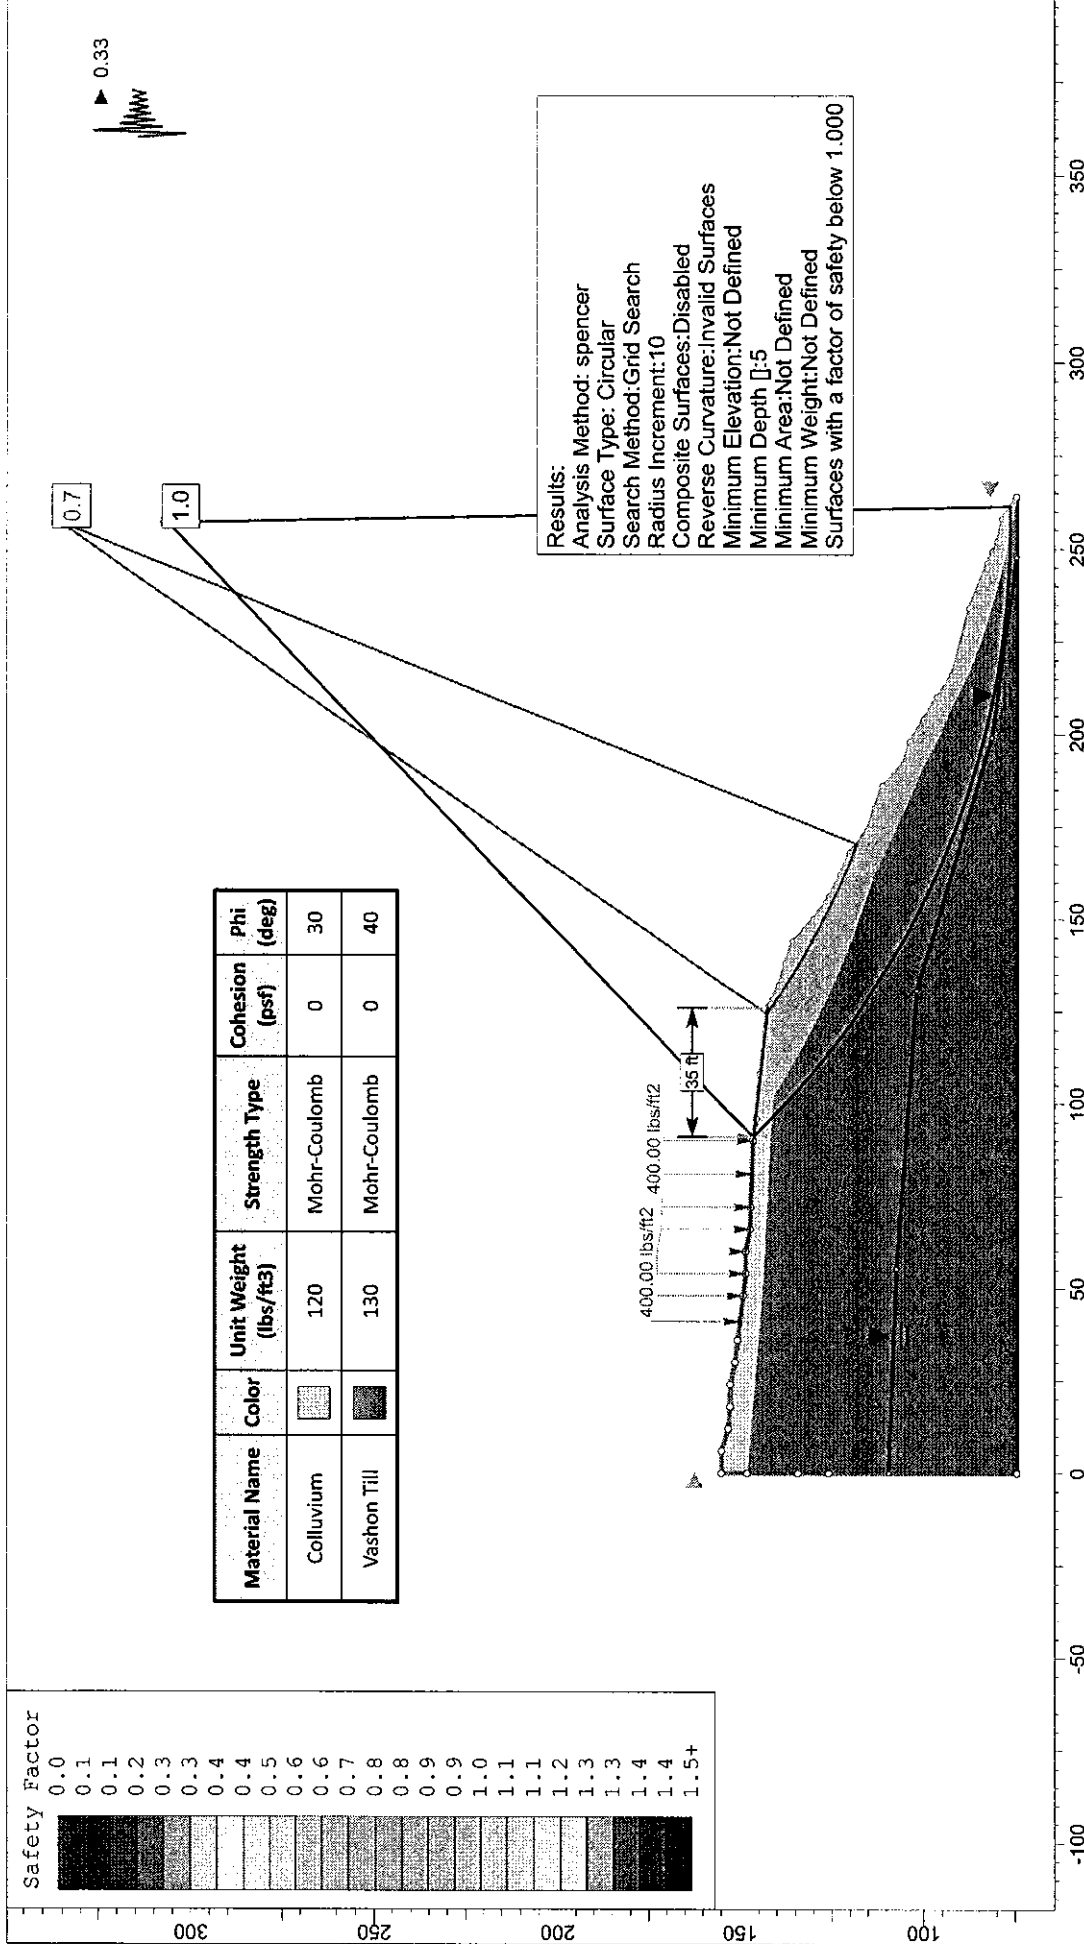
## Proposed Conditions Seismic Conditions

## Slope Stability Analysis
